# Final Report No. 2285 by the Swiss Transportation Safety Investigation Board STSB

concerning the serious incident involving the A319-132 Airbus aircraft, registration YU-APA,

on 17 October 2014

5.5 km north-west of Zurich Airport (LSZH)

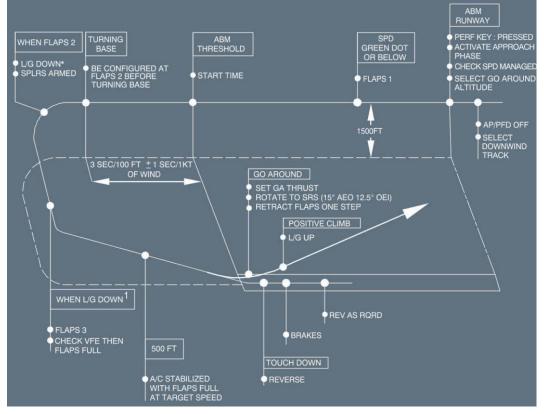
Figure 10: Procedures for visual approach (copied from OM Part-B)

After touchdown also, none of the required callouts (see chapter 1.17.1.3, figure 10) can be heard on the voice recordings. It must be assumed that the flight crew did not realise that the ground spoilers had not deployed at touchdown already, but only when reverse thrust was activated. Insofar, that is not surprising as – because of the APU's late initiation shortly before touchdown – the automatic display of the wheel page was not possible, and consequently, deployment of the ground spoilers could not be checked. In the present case, the wheel page would have had to be manually selected.

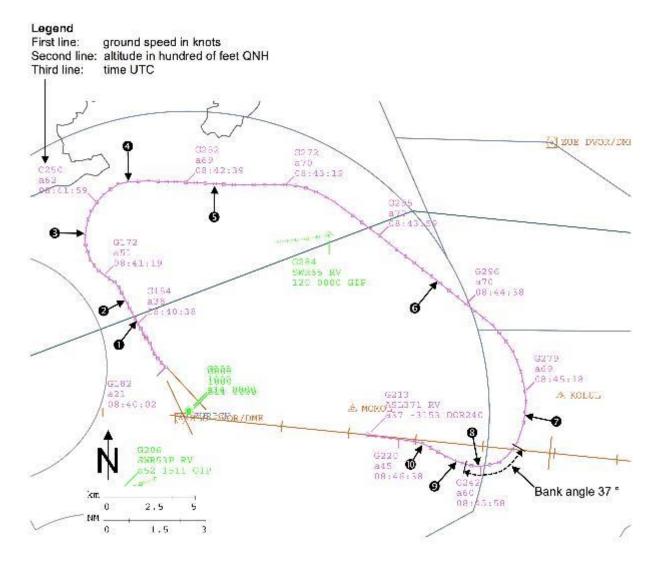
Flight path YU-APA

0	08:40:40 UTC	Master warning ENG2 OIL LO PR is triggered
0	08:40:56 UTC	The commander reports: "Air Air Serbia uh three seven one, request immediately return to the airport please."
0	08:41:44 UTC	The commander starts to execute the ECAM procedure
0	08:42:15 UTC	The right engine master switch is set to OFF
Ø	08:42:51 UTC	The flight crew confirms: "Uh yes we are ready and uhplease radar vectoring for runway two eight, uh maybe we will prefer from this position visual approach for two eight."
0	08:44:25 UTC	The flight crew confirms that they have visual contact to runway 28
0	08:45:27 UTC	The autopilot (AP) is switched OFF
0	08:45:59 UTC	The speed brakes get fully extended
ø	08:46:09 UTC	The gear gets extended
Ø	08:46:26 UTC	The ATCO asks the crew whether they will make it because they were slightly high
