# **Final Report No. 2303**

## **by the Swiss Transportation Safety Investigation Board STSB**

concerning the accident involving the  
ATR 72-202 commercial aircraft,  
registration D-ANFE,

on 4 December 2014

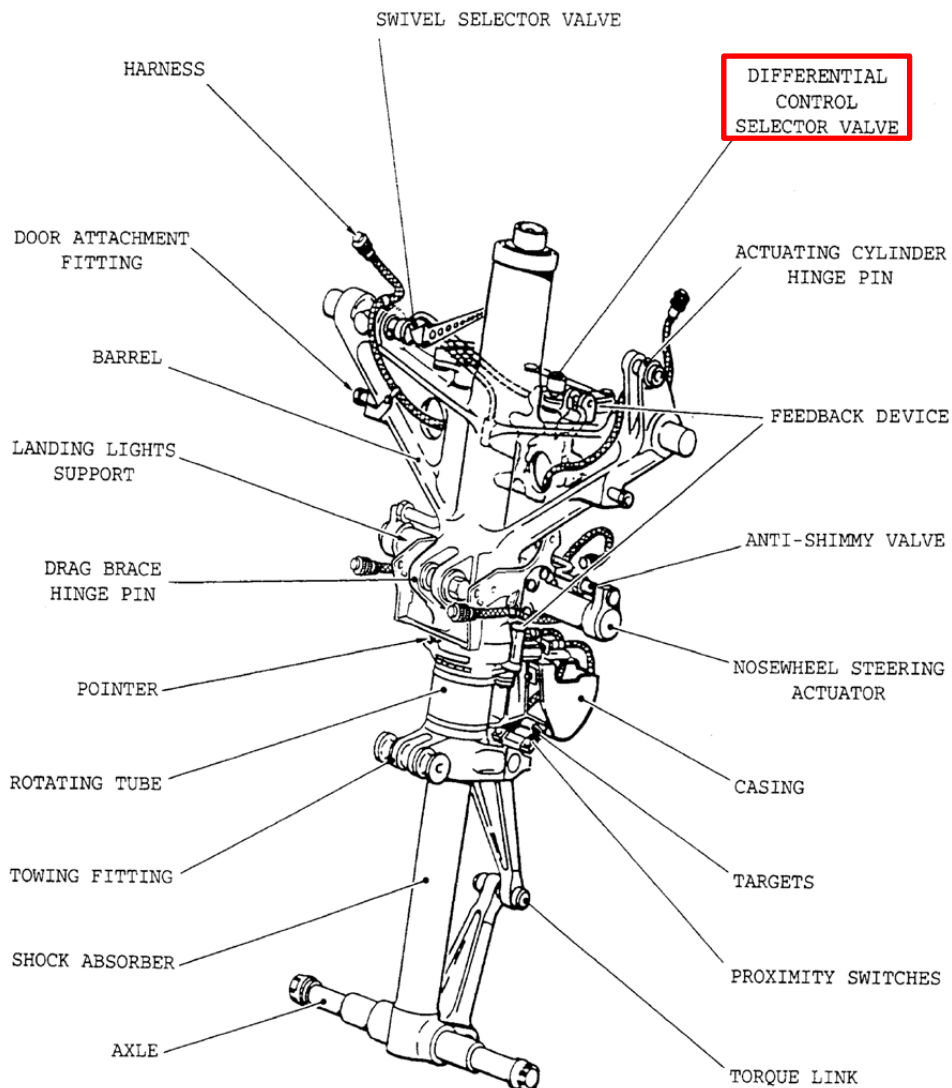
**Figure 1:** Illustration of the nose landing gear components with the description differential control selector valve (DCSV) framed in red

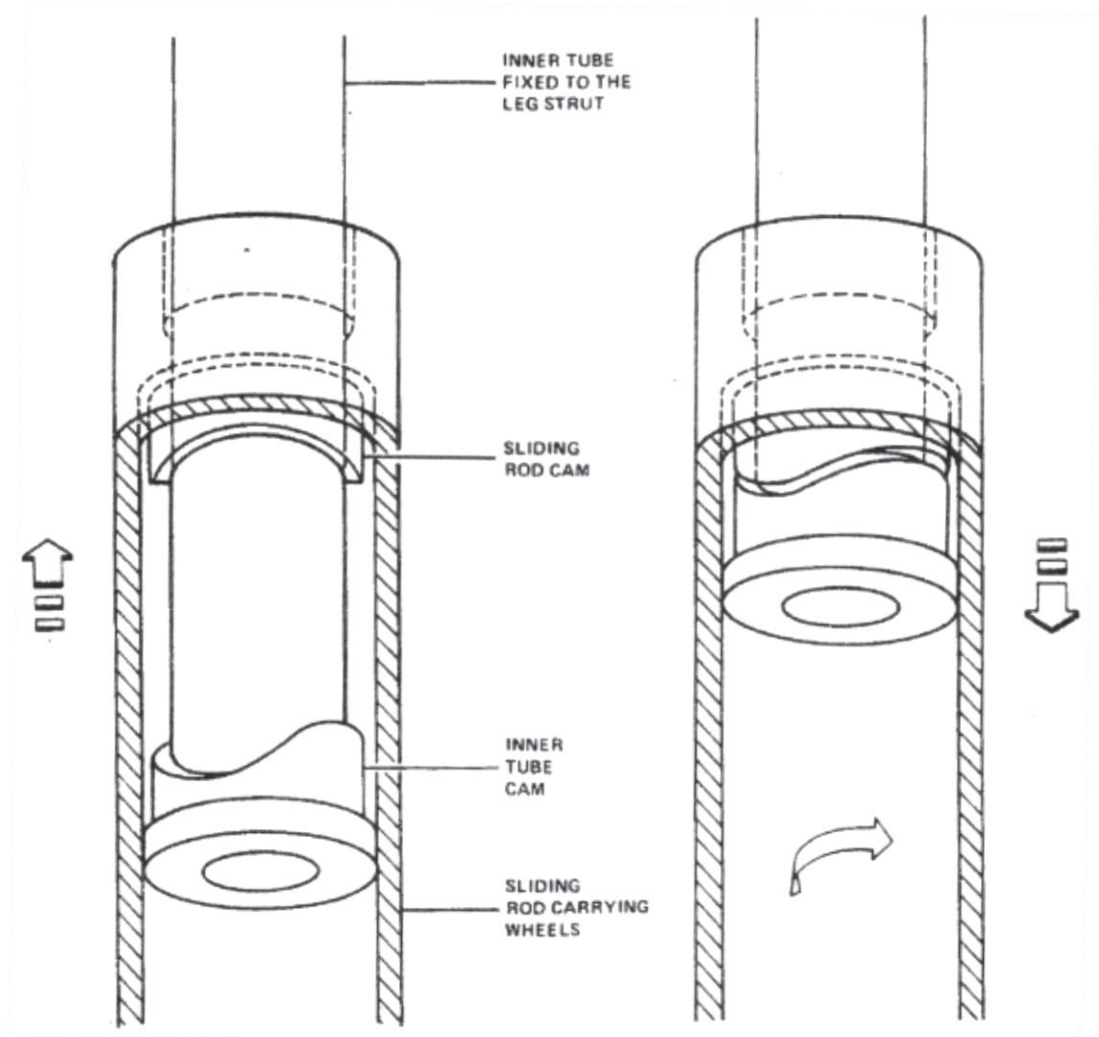
**Figure 2:** Illustration of the nose landing gear shock absorber in the compressed state on the left and in the extended state on the right, in which the nose landing gear is centred via the cams.

With the nose wheels not centered, the shock absorber is not fully extended due to the two cams (cf. Figure 2). As a consequence, the proximity switches cannot detect the NLG in air mode and the NLG cannot be retracted.

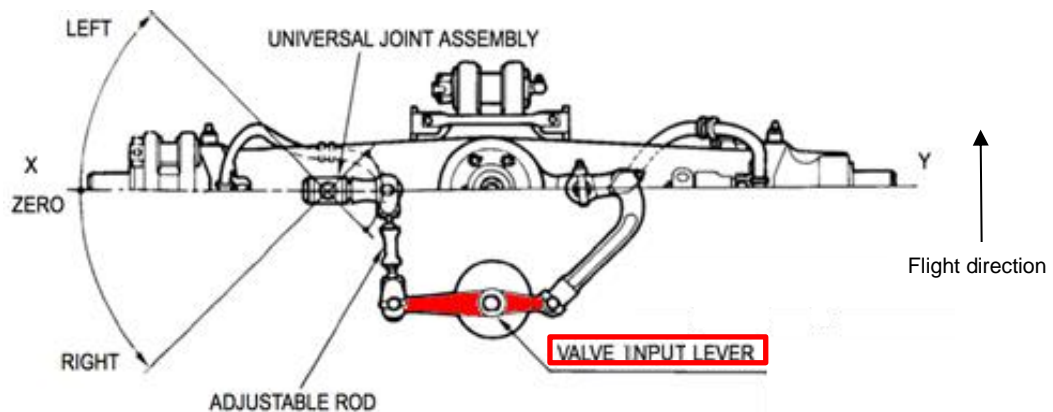
The differential control selector valve (DCSV) is mounted above the nose wheel steering actuator on the rear side of the nose gear. Two hydraulic lines connect the nose wheel steering actuator to the DCSV and this in turn is connected via two hydraulic lines to the blue hydraulic system (pressure and return lines). On its upper side the DCSV is mechanically connected via the valve input lever and the feedback device and other components to the tiller control in the cockpit. In turn the valve input lever is connected to a rocking plate which drives the DCSV through a control piston. In addition it has a control valve which connects both hydraulic lines to the nosewheel steering actuator control valve in order to allow free rotation of the NLG assembly during towing operations. In addition this assembly acts as an anti-shimmy. With the DCSV in its disassembled state, the valve input lever can rotate freely; add to this, it is not symmetrically constructed – one end is longer than the other (cf. Figure 3).

**Figure 3:** Illustration of the differential control selector valve (DCSV) with the valve input lever framed in red and the input angle (X) in a range of - 36 degrees to + 36 degrees.

Clearly, correct attachment of the valve input lever is associated with risks in view of the fact that this component is free to rotate if its ends are not attached (cf. Figure 3). This was already recognised in the context of the incident investigated in New Zealand, which is why the following comments were entered in the aircraft maintenance manual under Section 32-51-00.

*“Item 004 (Installation) Place the differential control [selector] valve input lever in position noted during the removal, with the long leg of the valve input lever pointing at the left side of the aircraft.”*

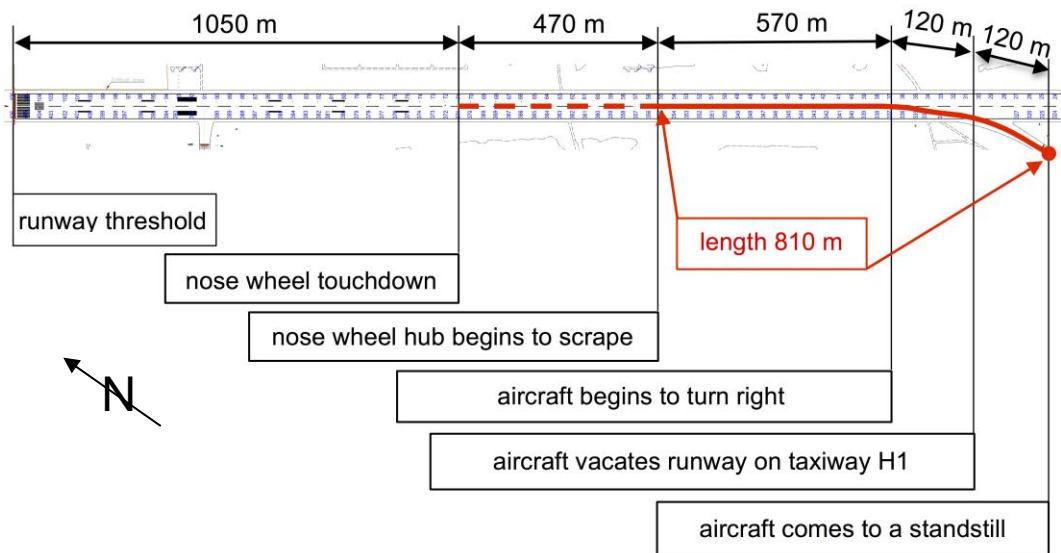
As is evident from the video recordings, the landing manoeuvre and touchdown of the wheels occurred normally. The nose wheels came into contact with the runway approximately 1050 m after the runway threshold 14. Subsequently both tyres separated from the wheel rims, whereby the left tyre got blocked between the wheel rims and the right tyre completely detached and was found 2080 m after the runway threshold. It was possible to measure the first abrasion marks from the rims on the surface some 1520 m from the threshold.

**Figure 6:** Schematic illustration of the landing sequence of D-ANFE on runway 14 and the exit via taxiway H1

Despite some lateral deviations from the runway centre line due to the alignment of the nose landing gear and the resulting damage, lateral control could be assured by setting asymmetrical power from the engines. It was finally possible to bring the aircraft to a controlled standstill behind the taxi holding position marker of taxiway H1. In the process, the surface of runway 14 was slightly damaged.
