Final Report No. 2309

by the Swiss Transportation Safety Investigation Board STSB

concerning the accident involving
the Airbus Helicopters AS 350 B3
helicopter, registration HB-ZIS,

on 14 July 2015

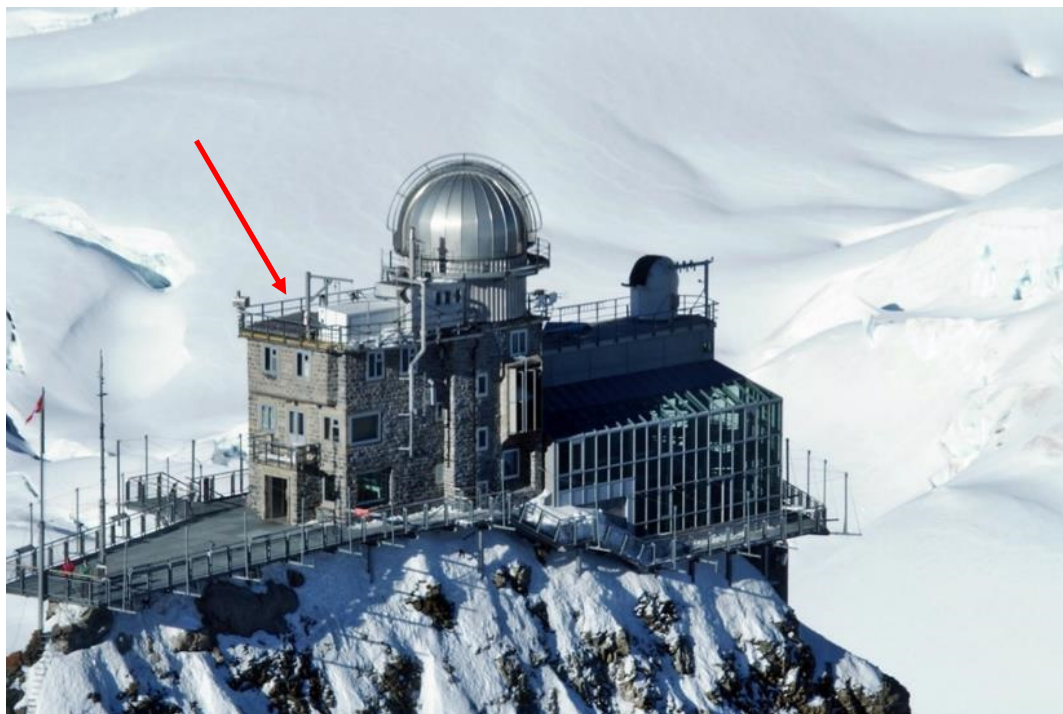
Figure 1: Sphinx Observatory; the red arrow points to the roof

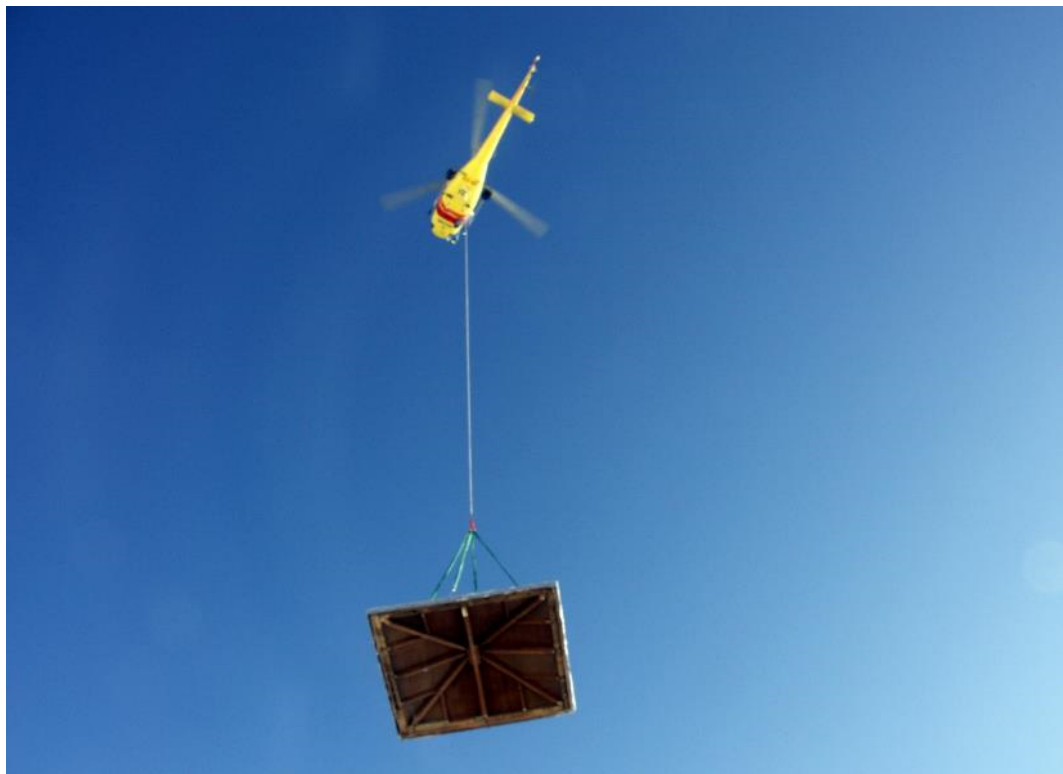
Figure 4: HB-ZIS flying off after taking up the load

The pilot steadily accelerated HB-ZIS to a ground speed (GS) of approximately 50 kt and initiated a gentle descent. At first, the load was hanging steady. However, the roof suddenly moved into a vertical position. The helicopter changed its attitude slightly. The roof then fell back into the slings. After this, the helicopter began to roll from side to side and at the same time the load was swinging and turning. The persons at the Sphinx observatory were now able briefly to see the underside of the roof. Suddenly the load became detached and fell towards the Guggigletscher. When the persons looked at the helicopter, they saw that the nose of the helicopter was pointing upwards at an angle of 50° to 60°. One person also thought they had seen a whitish cloud at this time. HB-ZIS then moved backwards and began to turn away sideways. Initially, it then appeared that the helicopter was attaining a normal flight attitude. But then HB-ZIS began to descend rapidly. The helicopter impacted with an almost horizontal attitude and at a low forward speed on the Guggigletscher. The pilot was fatally injured and the helicopter was partially consumed by fire. Several people observed the accident and immediately alerted the police.

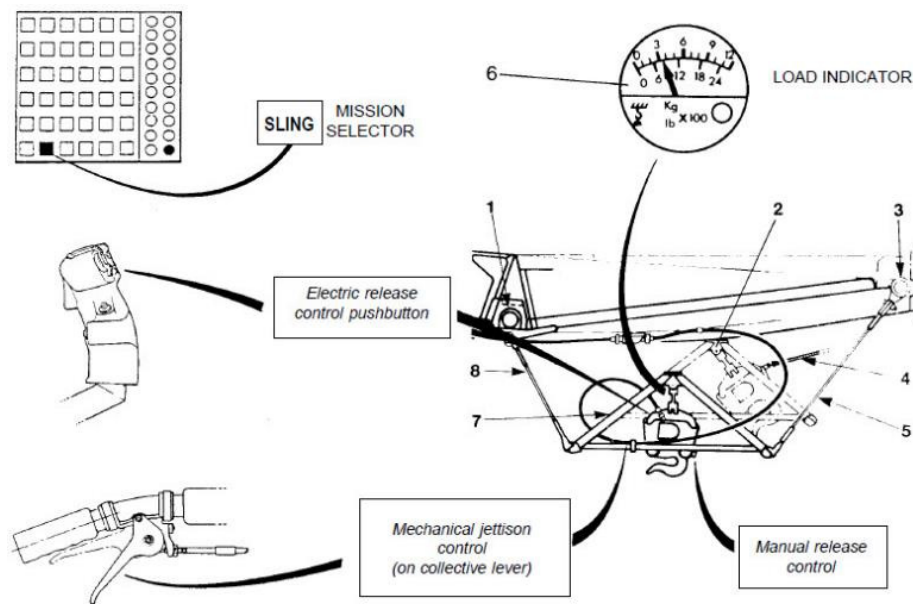
1.6.3	External load system	
	<p>HB-ZIS was equipped with an external load system of the cargo swing type. This system is characterised by a pyramid-shaped steel structure (7) with a centrally attached swivel hook (2), which was secured by four steel cables (5 and 8) to the bottom of the fuselage (1 and 3) of the helicopter.</p>

Figure 5: Illustration of the external load system from the Airbus Helicopters flight manual.

The swivel hook can be retained in the unloaded condition by a flexible line (4), in order to increase ground clearance. The swivel hook can be operated from the cockpit electrically or mechanically. A load indicator is also fitted (6).

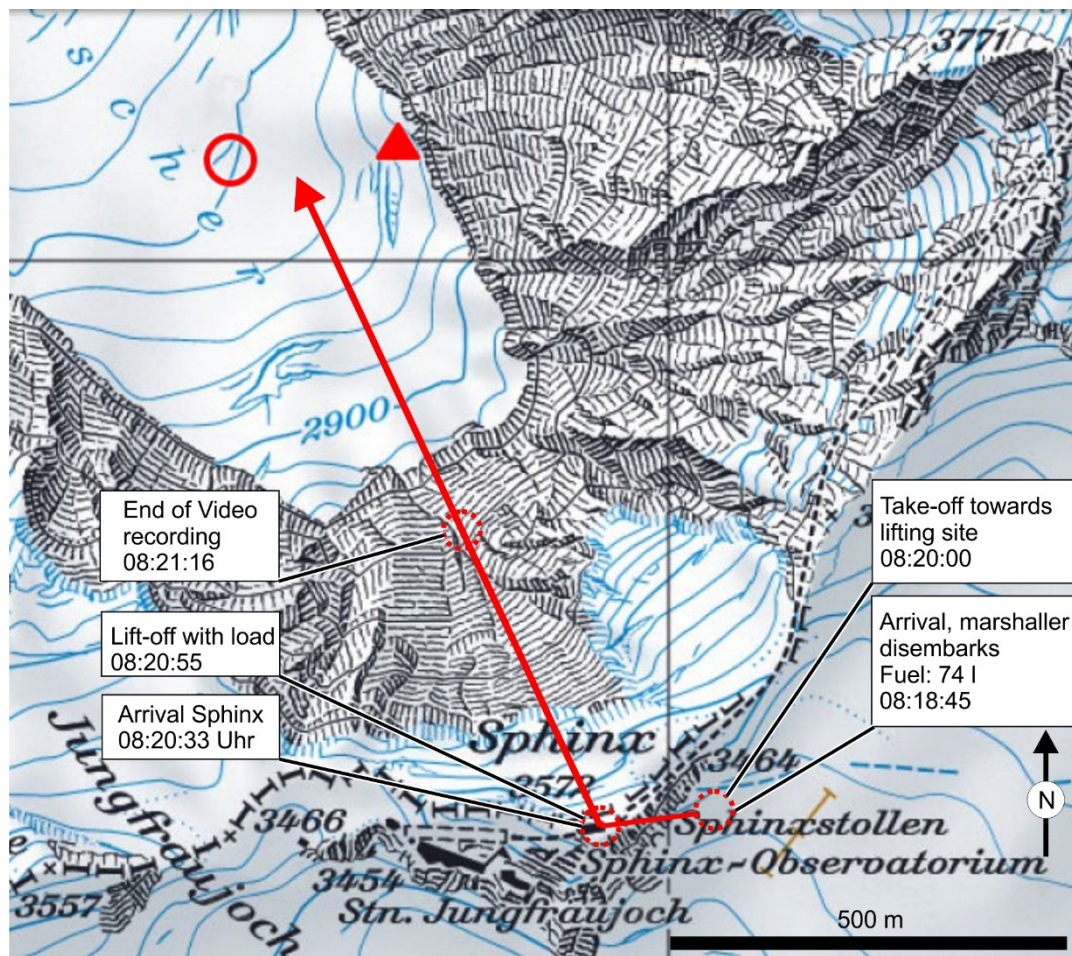
Figure 7: Flight path of HB-ZIS. The red circle marks the final position of the wreckage; the red triangle shows the final position of the external load.

The external load was found approximately 200 m from the accident site, close to a glacier crevasse. The surface of the roof or rather the pyramidal peak was pointing upwards and the timber structure was facing towards the ice.
