Final Report No. 2313

Concerning the accident involving the
DynAero MCR-ULC aircraft, HB-WAR,

on 13 December 2015

at Locarno Airport / TI (LSZL)

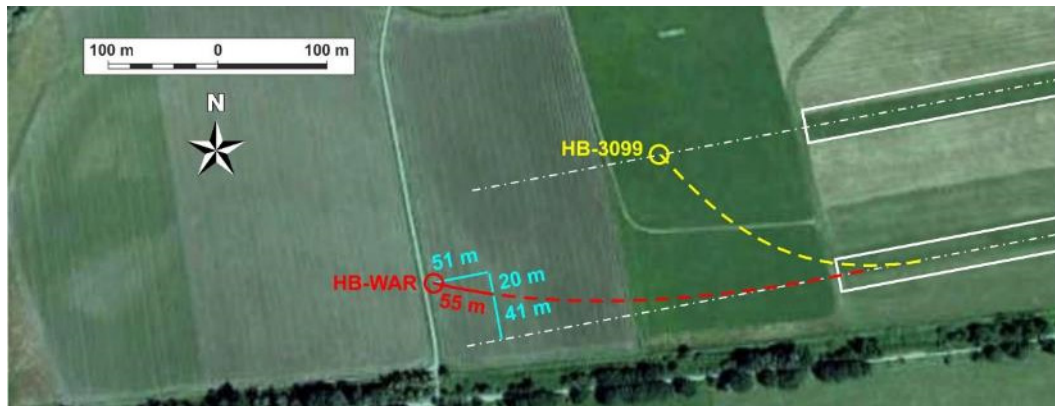
Illustration 1: Final positions of the two aircraft, HB-WAR and HB-3099, in the extension of runway direction 26

The final position of the aircraft was 365 m after the end of runway 26L. The wreckage lay in the direction of flight against the bank of a farm track. As a result of the impact with the bank, the nose landing gear was broken off, the two propeller blades at the bottom were bent and the two wing tips were damaged (see illustration 3).
