Final Report No. 2319

concerning the serious incident involving
the Robinson R22 Beta II helicopter
HB-ZGO

on 6th April 2016

1 km south-east of Worb, canton of Bern

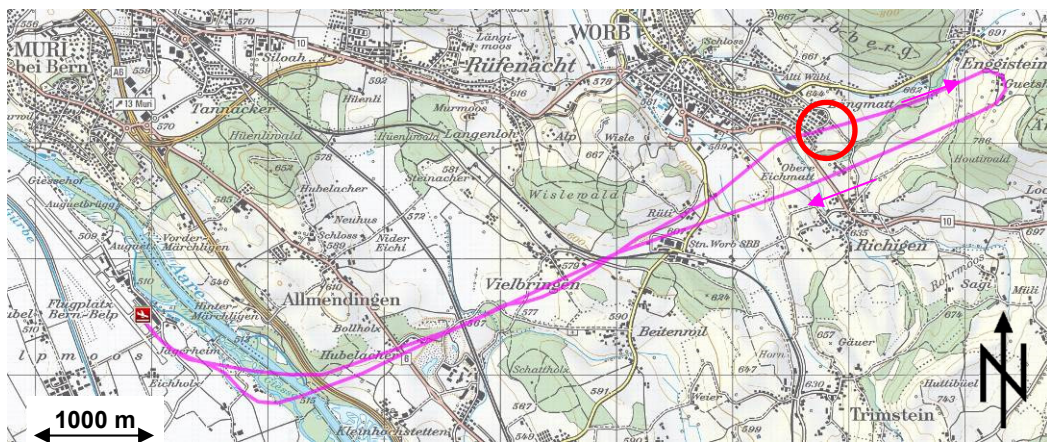
Illustration 1: The flight path according to the navigation software recordings; the red circle indicates the approximate position at which the flight crew noticed the problem with the electrical system; source of base map: Federal Office of Topography.

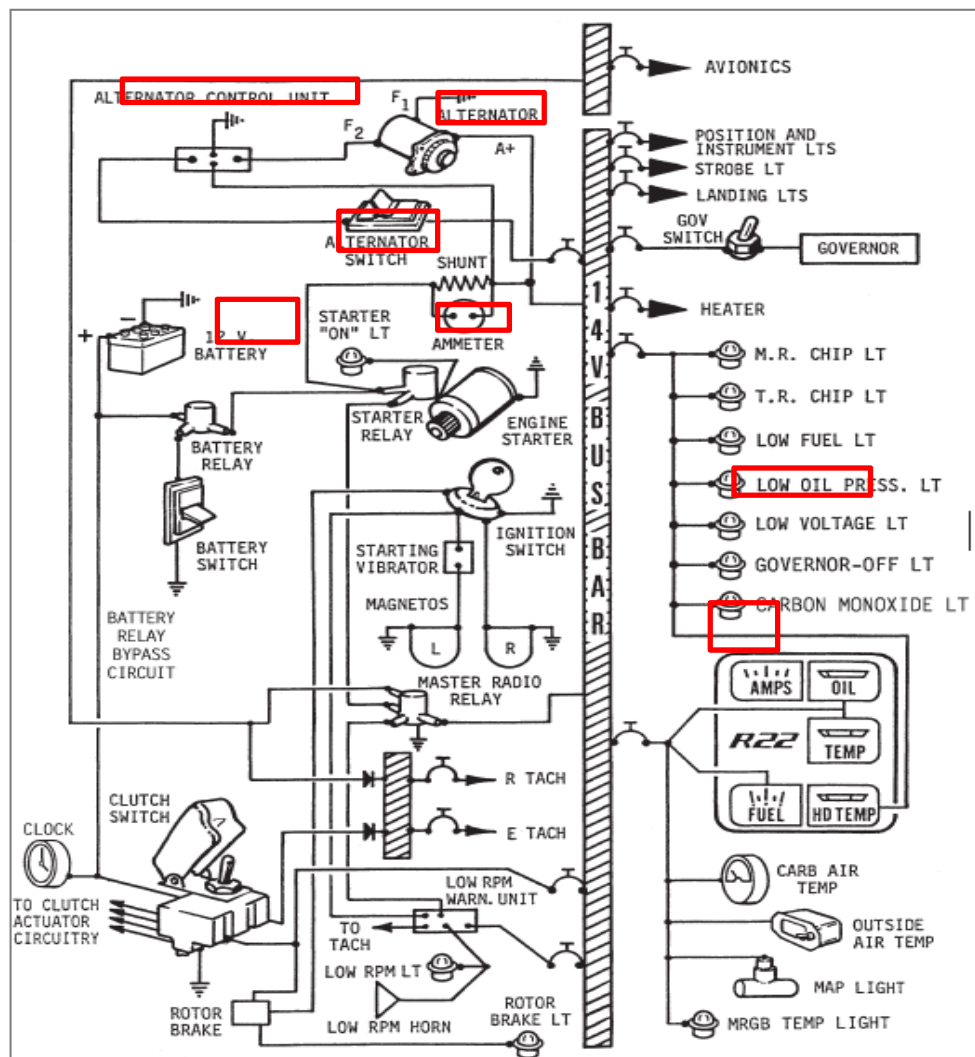
Illustration 2: A schematic diagram of HB-ZGO's electrical system as per the POH. The components relevant to the serious incident under investigation have been highlighted with a red rectangle by the STSB for better visibility.
