Final Report No. 2320

concerning the accident involving the
Bell 206B helicopter HB-XSL

on 9th June 2016

400 m north-west of Heimeneegg,
municipality of Buchholterberg
in the canton of Bern

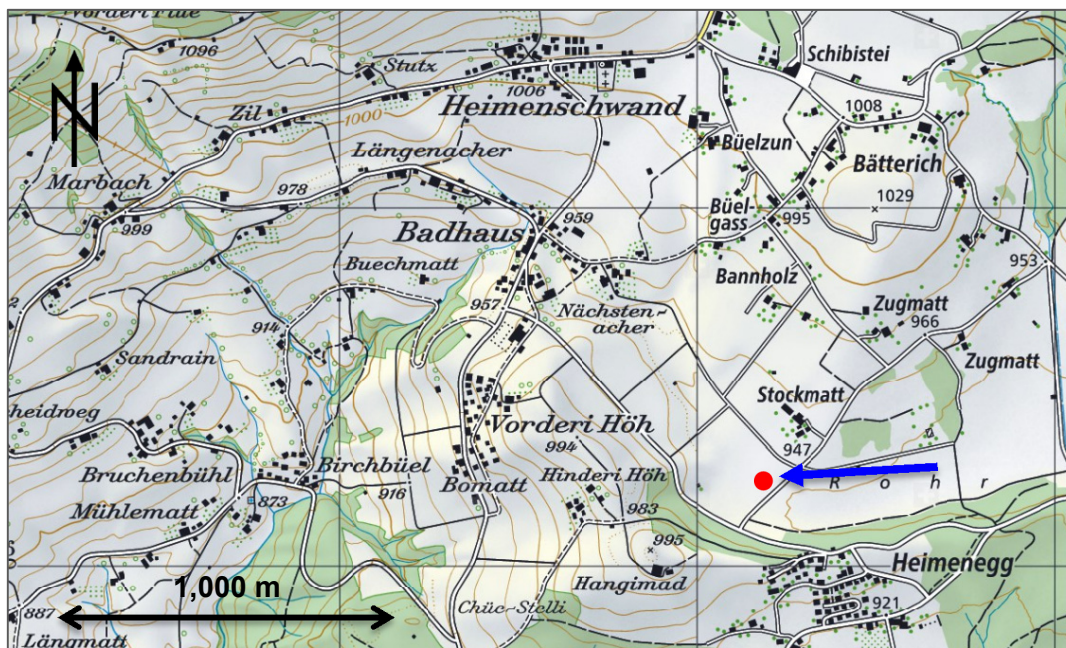
Illustration 1: Touchdown point of the helicopter HB-XSL north-west of Heimeneegg in the canton of Bern following the engine failure (red dot). The blue arrow indicates the approximate direction of the final approach during the autorotation exercise. Source of base map: Federal Office of Topography.

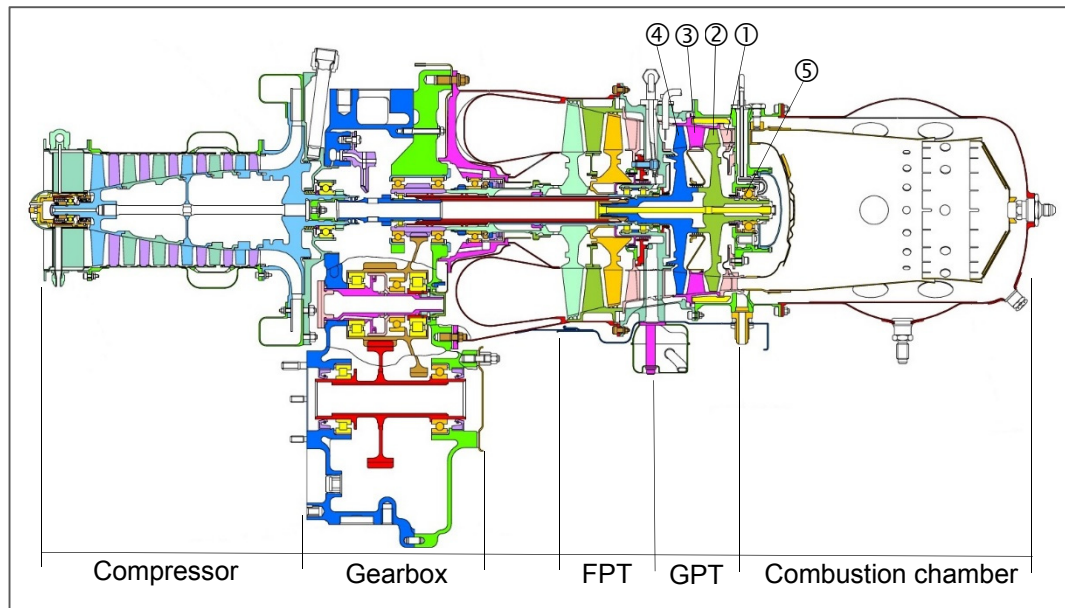
Illustration 4: Cross-sectional view of an Allison M250-C20 engine: ① GPT first-stage turbine nozzles ② first-stage turbine wheel, ③ second-stage turbine nozzles, ④ second-stage turbine wheel and ⑤ no. 8 GPT bearing. Illustration from the manufacturer, adapted by the STSB.
