Final Report No. 2325

by the Swiss Transportation Safety Investigation Board STSB

Concerning the serious incident (near-collision)
involving the commercial aircraft Fokker 50, OO-VLF,
operated by Vlaamse Luchttransportmaatschappij N.V.
(VLM) under the flight plan call sign VLM 22TX
and the Piper PA-28RT-201T aircraft, OK-ELL,
on 21 April 2016
approximately 10 NM north-east of
Friedrichshafen airport (EDNY), Germany

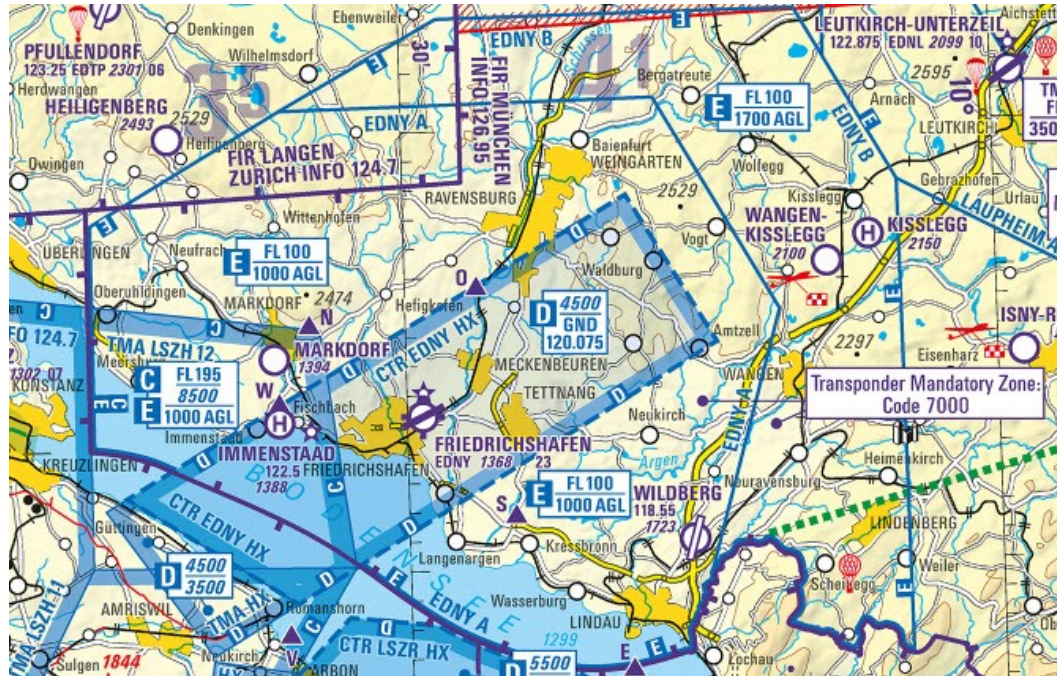
Figure 4: Aeronautical map of Switzerland and Liechtenstein of 31 March 2016 with the two transponder mandatory zones (TMZ) EDNY A and EDNY B, source: Swiss federal office of topography (Swisstopo)

Both transponder mandatory zones (TMZ) (cf. figure 4) around Friedrichshafen Airport not only make VFR traffic visible to the air traffic control units equipped with a radar, they also lay the foundation for the safety net of the airborne collision avoidance system (ACAS) relying on the transponder signal.

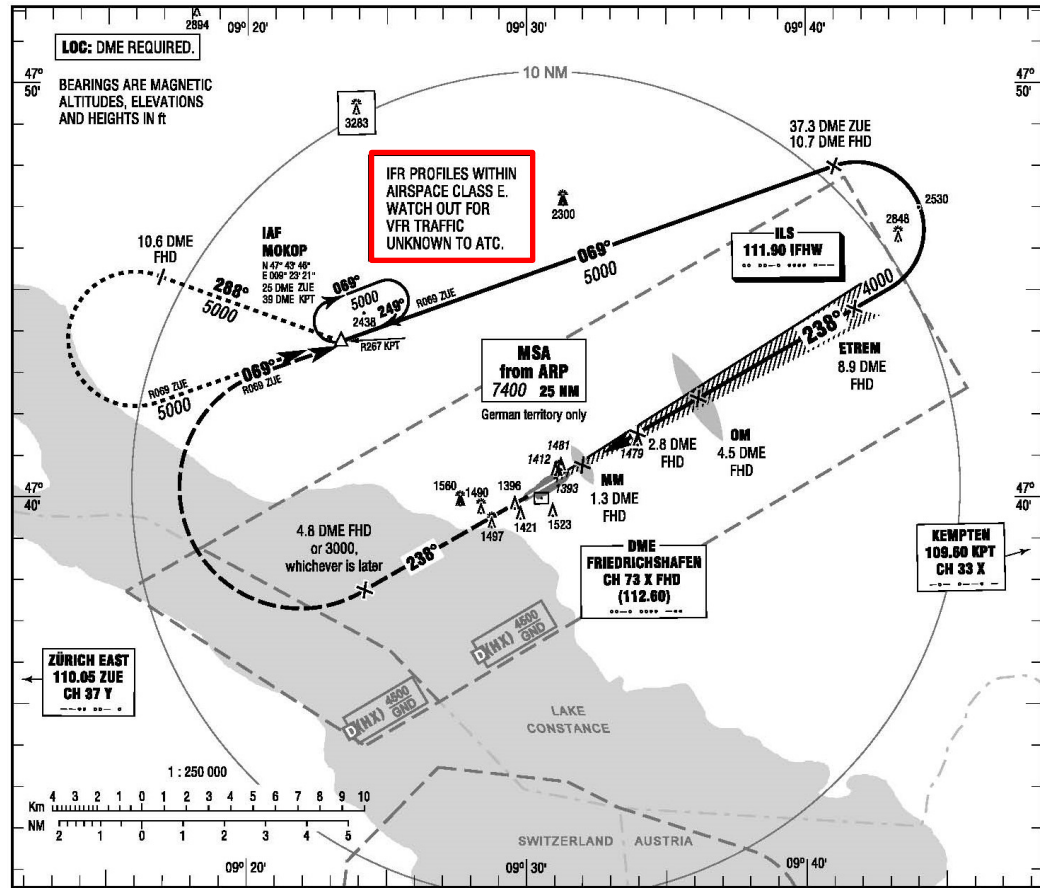
Figure 5: ILS approach to runway 24 in Friedrichshafen according to the German AIP with a note (red frame), stating that the approach leads partly through airspace E and therefore unknown VFR traffic is to be expected.

Six minutes later approximately, at 08:09:33 UTC and a second time at 08:09:48 UTC, the pilot of OK-ELL was instructed by the VFR Pick-up aerodrome controller to proceed towards waypoint ETREM, the final approach point FAP of the runway 24 ILS (cf. figure 5). Since he was on long final approach to runway 14 and after having been transferred to the controller at the workstation PL Main, the pilot of OK-ELL called on frequency 134.300 MHz and was once again instructed to turn right towards waypoint OSCAR and to remain outside of the CTR. This change of course in a northerly direction, at an altitude of 4000 ft QNH approximately, resulted in OK-ELL flying towards VLM 22TX which was in a right hand base. Consequently, OK-ELL did not circumnavigate the CTR of Friedrichshafen, as required by the operational guidelines in force during the aviation exhibition (cf. chapter 1.7.6.3), thereby establishing a key condition for the dangerous convergence.

which is the case for the ILS approach to runway 24 – to follow the complete approach procedure from the IFR waypoint MOKOP according the AIP (cf. figure 5), or if under radar vectoring, as was the case in this incident.

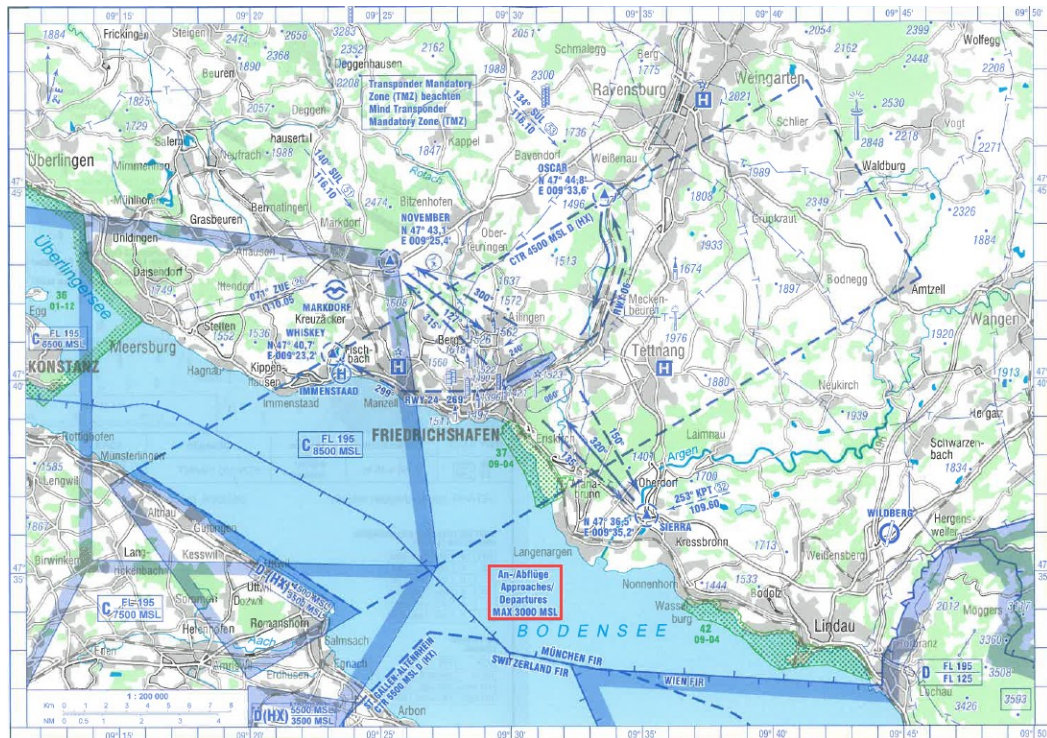
Figure 6: Visual approach chart for the airport of Friedrichshafen as per the aeronautical information publication (AIP) for Germany with a maximum flight altitude of 3000 ft AMSL for arrivals and departures (red frame)

Concentrating the VFR traffic over and across the runway, via the VFR waypoints NOVEMBER and SIERRA for the approach and departure during normal operation, allows for a geographical segregation from the IFR traffic on both runways 06 and 24 (cf. figure 6). Likewise, the VFR traffic in close proximity to the CTR is separated from the IFR traffic by the altitude limit of 3000 ft AMSL during arrival and departure, as the latter intercepts the glide slope of the ILS at 4000 ft AMSL.
