Final Report No. 2355 by the Swiss Transportation Safety Investigation Board STSB

concerning the serious incident involving the A220-300 aircraft, HB-JCC,

on 15 July 2018

at Porto Airport (LPPR), Portugal

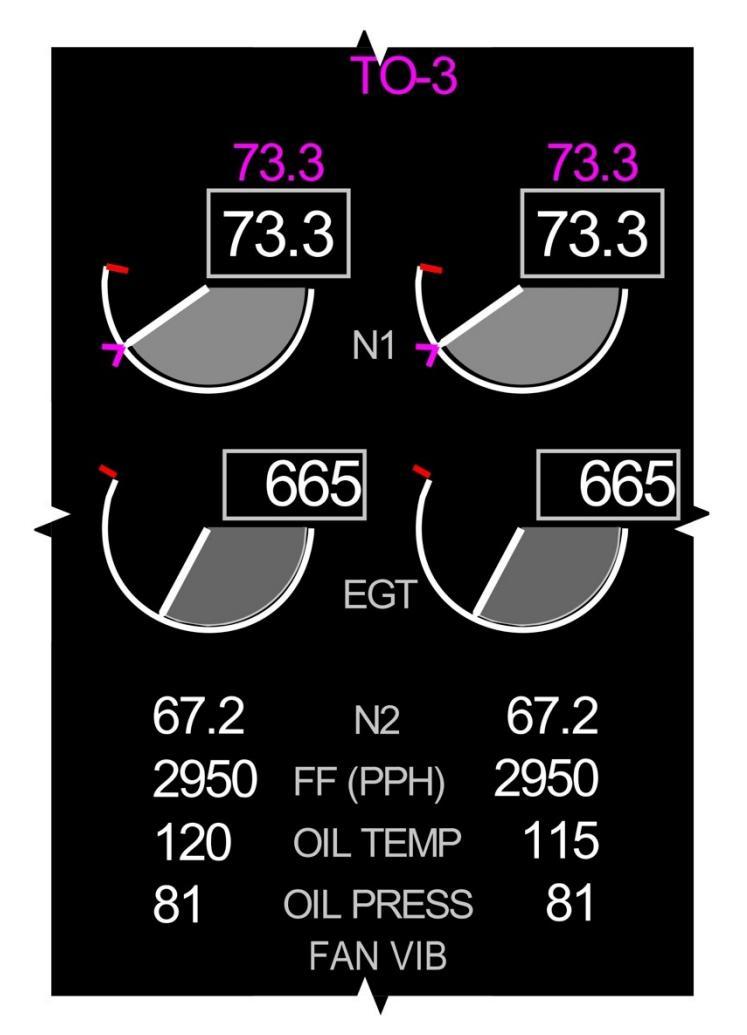
Figure 4: Detail from the EICAS with engine data (based on figure 18-09-14, FCOM 1)

The example in figure 4 shows a calculated power setting with an N1 of 73.3 % (magenta) for a TO-3 takeoff (derated takeoff thrust). The actual N1 power output is shown in white with a grey sector area – in this example also correctly set at 73.3 %.

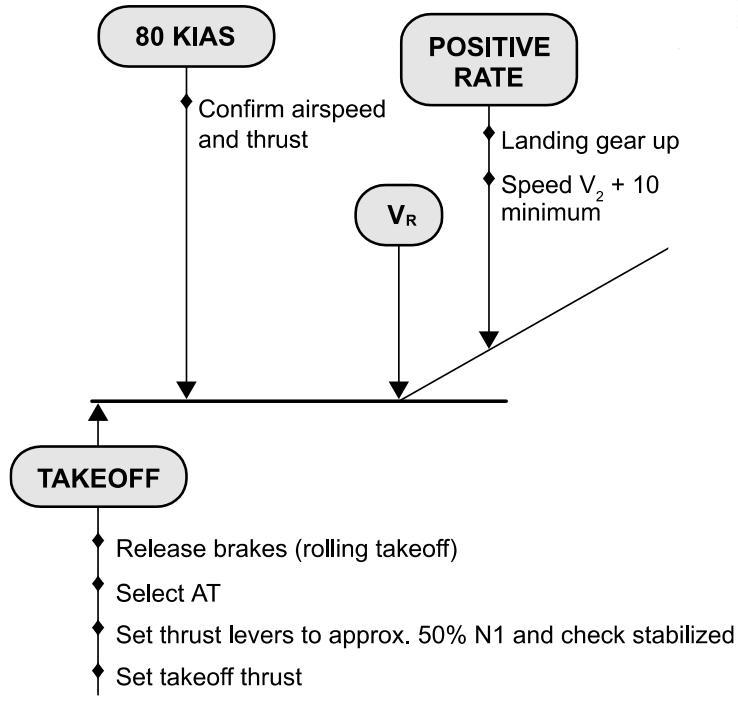
Figure 13: Copied (detail) from FCOM 2, section 03.01.02, "*Normal Procedures – takeoff procedures*", pages 28 and 29.

It is therefore essential that the set takeoff power is always monitored immediately after the throttles have been advanced. The setting of the power output is described in detail in points 4a to 4c in the appropriate checklist (see figure 13). The subsequent monitoring of the set power output, e.g. as point 4 d), is probably therefore no longer explicitly mentioned.

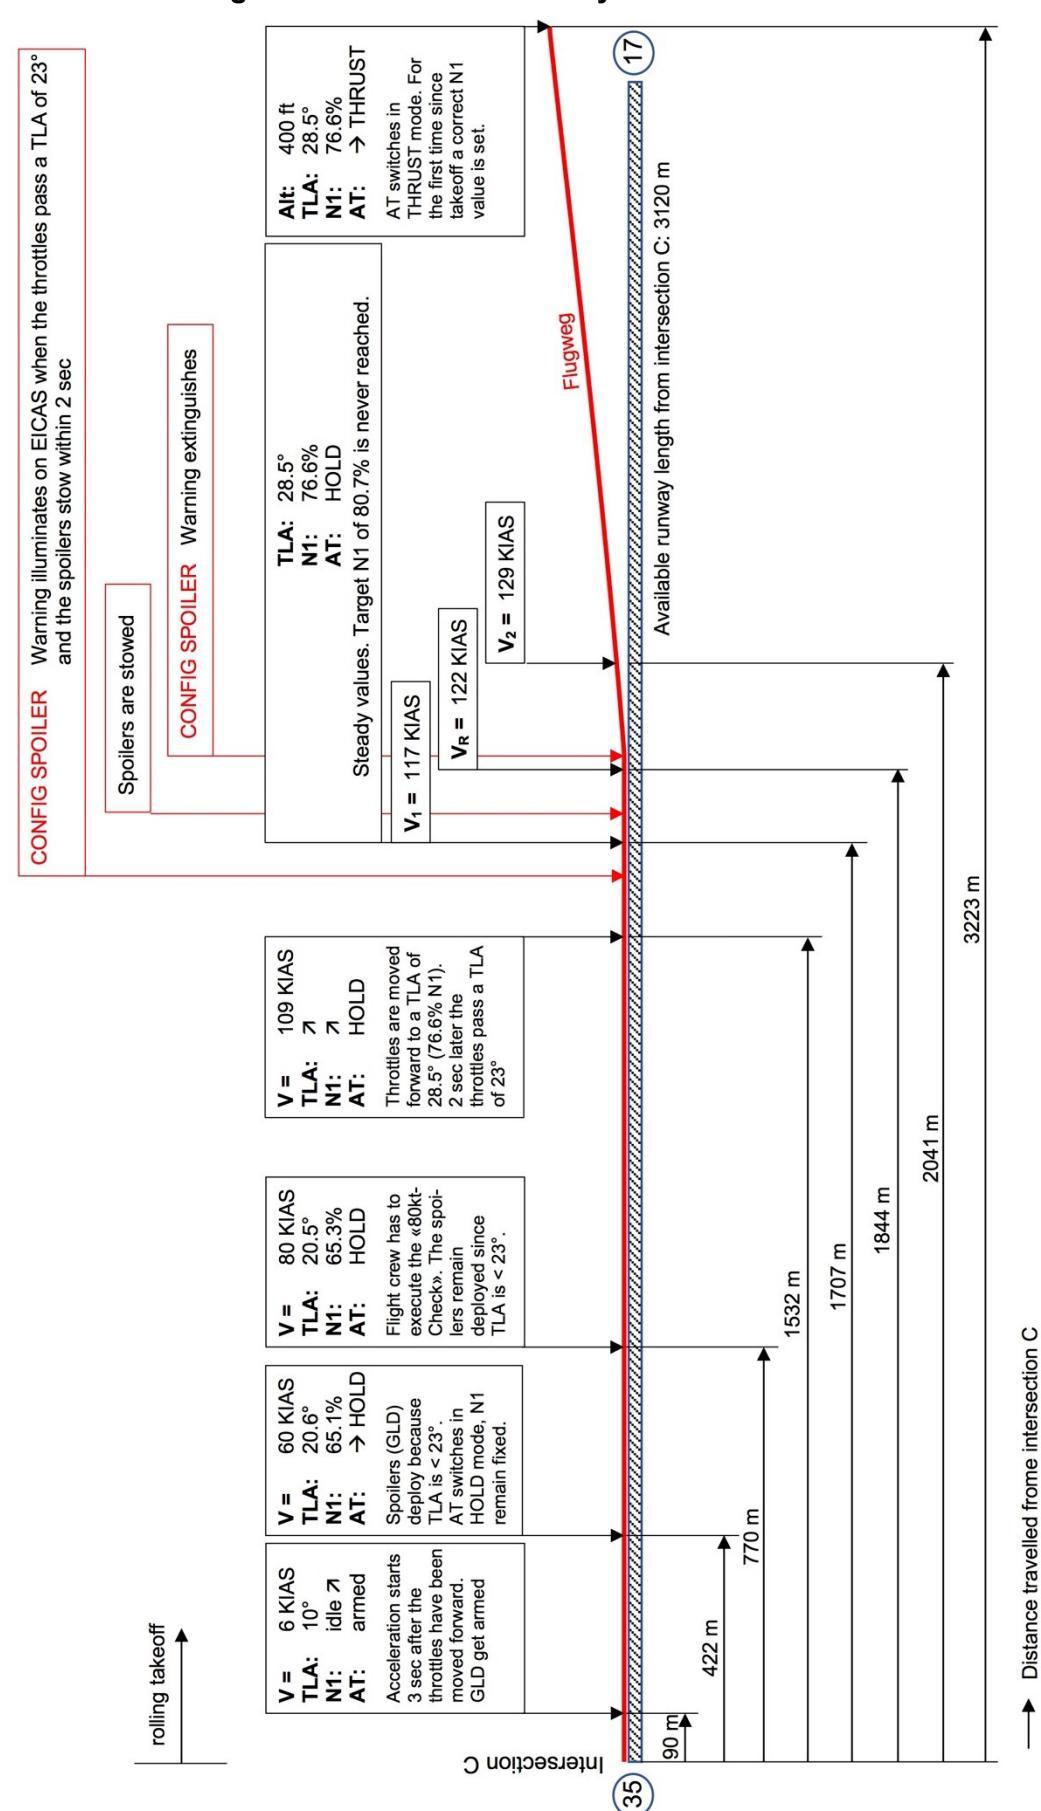
Annex 1: Records during takeoff roll of HB-JCC

Only once the CMD had pushed the throttles forward at a later time did the TLA change to above 23° and the spoilers retracted within 2 seconds, 23 seconds after having extended (see annex 1). As observed by the flight crew, the SPOILER CONFIG warning displayed on the EICAS for 4 seconds whilst the spoilers were retracting.
