Final Report No. 2359 by the Swiss Transportation Safety Investigation Board STSB

concerning the accident involving the
Bombardier Global 6000 aircraft 9H-AMZ

on 6th April 2016

at Geneva Airport (LSGG)

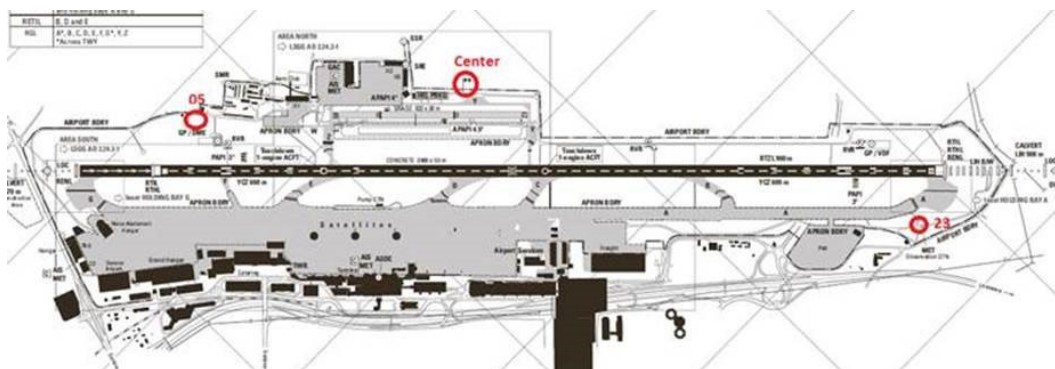
Illustration 3: Positions (red circles) of the three anemometers 05, centre, and 23 for measuring wind at Geneva Airport (LSGG)
