Summary Report

Aircraft	Boeing B777-300ER	A7-BAO
Operator	Qatar Airways Q.C.S.C., Doha, State of Qatar	
Owner	Qatar Airways Tower, Airport Road or P.O. Box 22550, Doha, State of Qatar

Location	16 NM north-north-west of Basel		
Coordinates	---	Altitude	Flight level (FL) 350
Date and time	19 November 2016, 09:10 UTC		
Type of operation	Scheduled flight		
Flight rules	Instrument flight rules (IFR)		
Flight phase	Cruise flight		
Incident type	Electrical smell in the cockpit, use of oxygen masks		
Point of departure	Miami (KMIA)		
Destination	Doha (OTHH)

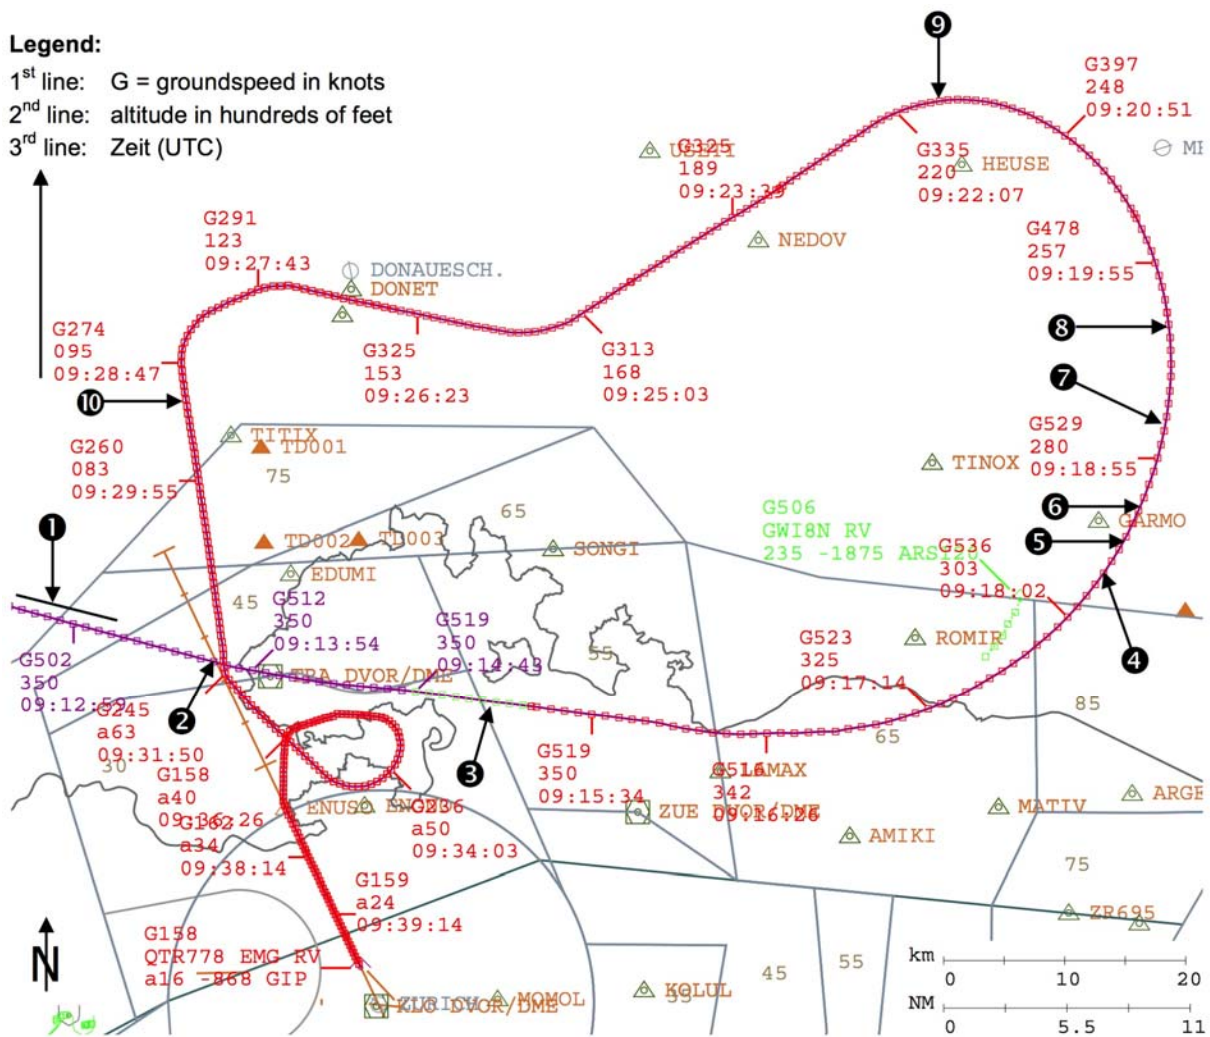
Annex 1: Flight path of A7-BAO

Pos.	Time UTC	Event
①	from 09:10	The flight crew detects an electrical smell. Commander A donned his oxygen mask.
②	09:13:41	Copilot A also donned his oxygen mask.
③	09:15:04	The flight crew reports: "Zurich, Qatari 778, Mayday Mayday, requesting divert to Zurich due to smoke in the flight deck."
④	09:18:16	The flight crew reports, "Qatari 778, we need to dump fuel, can we do it on the way to final?"
⑤	09:18:28	The flight crew receives the following clearance: "Qatari 778, affirm, now fuel dumping is approved."
⑥	09:18:41	Fuel dumping is activated.
⑦	09:19:05	The two nozzle valves open.
⑧	09:19:36	Fuel dumping is deactivated and the nozzle valves close at the same time.
⑨	09:21:47	Fuel dumping is activated and the nozzle valves open at the same time.
⑩	09:29:11	Fuel dumping is deactivated; the nozzle valves close at 09:29:15 UTC.
