Final Report No. 2383

concerning the accident involving the
aircraft PA-28RT-201, G-BVDH,

on 25 August 2019

Simplon Pass, within the municipality of
Simplon (in the canton of Valais), Switzer-
land

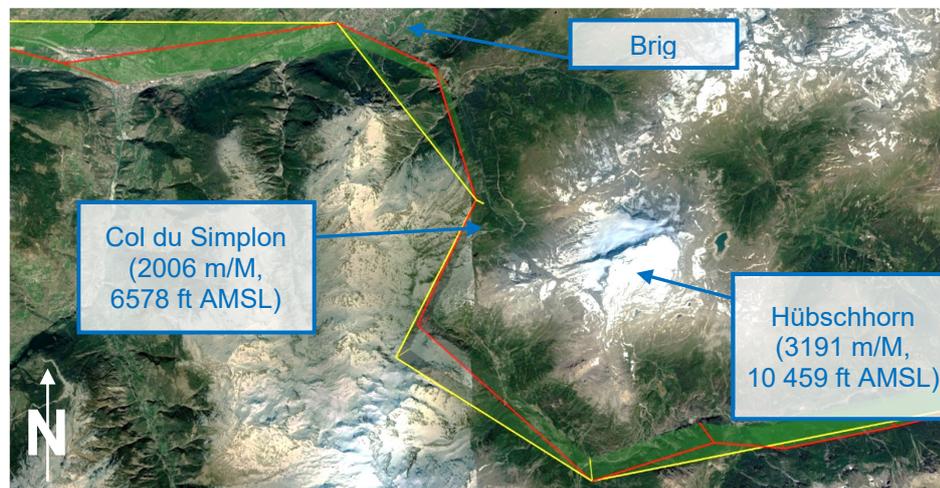
Figure 1: Planned routes across the Swiss Alps in the region of the Simplon Pass in Google Earth with altitudes in m/M and ft AMSL⁵. In yellow, the route planned on 13 August 2019 and, in red, waypoints as defined in the morning of 25 August 2019.

As shown below and in Figure 1, the pilot last amended his route 2 hours prior to departure from Lausanne - La Blécherette by adding waypoints in the vicinity of the Simplon Pass. Both routes in SkyDemon were planned by the pilot at an altitude of 15 900 ft. The altitude at which the aircraft was recorded by Flightradar24, as well as the planned altitudes, are depicted in the Google Earth picture below. The last recorded altitude of the aircraft in the vicinity of Brig was approximately 6100 ft AMSL. An average ground speed of 120 kt and a rate of climb of about 100 ft/min were recorded during the shallow climb from Montreux to Brig.

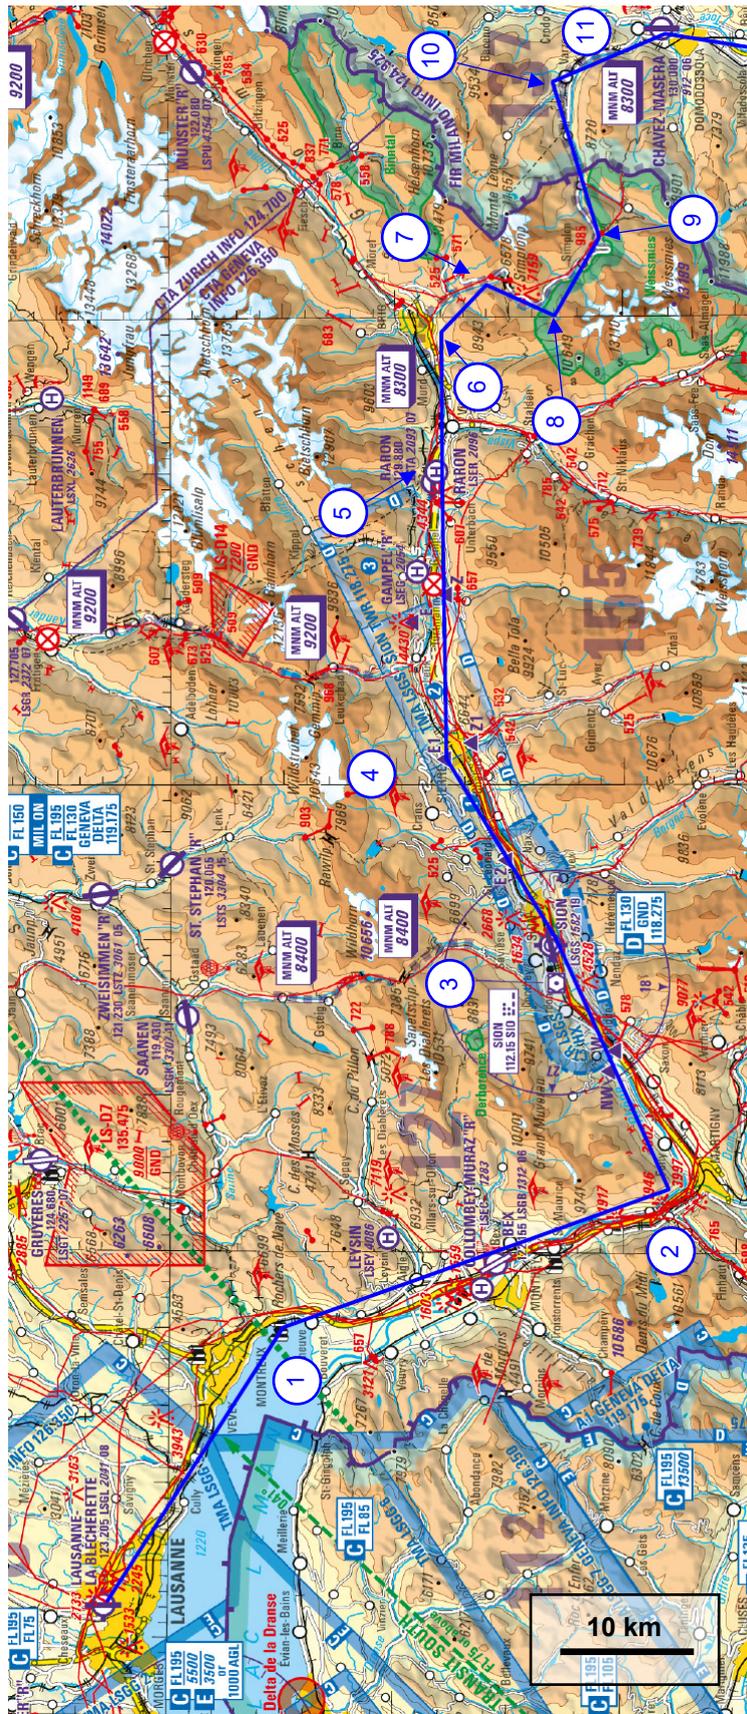
Figure 2: Extract of the planned route (waypoints 1-11) from the departure aerodrome, Lausanne – La Blécherette, to the intermediate navigation waypoint, the aerodrome of Chavez – Masera according the submitted ICAO flight plan and Illustrated on the ICAO 1:500 000 map of Switzerland. Source of map: Federal Office of Topography Swisstopo.

From Montreux (waypoint N°1 in Figure 2) to Brig (waypoint N°6) the lateral trajectory of the G-BVDH aircraft indicates that the pilot followed precisely his pre-programmed path on his electronic tablet. His ground speed remained stable at about 120 kt and the rate of climb was only about 100 ft/min as shown in Figure 3. These flight parameters brought him after 20 minutes of flight from Martigny to an altitude of 6100 ft AMSL at the entrance of the Simplon Valley, about 2200 ft below the minimum safe altitude recommended on the ICAO chart.

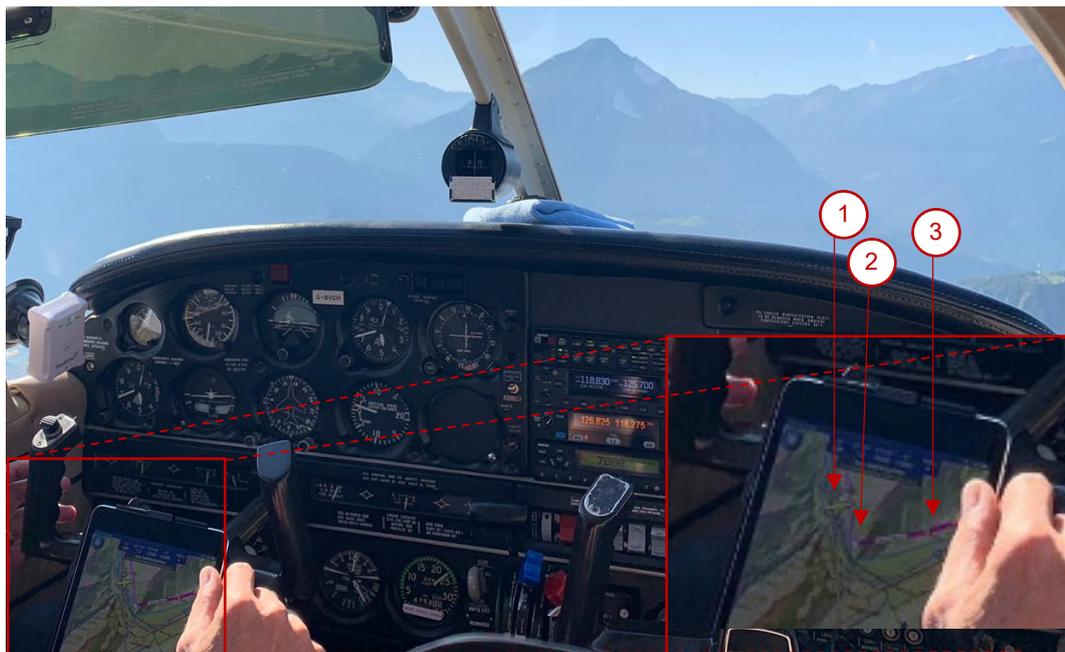
Figure 4: Picture taken from the right-rear passenger while approaching Martigny at the waypoint N°2 with a heading of 170° and an altitude of 4700 ft QNH⁶. The electronic tablet is fixed on the control wheel and is used by the pilot as a primary source of navigation. (1) depicts the current position of the aircraft, (2) is the location of the waypoint N°2, (3) represents the next active segment of the pre-programmed route to waypoint N°3 (see Figure 2). No clouds are visible in the Western Alps.

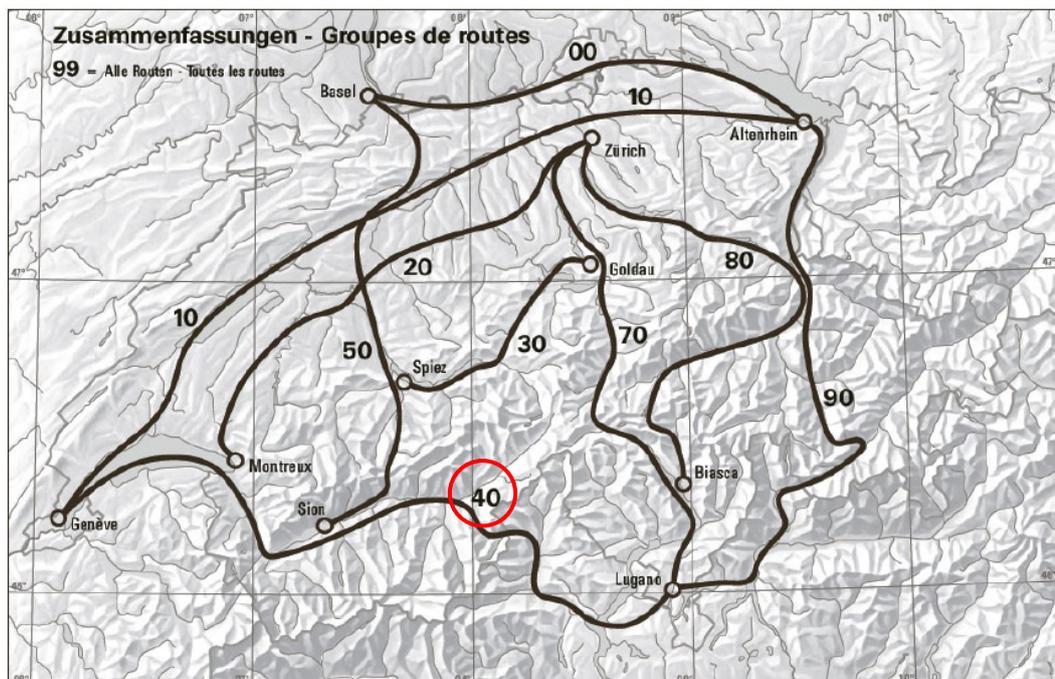
According to the initial flight plan, the pilot planned a flight from Lausanne to Montreux, then flying along the Rhone valley to Brig and finally flying over the Simplon Pass before reaching Perugia. In reference to the GAFOR, the flight plan follows the VFR route N°40, which includes the segments N°41, 42, 43 and 44 indicated in Figure 7 and 8.

Figure 7: Network of the visual flight routes of Switzerland as published in the « VFR Manual ». The planned journey followed segments of route N°40.

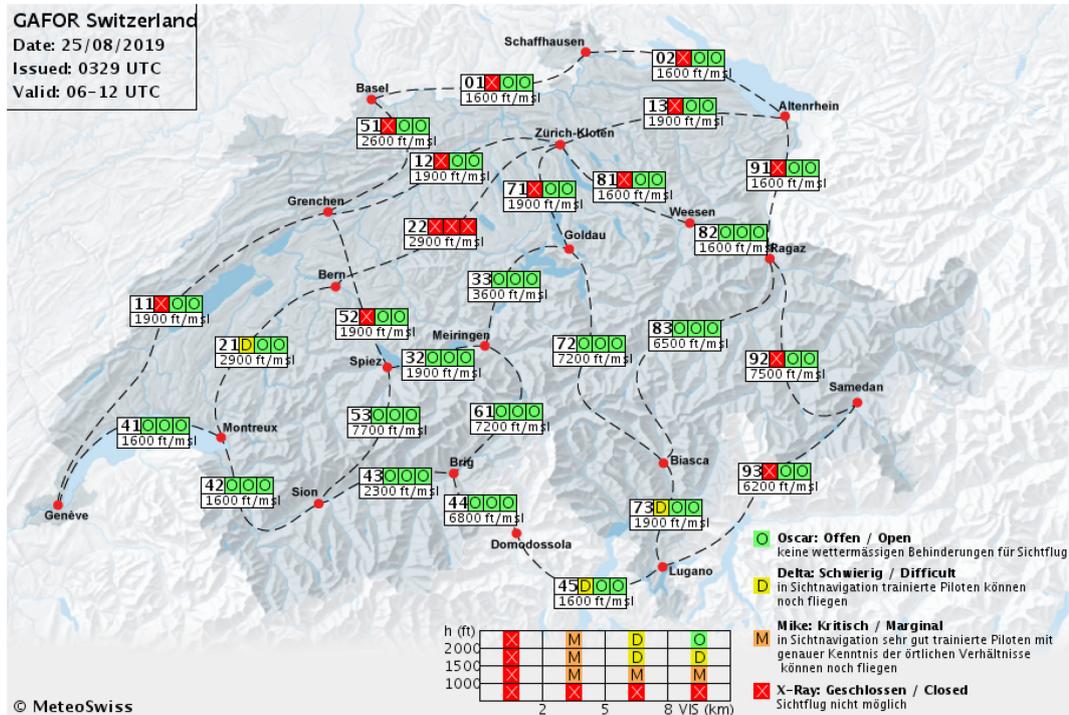
Between 08:00 and 14:00 the weather forecast for these VFR routes was showing a visibility greater than 8 km and a ceiling of 2000 ft or greater (see Figure 8). On route segment N°44, the highest obstacle is at 6800 ft AMSL as shown in the segment N°44 box (below). The minimum recommended altitude for a segment is obtained by adding 1500 ft (500 m) to the altitude of the highest obstacle, i.e. 8300 ft for route segment N°44. The recommended minimum altitude of 8300 ft is also shown on the ICAO 1:500 000 map in Figure 10.

Figure 8: GAFOR issued on 25 August 2019, valid for the duration of the foreseen flight period. The VFR route N°40 is open (O).

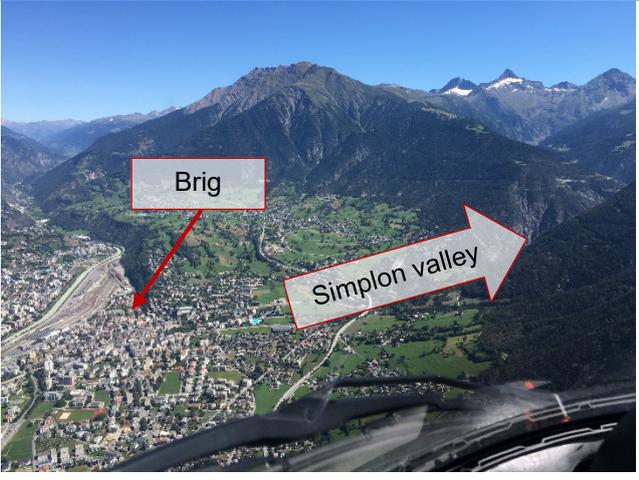
N°	Observations	Pictures
1	<p>Altitude : 6000 ft</p> <p>Heading : 090°</p> <p>Distance to impact : 6 NM</p> <p>Observations</p> <ul style="list-style-type: none"> - Left : city of Brig - Right : start of the Simplon Valley

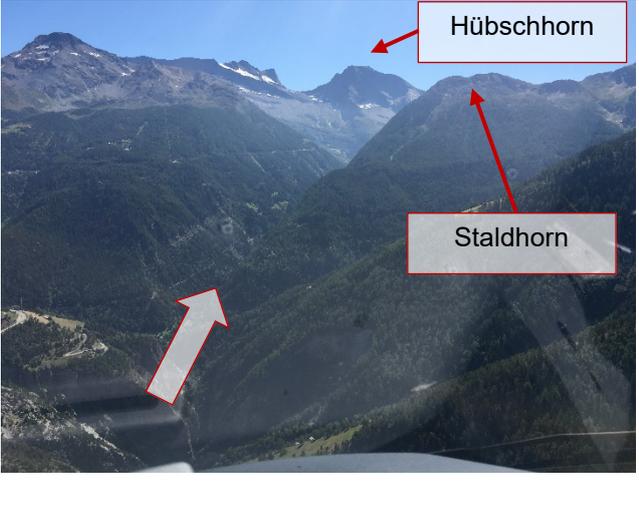
2	<p>Altitude : 6100 ft</p> <p>Heading : 170°</p> <p>Distance to impact : 5 NM</p> <p>Observations</p> <ul style="list-style-type: none"> - Entrance of Simplon Valley - Hübschhorn summit, 10 466 ft - Simplon Pass located behind Staldhorn (8072 ft)

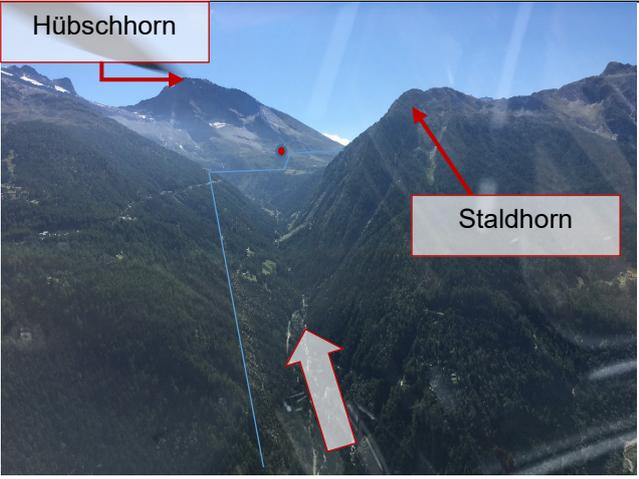
3	<p>Altitude : 6500 ft</p> <p>Heading : 170°</p> <p>Distance to impact : 3.0 NM</p> <p>Observations</p> <ul style="list-style-type: none"> - Impact location, 7364 ft (red dot) - High voltage power lines (blue)

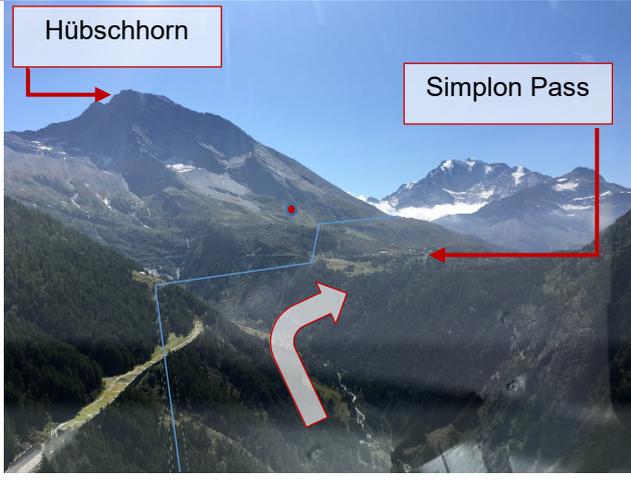
N°	Observations	Pictures
4	Altitude : 6600 ft Heading : 170° Distance to impact : 1.5 NM Observations - Simplon Pass, 6578 ft - Impact location, 7364 ft - High voltage power lines

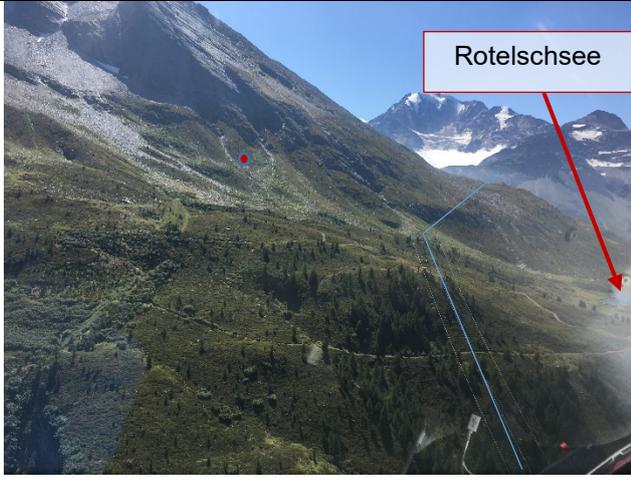
5	Altitude : 7100 ft Heading : 190° Distance to impact : 0.3 NM Observations - Impact location, 7364 ft - High voltage power lines - Rotelschsee, 6656 ft

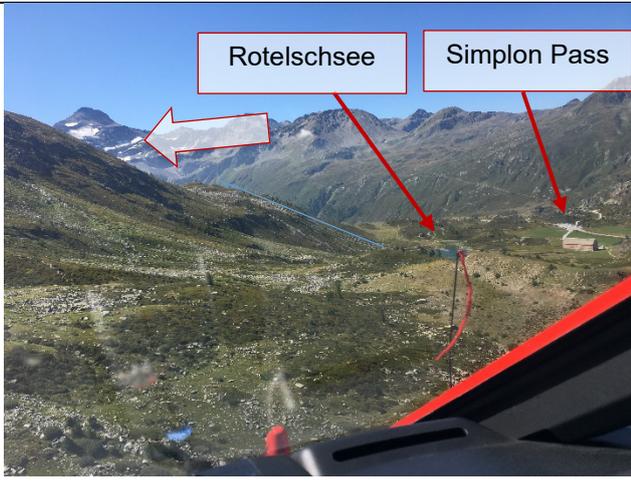
6	Altitude : 7400 ft Heading : 270° Distance to impact : 0 NM Observations - Simplon Pass, 6578 ft - Rotelschsee, 6656 ft - High voltage power lines

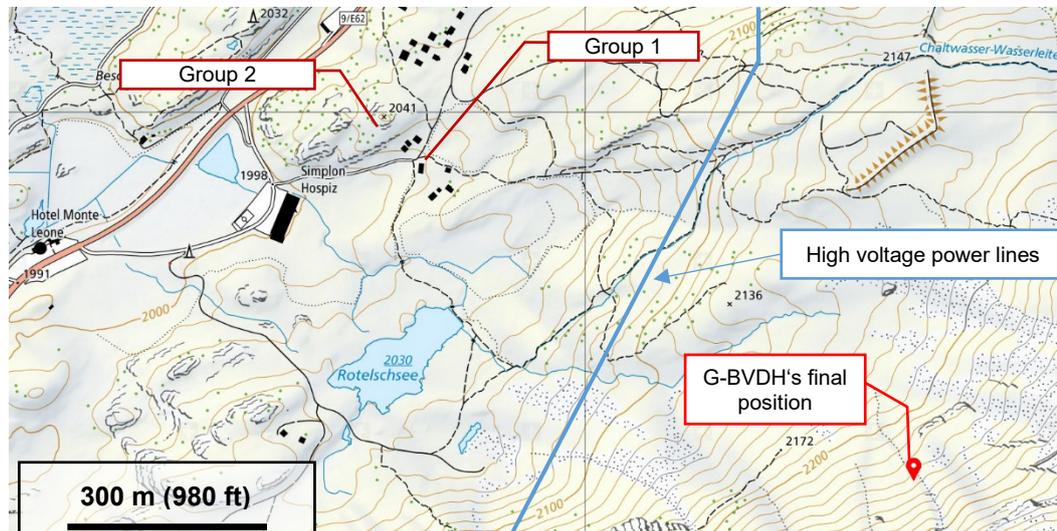
Figure 11: Position of the wreckage and the location of the two hiking groups. Source of map, Federal Office of Topography Swisstopo.

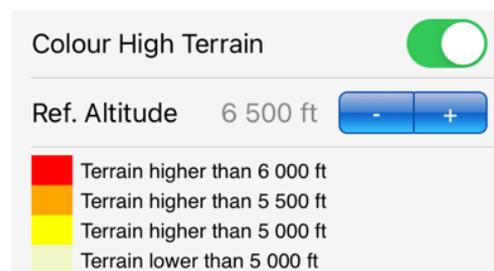
- Terrain above 500 ft below: bright red,
- Terrain between 500 - 1000 ft below: orange,
- Terrain between 999 - 1500 ft below: yellow
- Terrain below 1500 ft: shaded in light green

Figure 13: Explanation and visualisation of the terrain colouring according to the selected reference altitude at 6500 ft.
