A1. Factual information

A1.17 Information on organisations and their management

A1.17.1 Association of the Friends of the Swiss Air Force (VFL) and Ju-Air

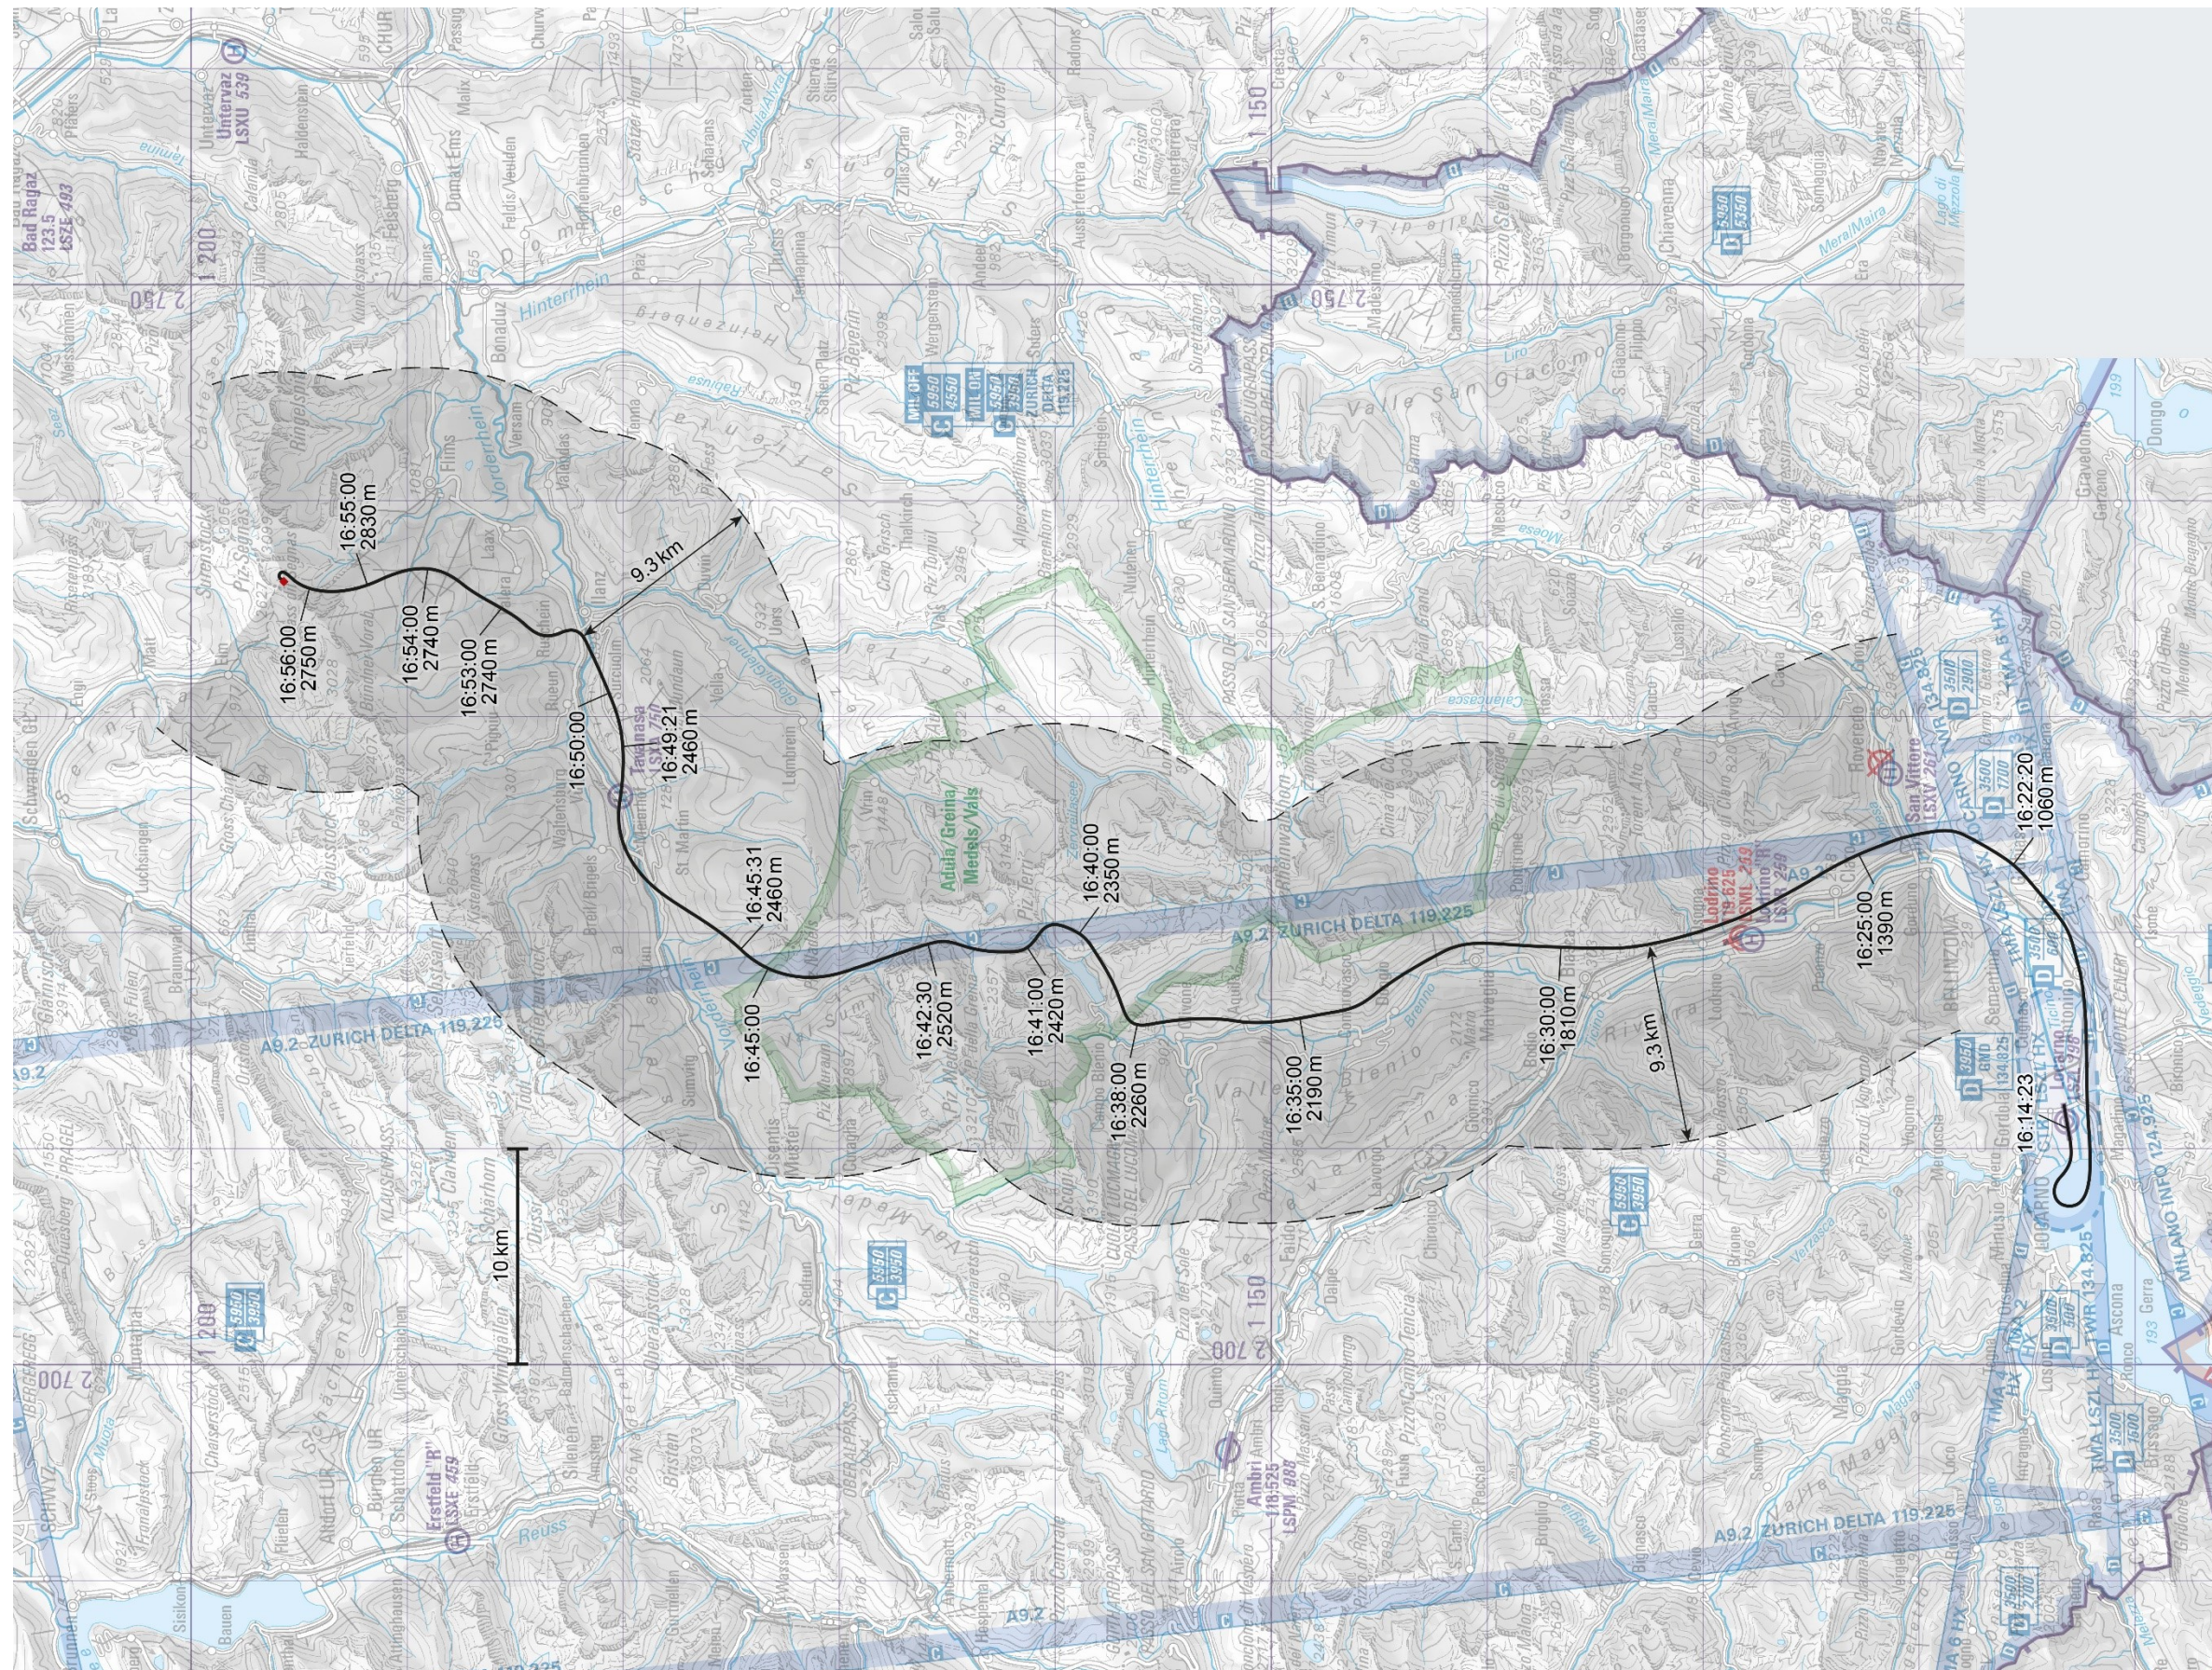
- In relation to the accident flight involving HB-HOT on 4 August 2018, the corridor of 9.3 km on both sides of the flight path from leaving the TMA LSZL is shown in figure 4. Within this corridor, the following mountain peaks in particular are located (from south to north): Torent Alto (2,952 m AMSL), Rheinwaldhorn (3,402 m AMSL), Piz Terri (3,149 m AMSL), Bifertenstock (3,419 m AMSL), Bündner Vorab (3,028 m AMSL) and Ringelspitz (3,247 m AMSL).

Figure 4: 9.3-km corridor on either side of HB-HOT's flight path on 4 August 2018; all altitudes are given in altitude above mean sea level; base map: glider chart from the Swiss Federal Office of Topography; reworked
