**A1. Factual information**

**A1.19 Useful or effective investigation techniques**

A1.19.1 Use of data memories from mobile phones and cameras

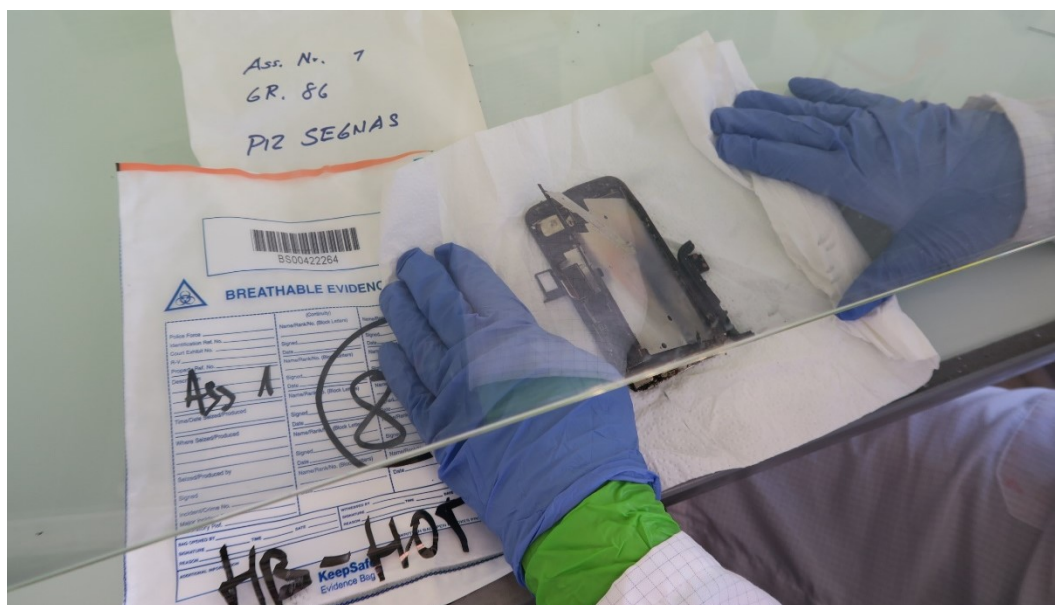
The electronic components were taken apart, cleaned and their data storage units removed in an ESD<sup>3</sup>-protected area in the BEA laboratory in Paris (see figure 1). For certain mobile phones, in addition to the data storage unit, the associated encryption unit had to be removed as well, so that the data could also be read at a later stage. After cleaning, the data storage units were dried in a special oven for approximately 72 hours.

**Figure 1:** Removal of the data storage unit from a damaged mobile phone in the BEA laboratory.

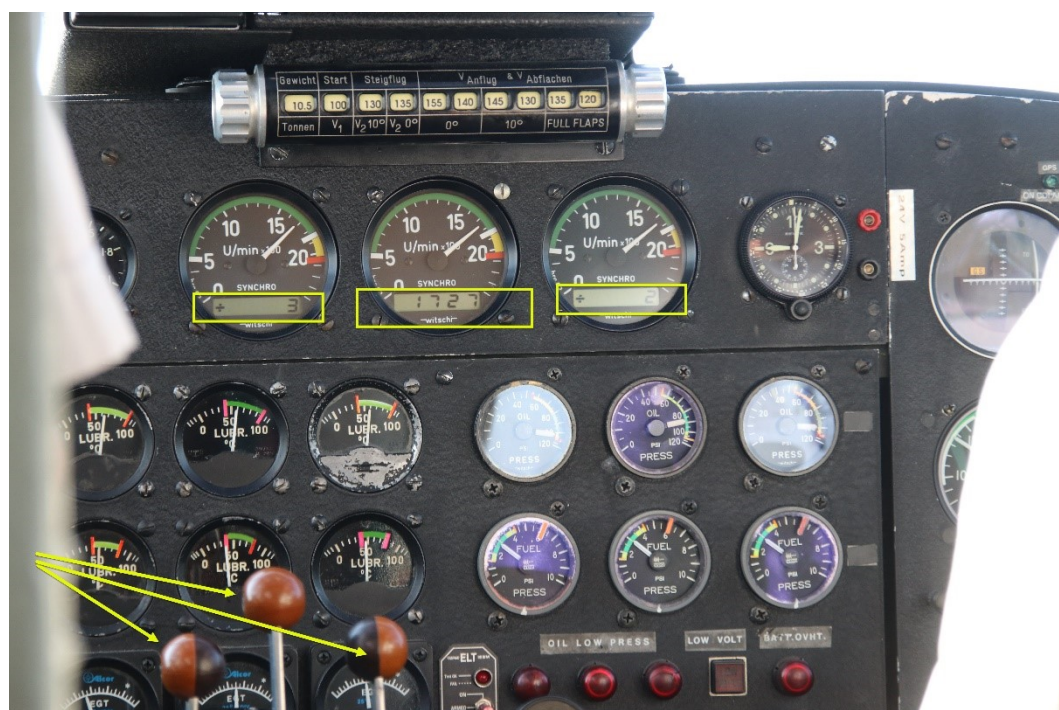
The digital gauges are used to synchronise the engines as closely as possible; adjustments can be made by slightly moving the throttle levers. Due to lack of accuracy, fine adjustment for synchronisation of two engines is not possible using an analogue gauge. It must be made by observing the digital gauges. This means that at least one of the pilots' pairs of eyes will linger on these gauges for a longer period of time.

**Figure 4:** Tachometers with digital displays, marked by yellow rectangles. The yellow arrows point to the three throttle levers that must be operated to set the respective rpm.

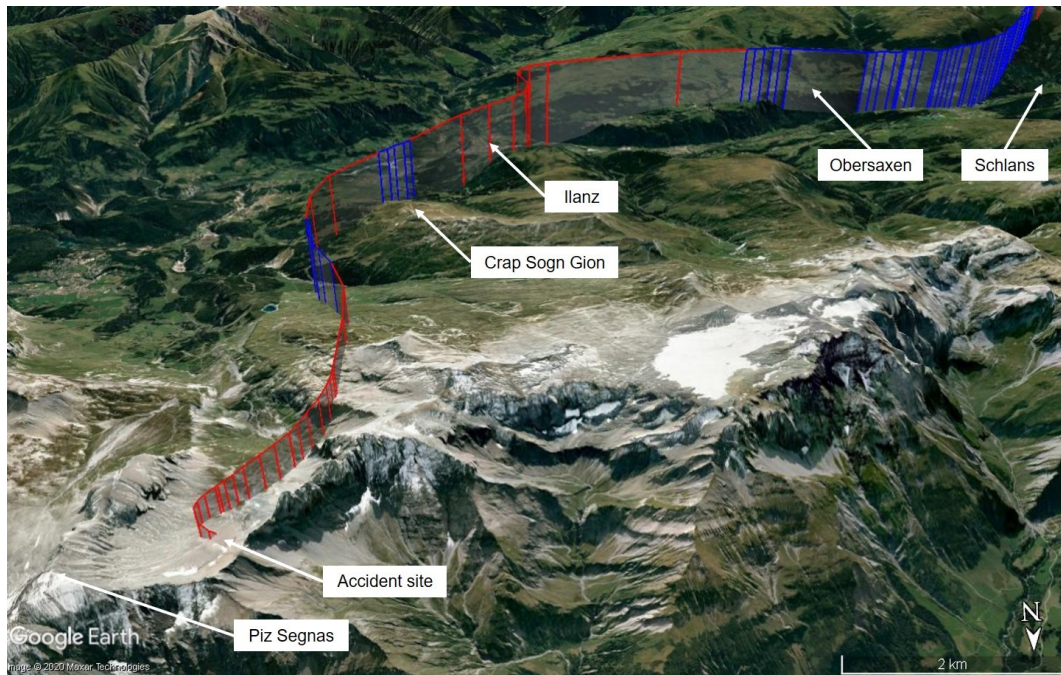
The images and video footage were visually evaluated in the geometry of the terrain. Based on the evaluation of these data and the information obtained, the gaps in the radar flight paths could be filled in most instances, the inaccuracies eliminated to a large extent, and the flight paths reconstructed (see figure 6).

**Figure 6:** Section of the accident flight on 4 August 2018 with stretches derived from radar data (blue) and that have been reconstructed (red). Shown on Google Earth.

The radar data points corrected in height are marked in the sections shown in blue, connecting them to the ground with vertical lines. In addition to position and altitude, MRT also calculates and records the time and ground speed (GS) for each data point. In the absence of radar data points, a missing stretch can be filled in with a straight line between adjacent known positions based on the information available – provided that no alternative flight paths are possible, as was the case near Obersaxen (see figure 6).
