# **Final Report No. 2370**

## **by the Swiss Transportation Safety Investigation Board STSB**

on the accident involving  
the Junkers Ju 52/3m g4e  
commercial aircraft, HB-HOT,

on 4 August 2018

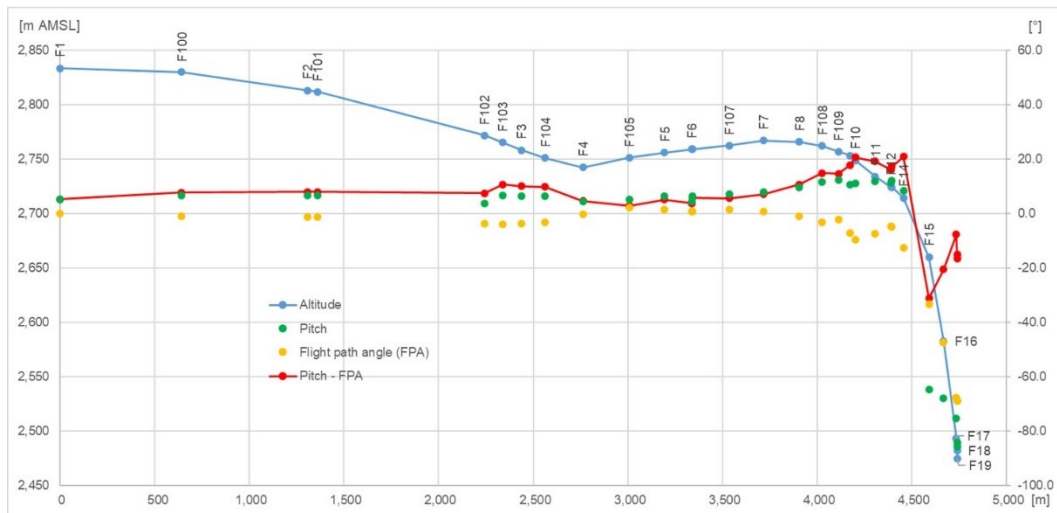
Figure 15 shows the altitude, pitch and flight path angles as well as the difference between these two angles.

**Figure 15:** Altitude, pitch and flight path angle (FPA) in relation to of the horizontal distance travelled. The left-hand y-axis shows the values for altitude and the right-hand y-axis shows the values for the angles.

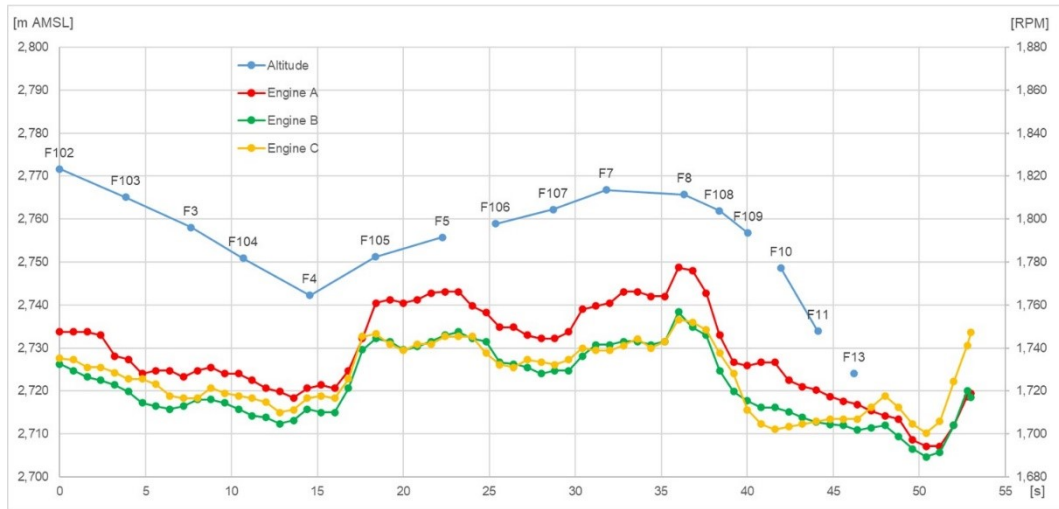
Figure 18 shows the course of the three engine speeds in relation to the video runtime. It was not possible to assign the speeds of engines A, B and C to the position of the engines (left, centre, right).

Figure 18: Altitude and engine speed in relation to the video runtime.

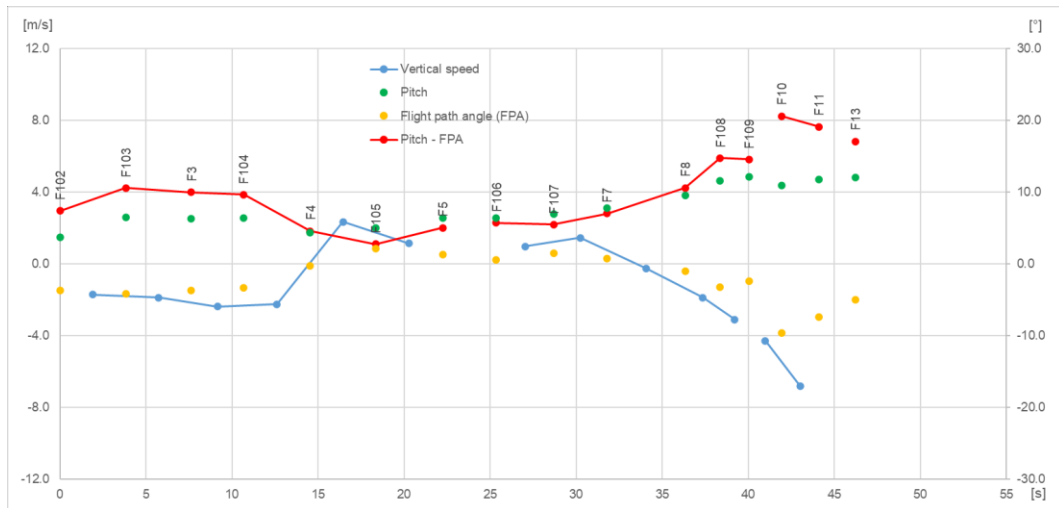
In addition to the pitch and FPA, figure 19 also shows the rate of ascent and descent in relation to the video runtime.

Figure 19: Vertical speed, pitch and flight path angle in relation to the video runtime.

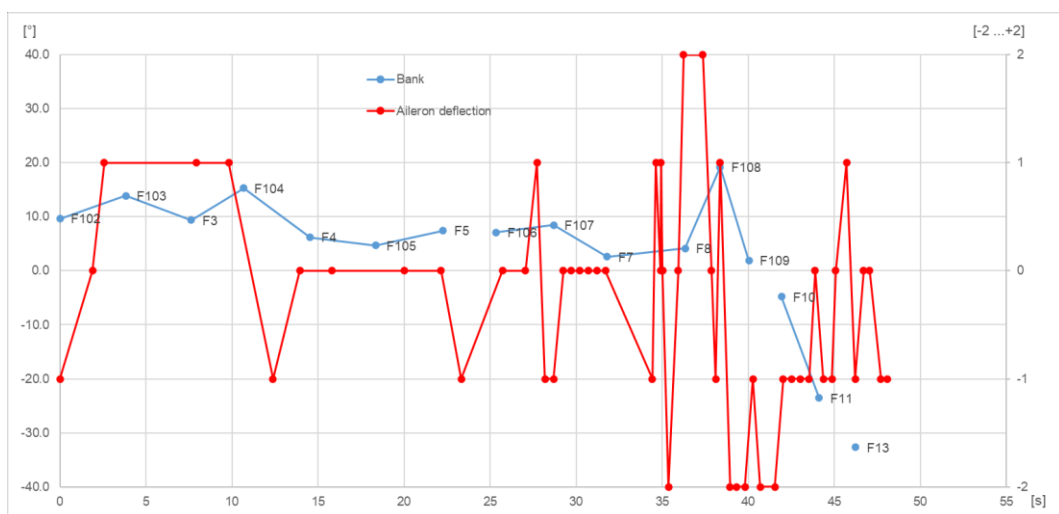
After point F13, the roll to the left increased steadily and did not decrease even when a significant aileron deflection to the right was made. The ailerons were then brought into a neutral position and temporarily deflected into a position for a left turn.

Figure 20: Bank and aileron deflection in relation to the video runtime. Positive values on the y-axis indicate bank to the right and aileron deflections for a right turn respectively. The bank angles were determined photogrammetrically.

The aileron deflections were qualitatively evaluated with values of - 2, - 1, 0, + 1 and + 2 (figure 20, right-hand y-axis) based on a video recorded from inside the aircraft. Positive values indicate an aileron deflection for a clockwise roll as seen in the direction of flight, i.e. for a right turn, whilst negative values indicate an aileron deflection for a left turn and a value of zero means the aileron position was neutral.
