Final Report No. 2435

concerning the serious incident involving
the airliner Airbus A330-343 , HB-JHI ,

on 13 September 2024

approx. 50 NM west-northwest of Basel

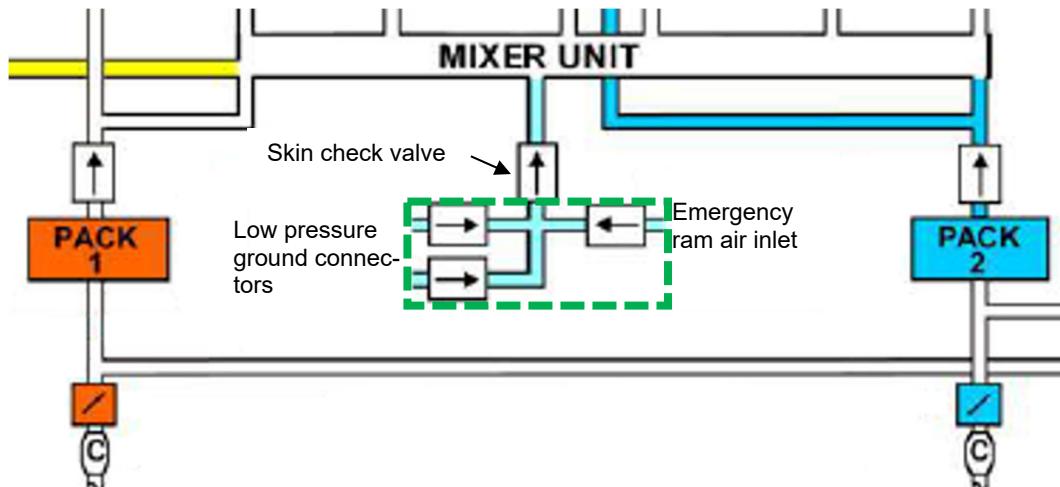
Figure 4: Schematic of the mixer unit of the cabin pressure system and the low-pressure manifold (green dotted frame). Source: Aircraft manufacturer, edited by STSB.

The air is fed through the low-pressure manifold and a second check valve, known as the skin check valve, directly into the mixer unit (see figure 4 and Appendix 1). The mixer unit combines fresh air with recirculated air and feeds it to the various cabin zones, ensuring that the conditioned air is distributed throughout the entire aircraft.

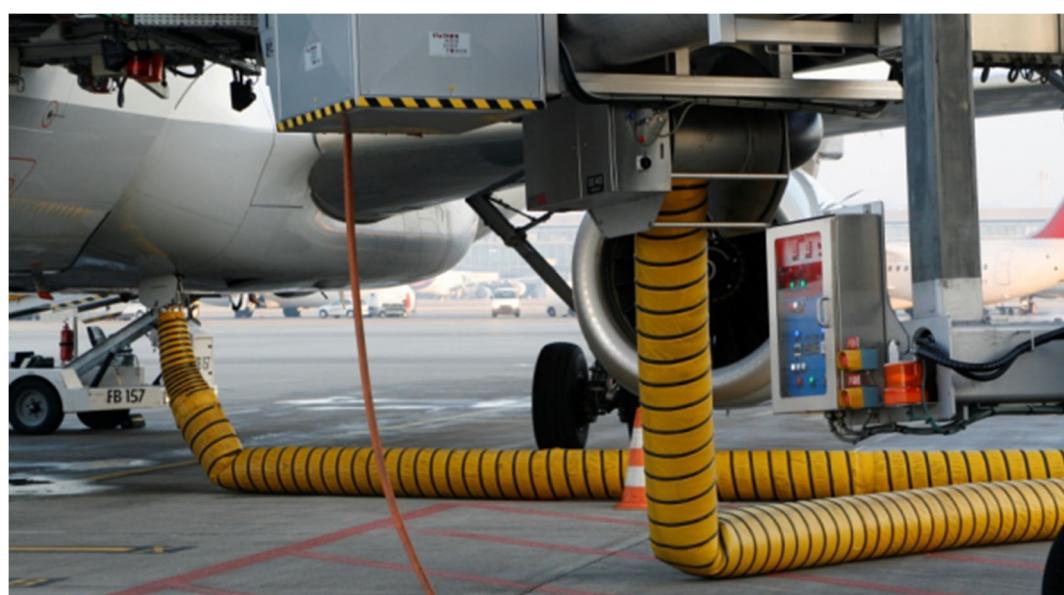
Alternatively, an external pneumatic source, a preconditioned air unit (PCU), can be used via the low pressure ground connector. While the aircraft is being prepared at the gate, this connection is typically used so that the APU does not have to be operated. The ground air connection consists of two adjacent connections, each equipped with a check valve, through which external air can be fed into the low-pressure manifold. This is done via flexible air hoses attached to the passenger boarding bridges (see figure 5).

According to the aircraft manufacturer, the low-pressure manifold is not designed to absorb the entire differential pressure of the cabin in the event of a skin check valve failure.

Figure 5: Air hose of the pre-conditioned air system connected to the low pressure ground connectors. Source: Zurich Airport.

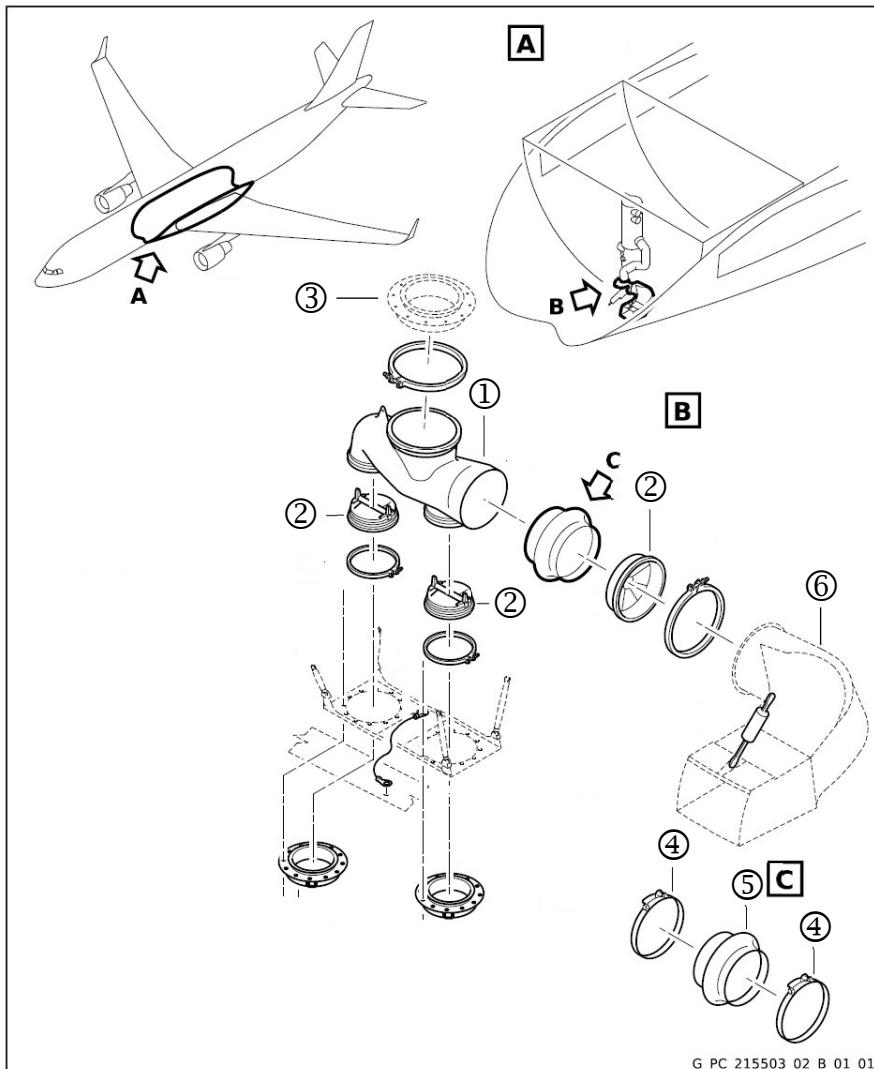
Figure 21-55-03-02B (SHEET 1)
** ON A/C FSN ALL

Appendix 1: Ground air connection and emergency air intake
