# **Interim Report by the Swiss Transportation Safety Investigation Board STSB**

concerning the serious incident involving  
the helicopter Guimbal Cabri G2,  
HB-ZPU,

on 26 June 2021

Bola, Lostallo (canton of Graubünden),  
Switzerland

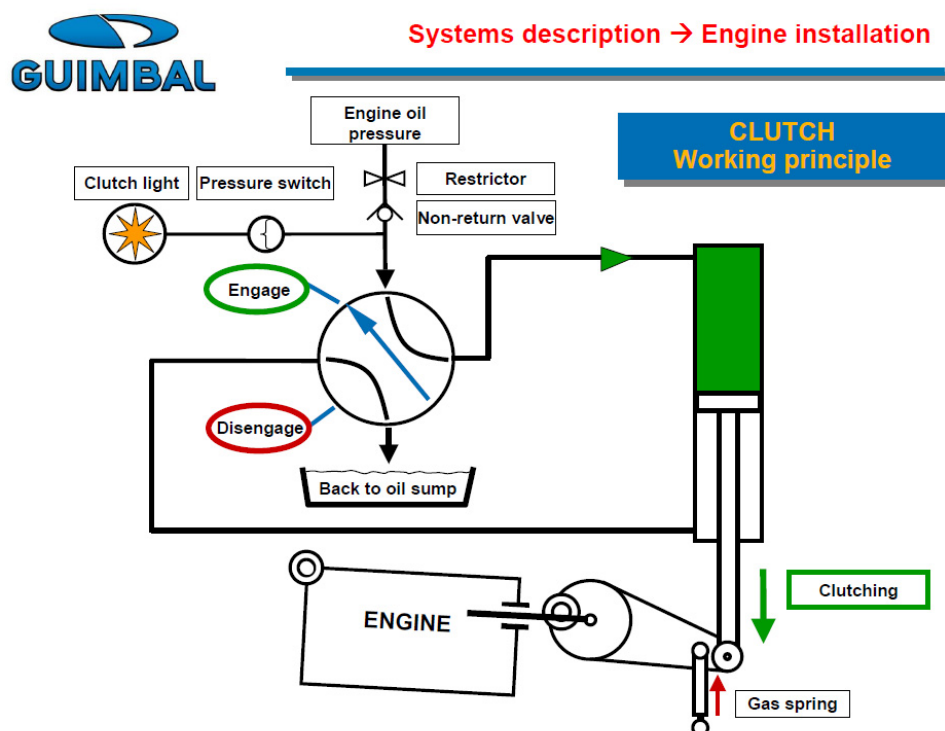
Oil pressure is maintained using a non-return valve. The yellow clutch light goes off to notify the crew that the minimum drive belt tension has been reached. The threshold value for this clutch light is set at 3.6 bar (see Figure 2).

**Figure 2:** Illustration of the drive belt tensing system (Source: Hélicoptères Guimbal training documentation)

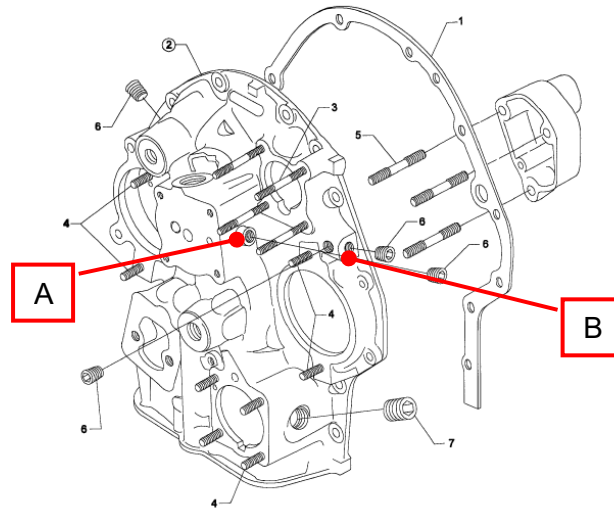
**Figure 3:** Accessory housing: (A) marks the oil pressure sensor pick-up point, (B) the installation point for the restrictor and simultaneously the pick-up point for oil flow through to the clutch system (Source: Lycoming Engines, Illustrated Parts Catalog)

With Lycoming engines, the engine oil pressure is set after production during the test run. Oil pressure is measured at pick-up point (B), without the restrictor (see Figure 3).

If the oil pressure needs to be reset or adjusted during subsequent operations, the value is read off the EPM. In the Cabri G2 model, the oil pressure sensor pick-up point is located at position (A) on the accessory housing (see Figure 3).

- The settings and values read from the sensor system (oil pressure gauge, oil pressure switch, clutch light oil pressure switch) corresponded to specifications;
- The restrictor was removed and examined. The nominal diameter of 1 mm and the free flow of oil were checked. Both corresponded to specifications;
- There was a difference of around 2 bar (see Figure 4) between the oil pressure displayed on the EPM, measured by STSB with an additional manometer between pick-up point (A) on the accessory housing, and pick-up point (B) downstream of the restrictor (see Figure 3).
