# **Final report no. 2430 of the Swiss Transportation Safety Investigation Board STSB**

concerning the accident of the helicopter  
Bell 505 Jet Ranger X, HB-ZWC,

on March 12, 2024

Egg, 3 km south of Weinfelden, municipal-  
ity of Bussnang (TG)

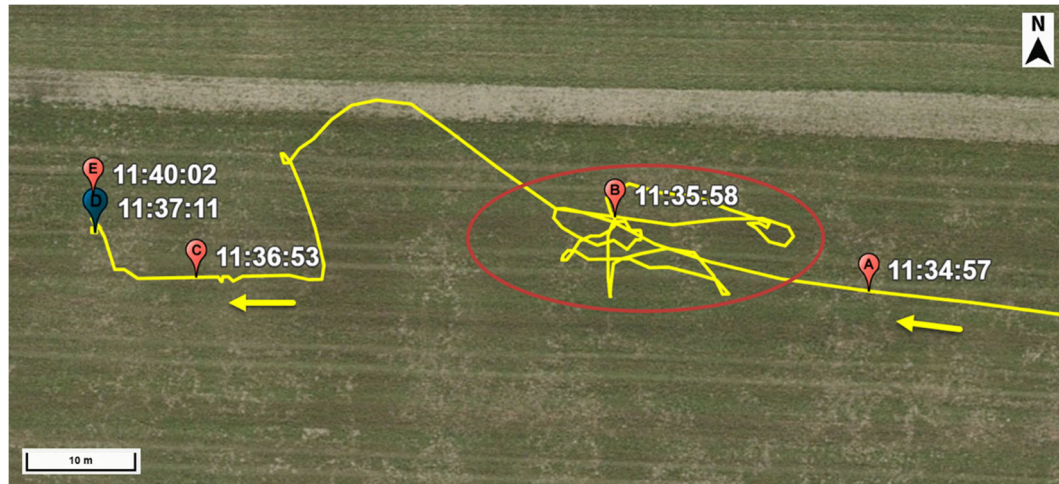
At 11:29, the flight instructor demonstrated the reconnaissance procedure, followed by an approach to hover. This was followed by hovering exercises for around two minutes (see Figure 1 , A, B and C). Due to the south-westerly wind direction, with a strength of 10 to 13 kt and gusts of up to 20 kt, the helicopter nose was facing west.

After landing, which took place around 60 m further west of the location of the hovering exercises (see Figure 1 , D), a debriefing took place for around two minutes with the rotor running. Among other things, the particular attention required at the controls during lift off and touch-down was discussed. During this debriefing, the flight instructor demonstrated how the downwash of the helicopter could be seen visually in the meadow by raising and lowering the collective pitch control slightly for several times. The flight crew then began, without time pressure, preparations for take-off in a westerly direction.

**Figure 1** : Last part of the flight path before the accident. Area B (red circle) between A and C corresponds to the point where hovering exercises were carried out for about two minutes. D corresponds to the touchdown point and E to the final position of the helicopter. Source of the base map: Swisstopo, edited by the STSB.

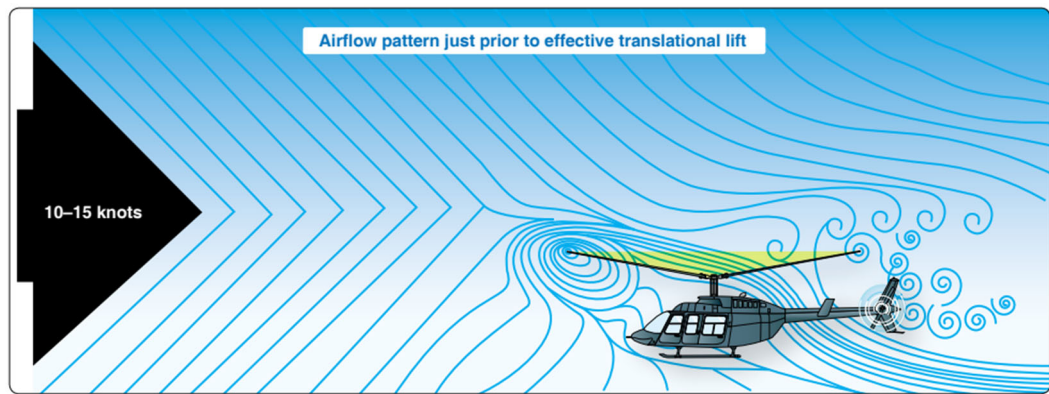
The air, which is pressed to the ground in the HIGE state, leaves the helicopter radially outwards in the area below the main rotor when there is no wind, and the helicopter is stationary or hovering and rises upwards again in a vertical rotary motion. This rising air is outside the rotor blade tips when there is no wind or when hovering. However, it becomes noticeable when the helicopter catches up with this area when picking up speed. This and the increase in speed result in different angles of attack (AoA) in the front and rear areas of the rotor plane: While the rotor disk is lifted in the front area, it is pushed down in the rear area (see Figure 6). This phenomenon is known as the "transverse flow effect".

**Figure 6** : Airflow around the helicopter at a speed just below the ETL point. Source: FAA Rotorcraft Flying Handbook, Ed. 2019, Fig. 2.40.

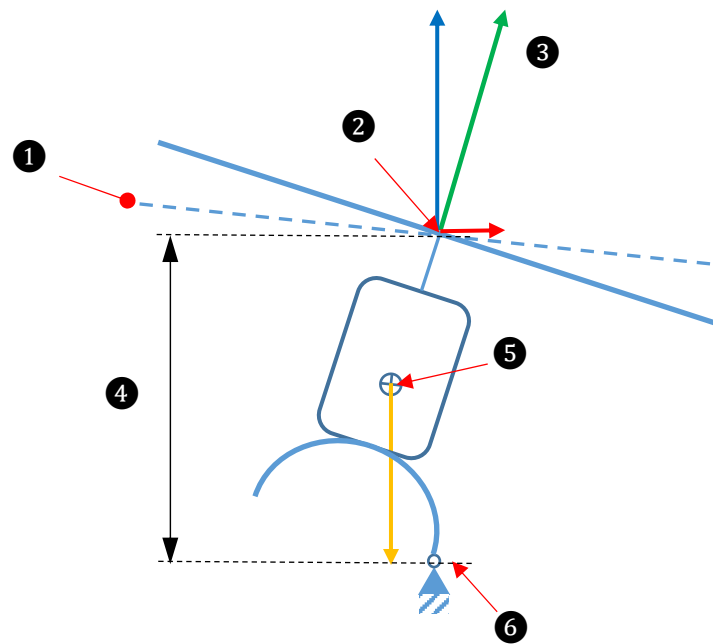
**Figure 7:** Schematic representation of the dynamic rollover with a helicopter in the direction of flight. Maximum deflection of the main rotor plane to the left ①; point of application of the aerodynamic forces on the main rotor head ②; resulting aerodynamic force (perpendicular to the rotor plane, green vector) ③, lateral component (red vector), vertical lift component (blue vector); lever arm ④ between the point of application of the aerodynamic forces ② and the point of contact on the ground ⑥; center of gravity of the helicopter with the weight force (orange vector) ⑤; point of contact on the ground of the skid incl. bear paw ⑥.
