Summary Report

Aircraft	SF50 Vision Jet	N474CG		
Operator	I-Fly AG, c/o Aximos Treuhand AG, Baarerstrasse 11, 6300 Zug, Switzerland			
Owner	Southern Aircraft Consultancy Inc Trustee, Office 3, Earsham Hall, Bungay Norfolk, England			
Flight instructor	Swiss national, born 1961			
Licence	Airline Transport Pilot Licence Aeroplane (ATPL(A)), issued by the American Federal Aviation Administration (FAA)			
Flying hours	Total	27,610 h	during the last 90 days	246:30 h
	on the aircraft type	99:31 h	during the last 90 days	32:34 h
Student pilot	German national, born 1978			
Licence	Commercial Pilot Licence Aeroplane (CPL(A)) according to the European Aviation Safety Agency (EASA), issued by the Federal Office of Civil Aviation (FOCA).			
Flying hours	Total	478 h	during the last 90 days	4:29 h
	on the aircraft type	0:59 h	during the last 90 days	0:59 h
Location	Zürich airport (LSZH)			
Co-ordinates	-	Altitude		-
Date and time	22 September 2018, 20:17 (LT = UTC + 2 h)

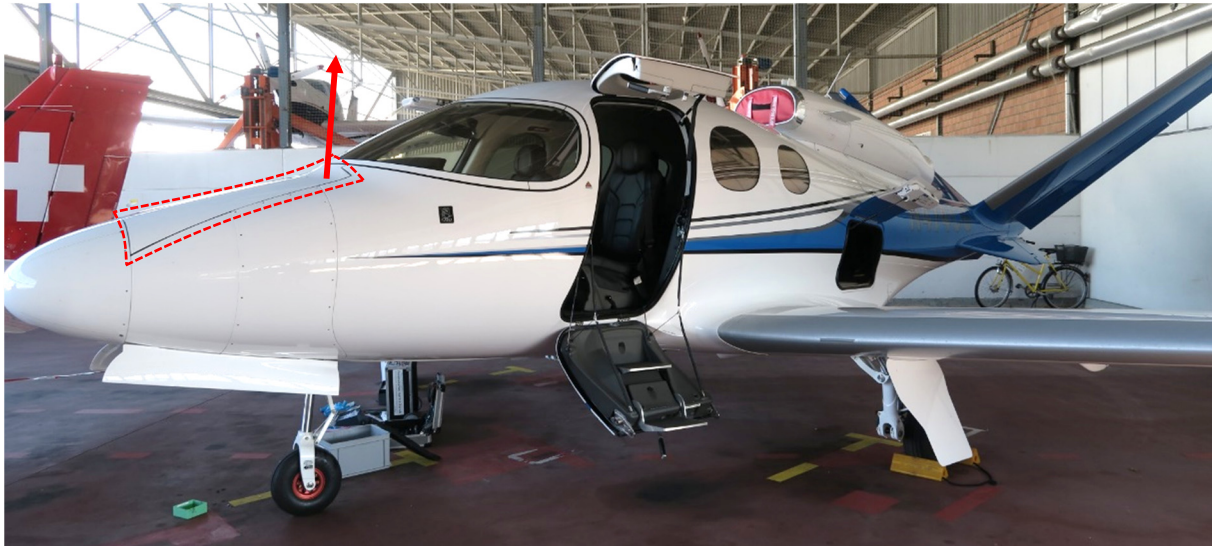
Figure 4: CAPS deployment opening (red dashed line) on the upper part of the front fuselage and direction of deployment of the rocket for the rescue parachute (red arrow).
