# **Final report No. 2408**

## **by the Swiss Transportation Safety Investigation Board STSB**

concerning the serious incident involving  
the aircraft Rockwell 112 “Commander”,  
N559SG,

on 18 September 2021

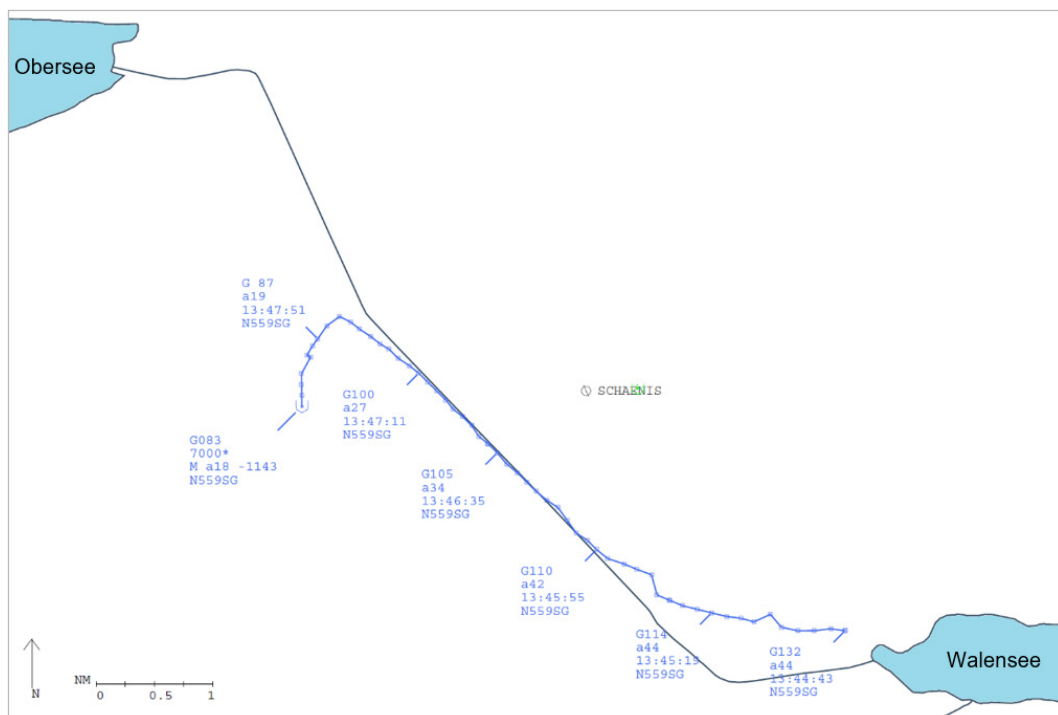
At approximately 15:25 on 18 September 2021, the pilot, who was alone onboard, took off from runway 30 of Bad Ragaz airfield (LSZE) in the aircraft Rockwell 112 "Commander", registered as N559SG. He flew along the Walensee towards Weesen. Shortly after Weesen and at a pressure altitude of around 4400 ft QNH<sup>2</sup>, the pilot suddenly became aware of vibrations (cf. figure 1). He checked the engine instruments, and seeing nothing untoward, continued the flight.

**Figure 1:** Radar recording of the N559SG's flight path indicating ground speed (G) in knots, pressure altitude (a) in hundreds of feet and time in UTC, from the Walensee to a position shortly before the aircraft landed at a pressure altitude of 1800 ft QNH. In the centre of the picture Schänis airfield (LSZX) can be seen; this is at 1365 ft AMSL and has a concrete runway 520 m long.
