Swiss Confederation

Summary report

Aircraft type	Beech B200 Super K	ing Air	N7779V			
Operator	Private					
Owner	Aerospace Trust Management LLC Trustee, 1013 Centre Rd Ste 403A, Wilmington, DE 19805-1270, USA					
Pilot	Dutch citizen, born 1	962				
Licence	Commercial Pilot Lic Aviation Administration	ence Aeroplane on (FAA)	(CPL(A)) issued	by the Federal		
Flying hours	Total On type	13 200 hours 549 hours	Last 90 Last 90	days62 hoursdays22 hours		
Second pilot	Dutch citizen, born 1	981				
Licence	CPL(A) issued by the	e Civil Aviation A	uthority Netherla	inds		
Flying hours	Total	427 hours	Last 90	days 3 hours		
	On type	239 hours	Last 90	days 0 hours		
Location	12.2 NM north-east of	of Lausanne Airp	ort (LSGL)			
Coordinates	553 337/171 312 (Sv N 46° 41' 29"/E 006°	viss Grid 1903) 49' 43'' (WGS ¹	Altitude 84)	Flight level 155		
Date and time	23 February 2019, 14	4:54:18 UTC (LT	= UTC + 1 hour)		
Nature of flight	Private					
Flight rules	Instrument Flight Rul	es (IFR)

Departure airport	Saanen (LSGK)					
Destination airport	Amsterdam (EHAM)					
Flight phase	Climb					
Nature of the serious incident	Total electrical failure)				
Injuries	Crew members	Pass	engers ⁻	Third parti

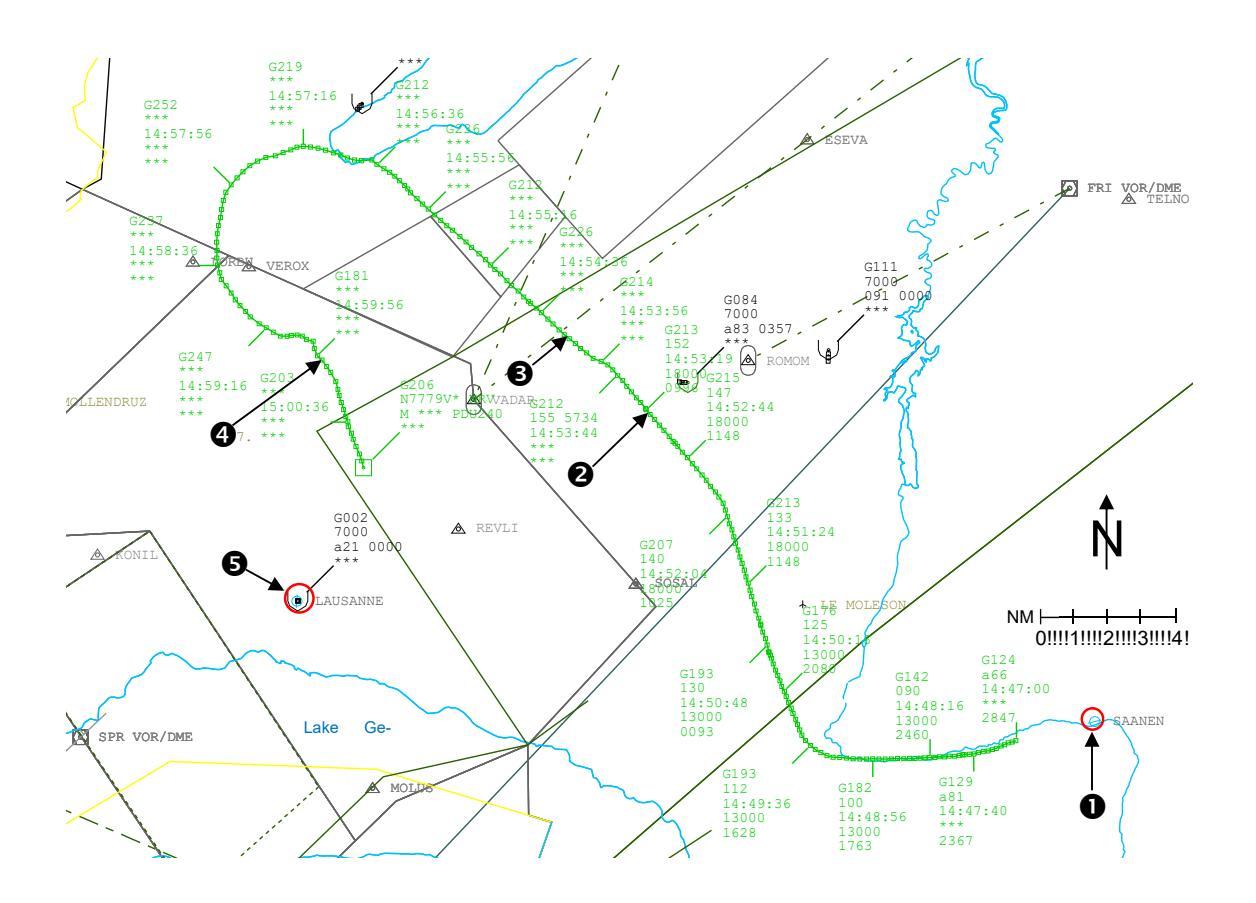
Appendix 1: Radar recording of the flight path (green) of N7779V and flight crew's communications with the air traffic controller

Lege	Legend					
	UTC	Flight level	Radio communication			
0	14:20:00		Take off from Saanen (LSGK)			
0	14:53:17	152	Pilot reports that he is climbing to FL 180, FL 150. The air traffic controller then gives clearance to the PENDU waypoint and FL 240.			
₿	14:54:18	155	Radio contact is lost and the «lost on» label is displayed			
4	15:00:03	Not known	The pilot reports on the 121.5 MHz emergency frequency that the aircraft is suffering a total electrical failure and that they plan to land in Lausanne.			
6	15:05:00		Landing in Lausanne (LSGL)
