# **Final Report No. 2390**

## **by the Swiss Transportation Safety Investigation Board**

concerning the accident involving the  
drone Matternet M2 V9, SUI-9903,

on 9 May 2019

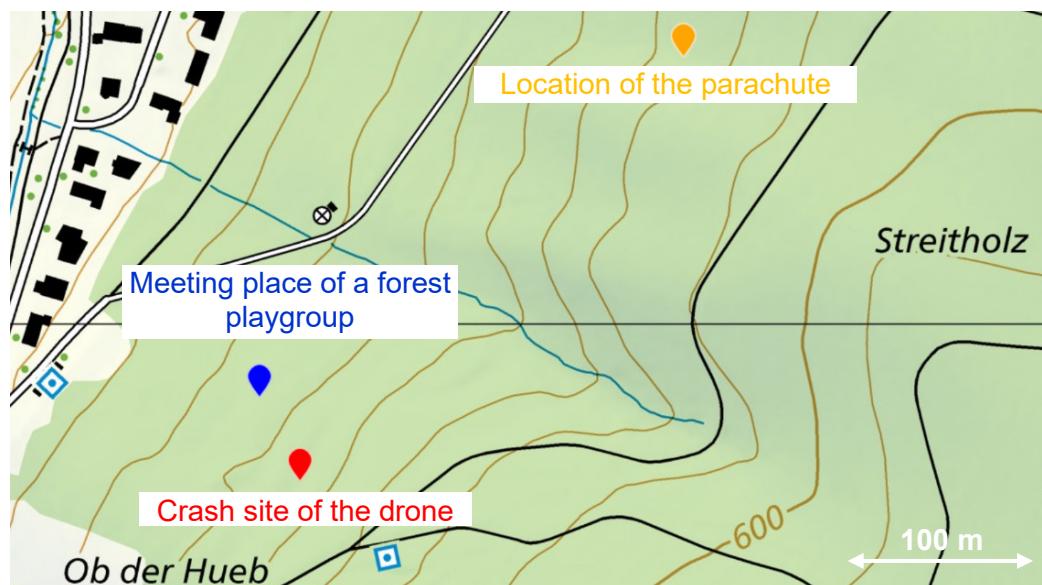
About one minute after take-off from the University of Zurich (UZH) Irchel, the drone automatically triggered the flight termination system (FTS) and initiated an emergency descent with a parachute. After ejection of the parachute, the connecting rope broke and the drone hit the forest floor near playing children without deceleration (cf. figure 1). The drone was destroyed on impact; no one was injured.

**Figure 1:** Crash site of the drone (red marker) in the wooded area "Ob der Hueb", about 500 m southeast of the University of Zurich (UZH) Irchel, not far from children playing in the woods (blue marker). The parachute (orange marker) was recovered in the trees about 330 m to the northeast. Source of map: Federal Office of Topography.

Neither the children nor the two kindergarten teachers who observed the crash of the drone at a distance of about 50 metres from the crash site (cf. figure 1) could perceive an acoustic warning signal.

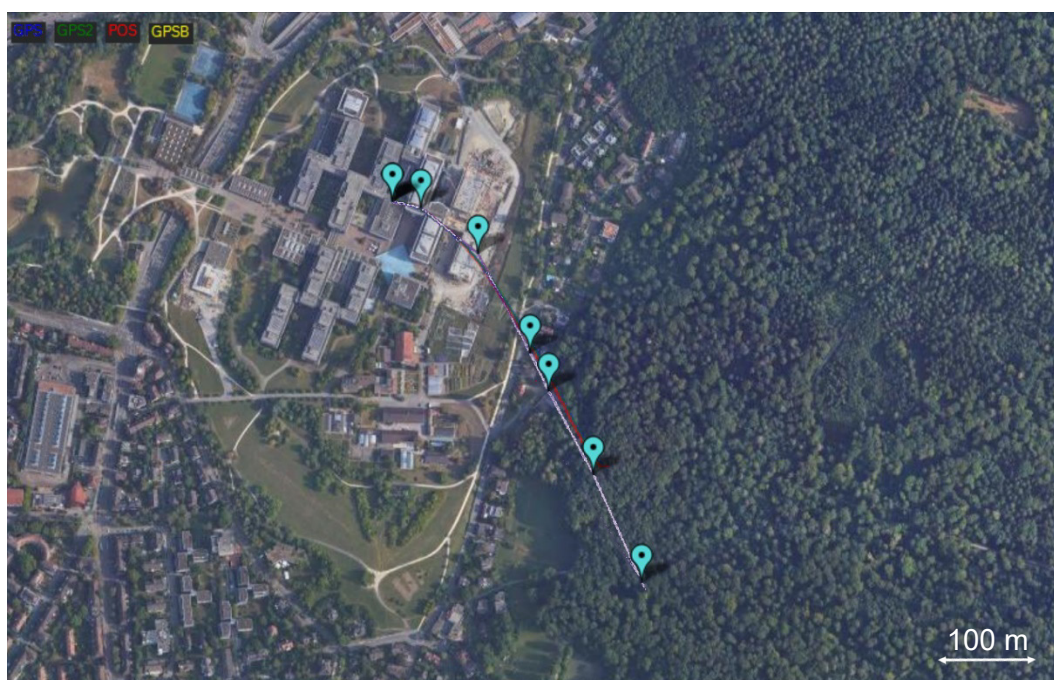
The log file of the accident flight included records from 10:03:33 to 12:41:26. During this time, the engines were activated three times; the actual flight took place between 10:37:35 (take-off) and 10:38:48 (impact). The map shows the completed part of the flight including some waypoints (cf. figure 7).

**Figure 7:** Map representation of the accident flight of SUI-9903 on 9 May 2019 according to the log files (source: STSB)

The drone initially ascended vertically to 92 m above the launch point on a magnetic heading of initially 302°. Subsequently, as the drone continued to climb, it also picked up speed in a horizontal direction, slowly turning towards the next waypoint. At 10:38:22, it reached a speed of 12.5 m/s over ground.
