Final Report by the Swiss Transportation Safety Investigation Board STSB

on the marine casualty concerning the
Swiss-flagged general cargo ship SABINA

off the island of Bornholm, Denmark,

on 15 October 2015

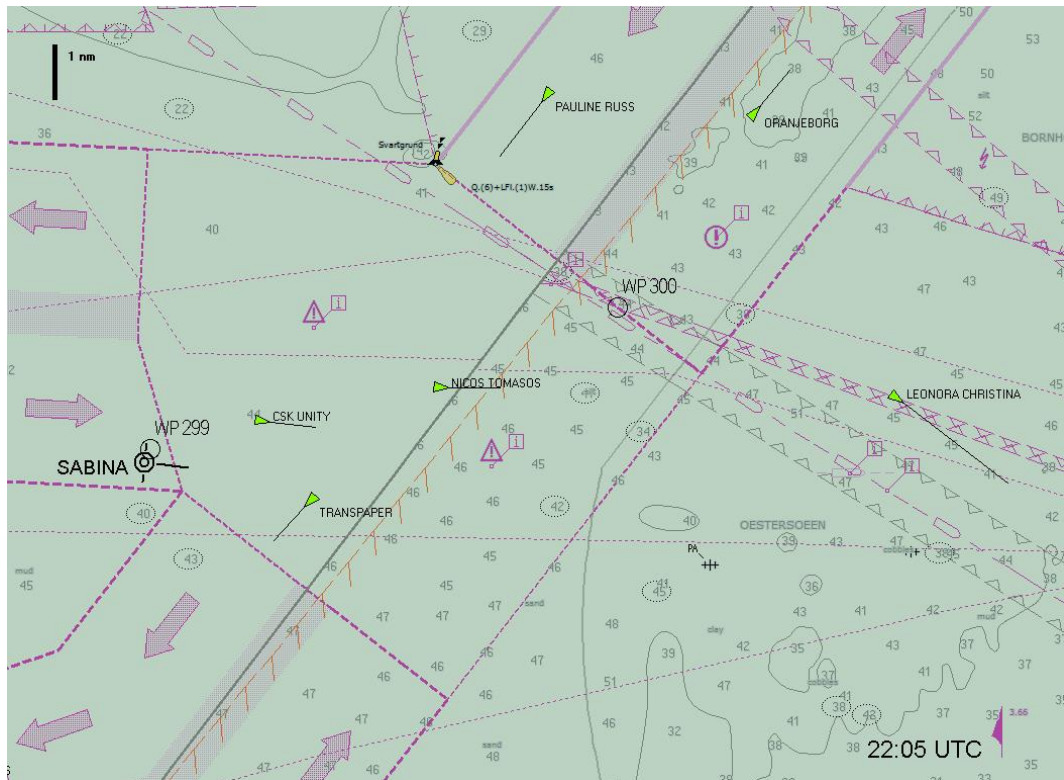
At 22:05 UTC, SABINA passed waypoint 299 but without changing course from 096° to 074°, as set out in the passage plan (see Figure 4, Figure 5 and Figure 8).

Figure 4: Waypoints, SABINA’s position and the traffic at 22:05 UTC as recorded by the AIS. SABINA passes waypoint 299 and maintains a course of 096°. CSK UNITY is sailing a virtually identical course and is about two nautical miles ahead of SABINA, to her port side.

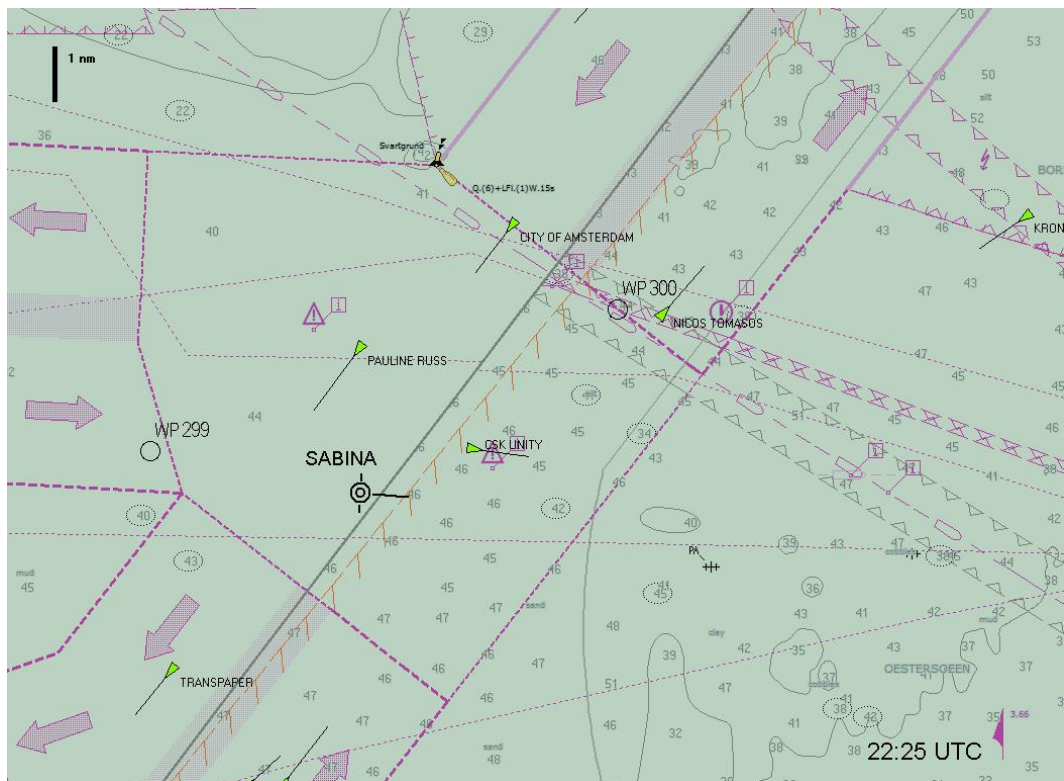
Figure 5: Waypoints 299 and 300, SABINA’s position and the traffic at 22:25 UTC as recorded by the AIS. SABINA is still holding a course of 096°. CSK UNITY also maintains its course and distance to SABINA. KRONVIKEN can be seen in the top right corner.

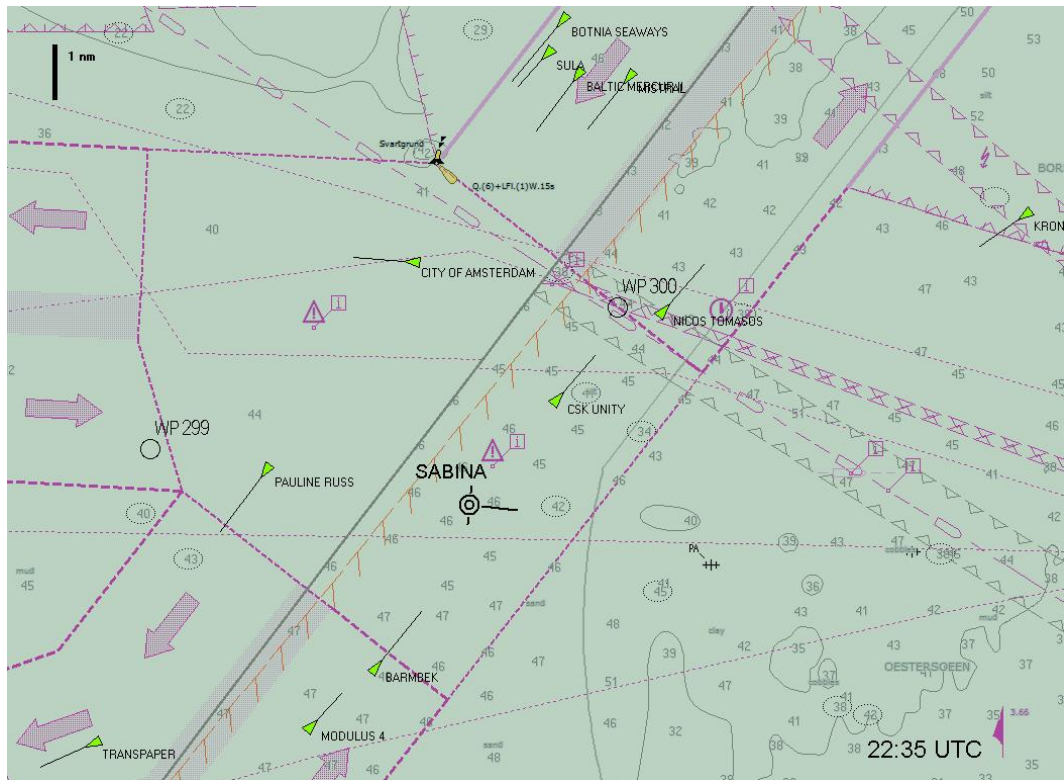
Figure 6: Waypoints 299 and 300, SABINA’s position and the traffic at 22:35 UTC as recorded by the AIS. SABINA is still holding a course of 096°. CSK UNITY changed course, now heading towards a north-easterly direction. BARMBEK approaches from the south-west.

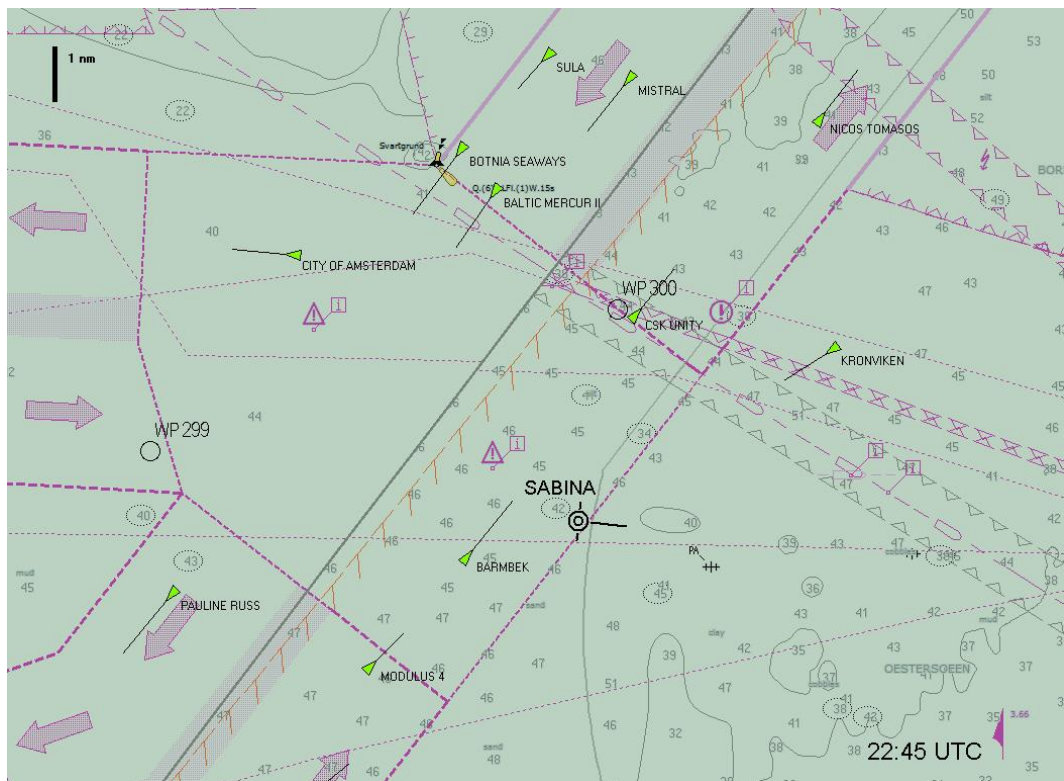
At 22:45 UTC, SABINA left the precautionary area that centrally connects the three zones of the Bornholmsgat TSS (see section 1.9.2), heading towards 096° (see Figure 7).

Figure 7: Waypoints 299 and 300, SABINA’s position and the traffic at 22:45 UTC as recorded by the AIS. SABINA still holds a course of 096° and leaves the precautionary area of the Bornholmsgat TSS. The boundaries of the Bornholmsgat TSS and its precautionary area are shown with purple, dashed lines.

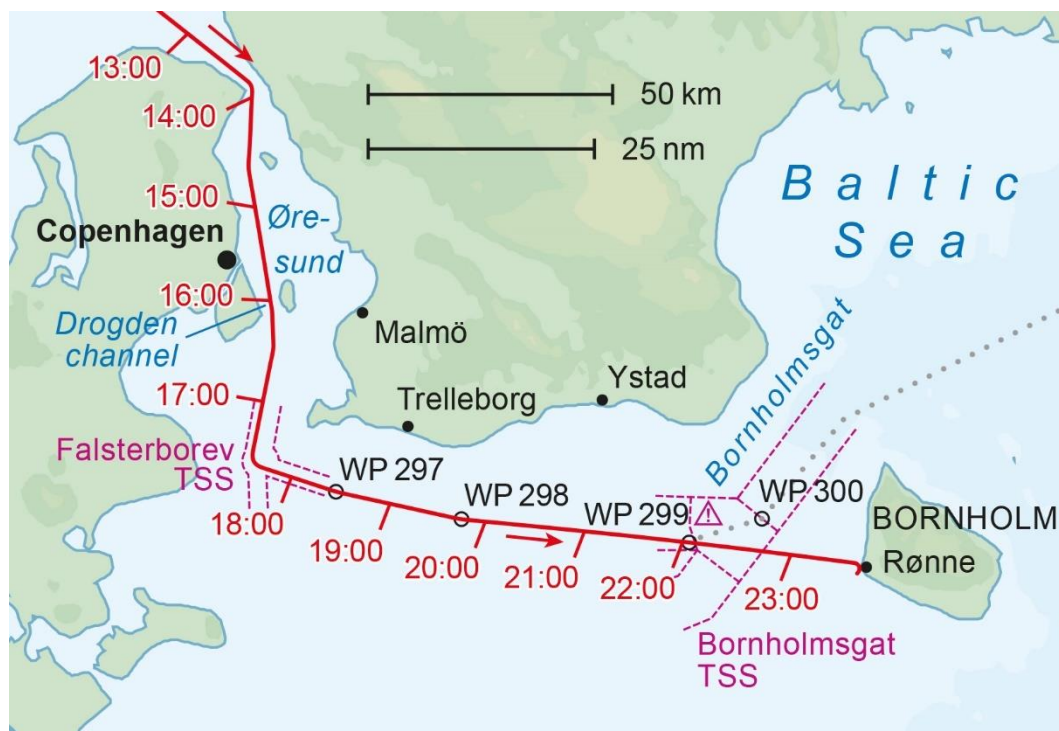
Figure 8: SABINA's actual track from Øresund to the position of grounding off Bornholm (red line) with time markers in UTC. SABINA's intended route, as set out in the passage plan, from waypoint (WP) 299 through Bornholmsgat and towards the open Baltic Sea (grey, dotted line). Base map: Wikimedia Commons.

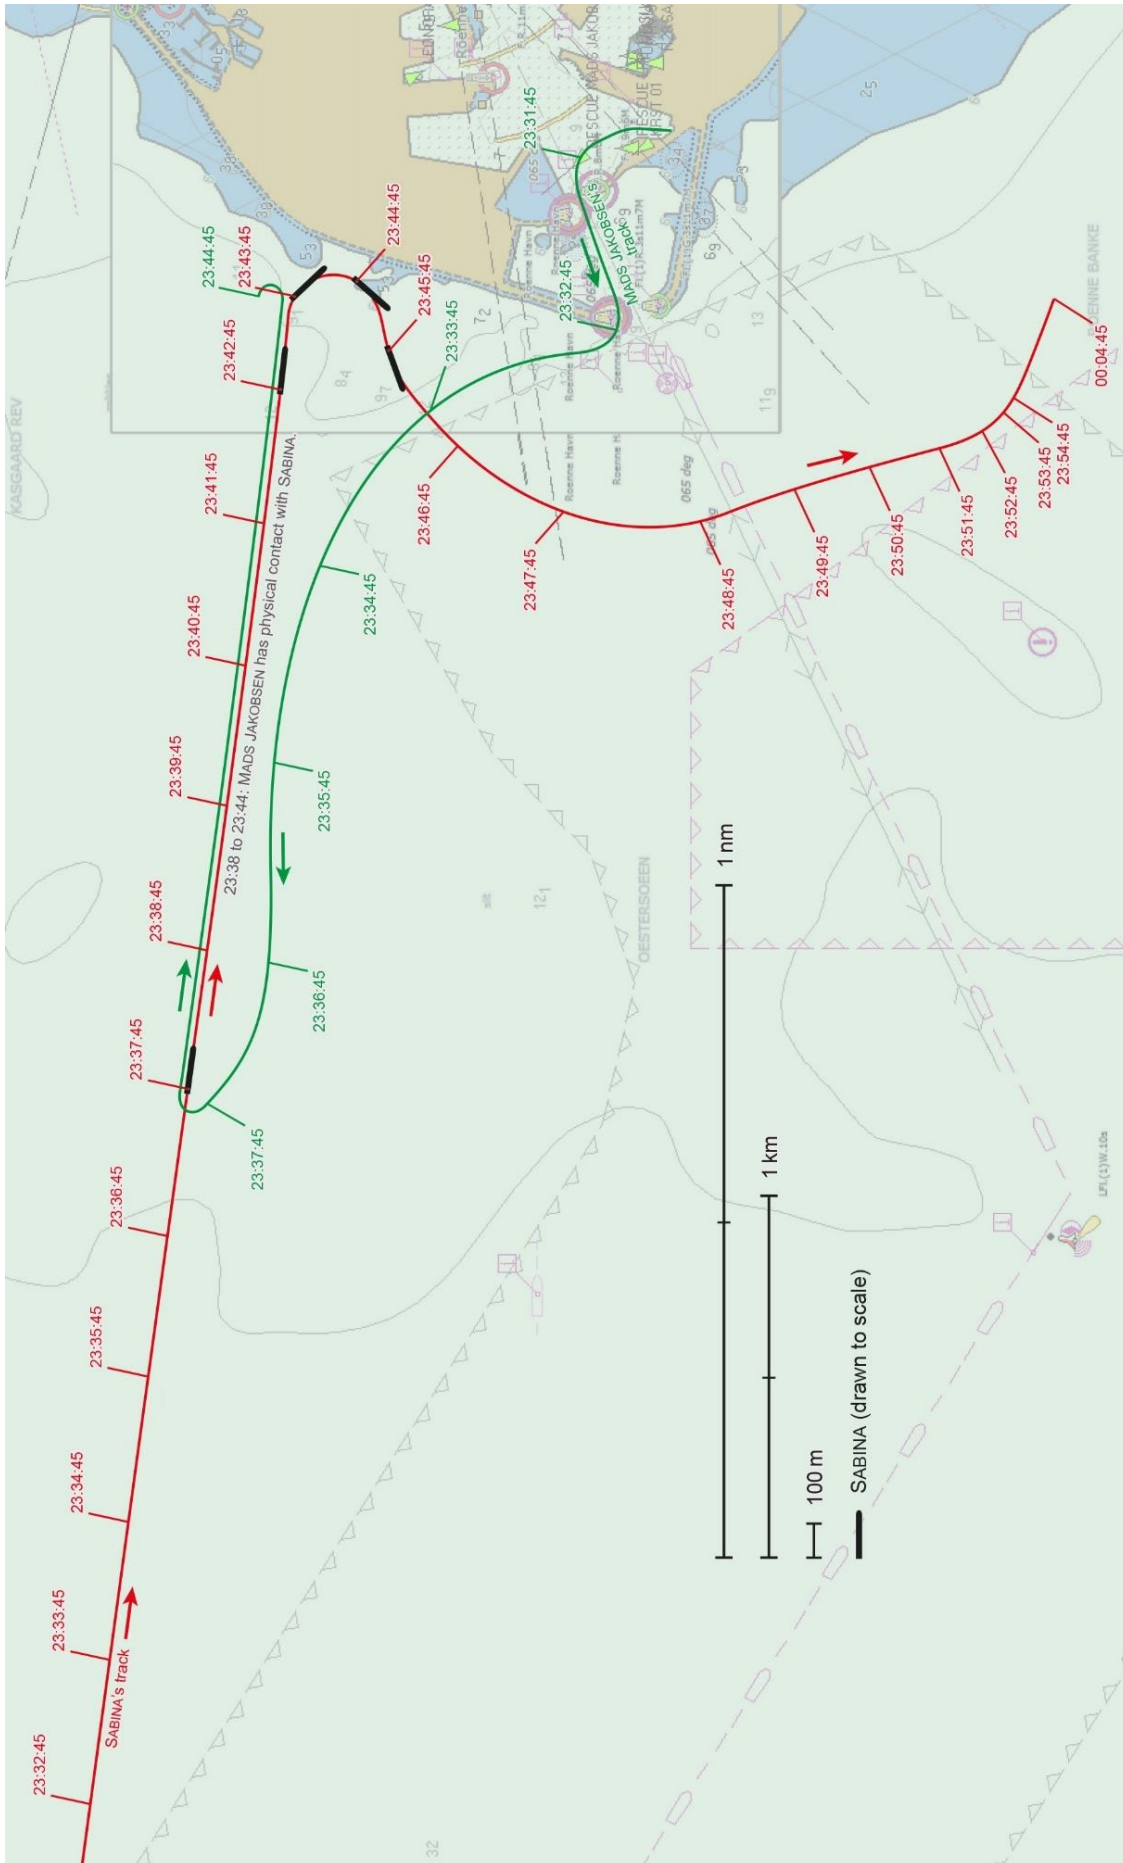
During its turn to starboard, SABINA struck the seabed off the west coast of Bornholm on several occasions between 23:43:38 UTC and 23:45:15 UTC and grounding²² could be heard in the wheelhouse. The shortest distance between the vessel's hull and the rocky coast was between 20 and 50 metres.²³ The ship's speed was temporarily reduced to approximately five knots during the turning and braking manoeuvre. The yaw to port of SABINA's stern during the vessel's turn to starboard had also slightly damaged MADS JAKOBSEN, whose crew was banging on SABINA's port-side hull below the ship's superstructure at the time.

²² The nautical charts show water depths ranging between 5.3 and 7 metres for this area. SABINA crossed the 6-metre depth contour displayed on the nautical charts which protrudes from the coast into the sea at this point at least twice (see Figure 9). According to the nautical chart, the seabed there is made up of cobbles.

Figure 9: Tracks of SABINA (red) and MADS JAKOBSEN (green) off Bornholm. Outlines of SABINA drawn as icons to scale. Track of SABINA displayed up to the location of anchorage. Track of MADS JAKOBSEN shown until turning away from SABINA. Times in UTC.

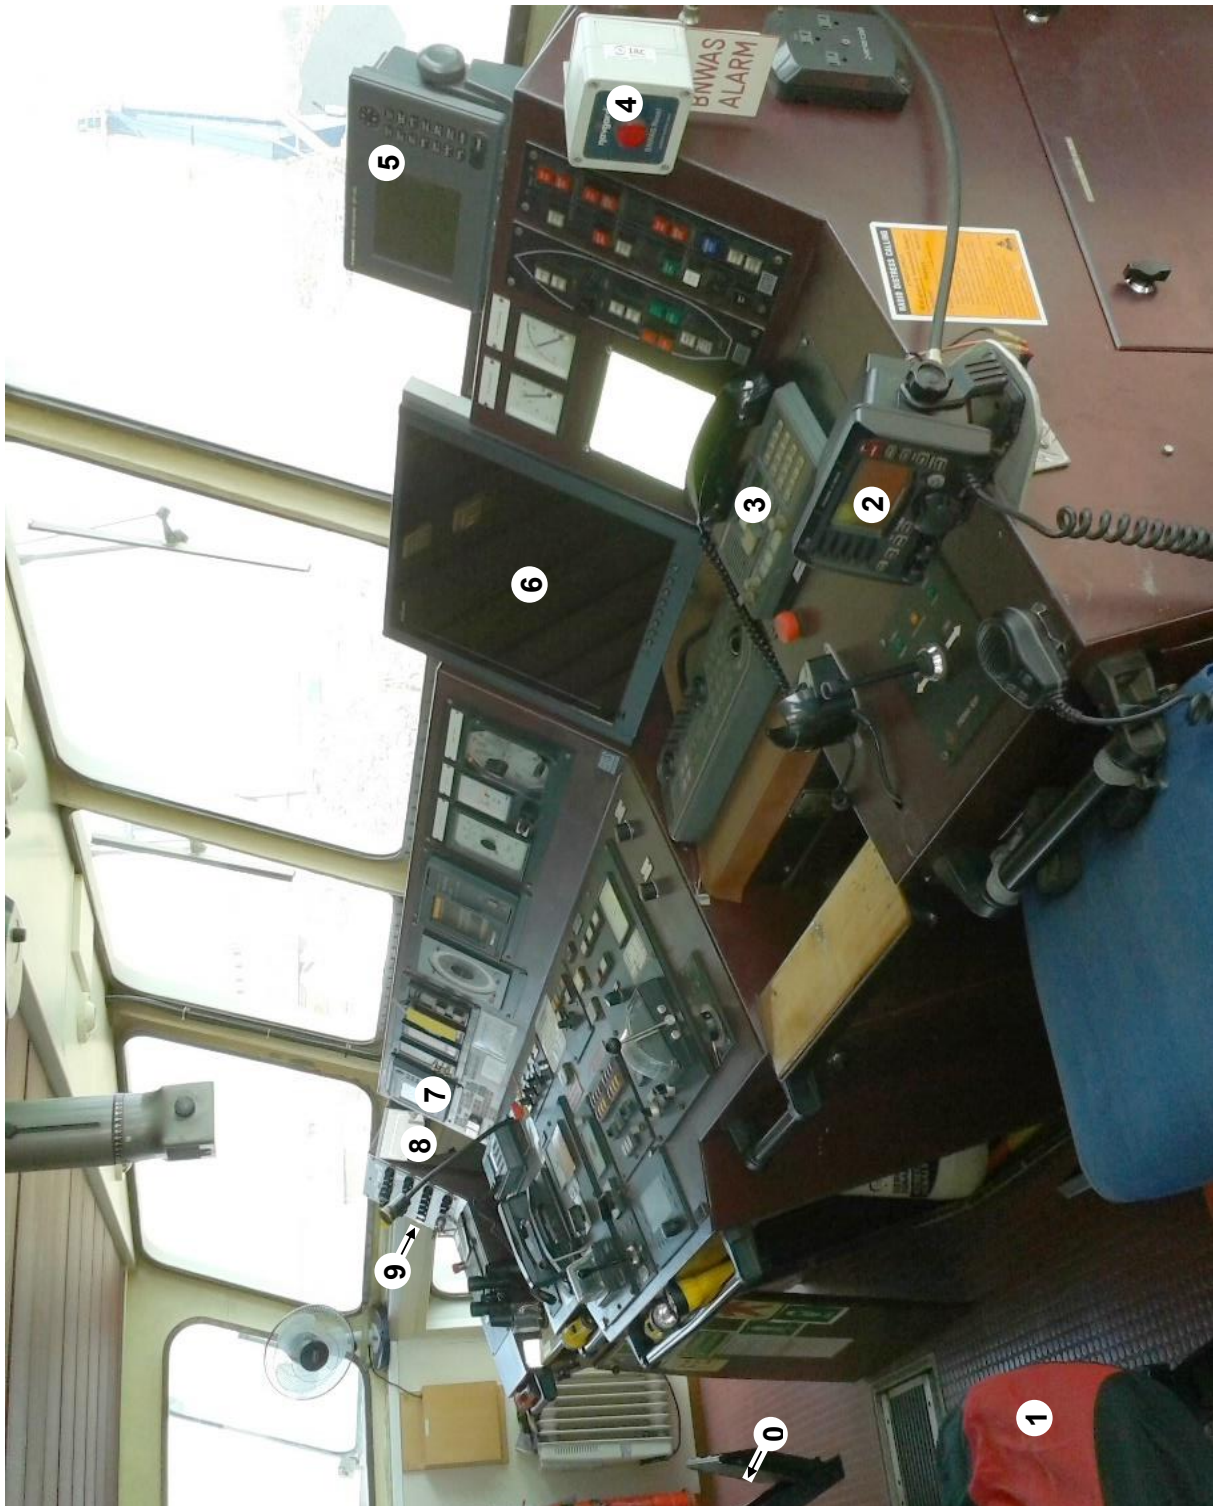
Figure 17:
Bridge control panel on board
SABINA.

On board SABINA, the control panel of the BNWAS installed on the port side of the bridge control console (see Figure 17) was visible from the port-side seat in front of the console. However, it was not visible from the starboard seat in front of the console and from other locations on the bridge.
