Final Report by the Swiss Transportation Safety Investigation Board STSB

on the marine casualty concerning the
Swiss-flagged general cargo ship SABINA

in a shipyard in Constanța, Romania,

on 26 June 2015

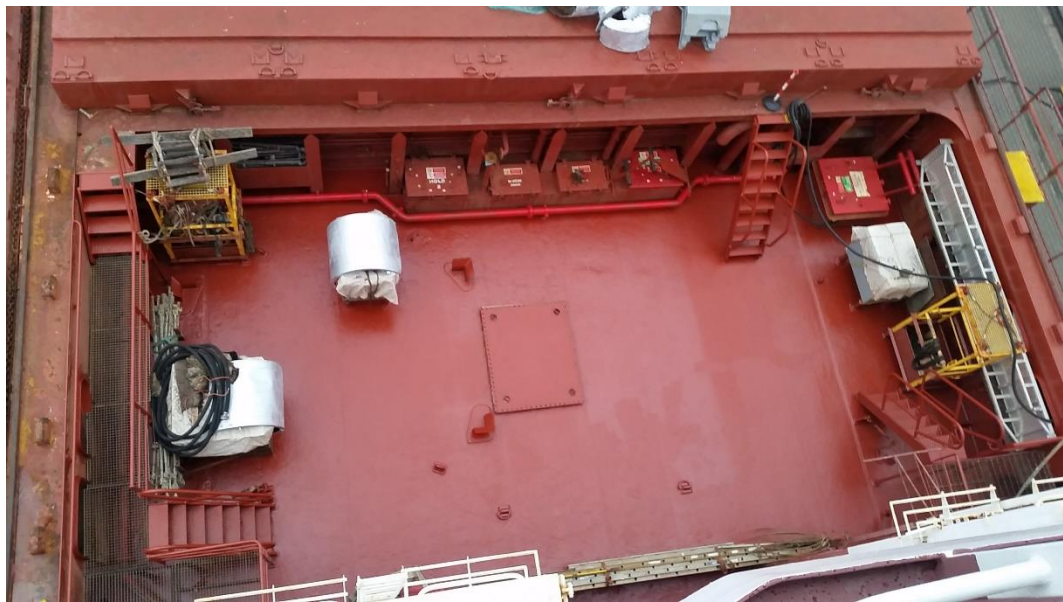
Skylight is the term used by SABINA's crew to refer to a maintenance hatch, measuring approximately 1.5 metres squared, that leads from the main deck into the engine room below (see Figure 2 and Figure 3). The hatch was usually closed, particularly during voyages. Prior to major work in the engine room, the hatch could be opened to allow components or heavy tools to be raised and lowered. To open the hatch, chains would be attached to the hatch cover (see Figure 4). The hatch cover could then be lifted from – and placed back onto – the coaming.⁵ A crane was usually used, as the cover weighed more than 100 kilos.

The coaming on the maintenance hatch on the main deck was just a few centimetres high.

Figure 3: The vertical view from the accommodation down to the main deck. The closed maintenance hatch is in the centre.
