Final Report No. 1887

by the Federal Aircraft Accident Board

concerning the total failure of the radar air picture presentation

on all workstations of the Area Control Centre (ACC)
and the approach and departure control centre (APP)
in Zurich Air Traffic Control (ATC ZRH)
on 11 November 2003

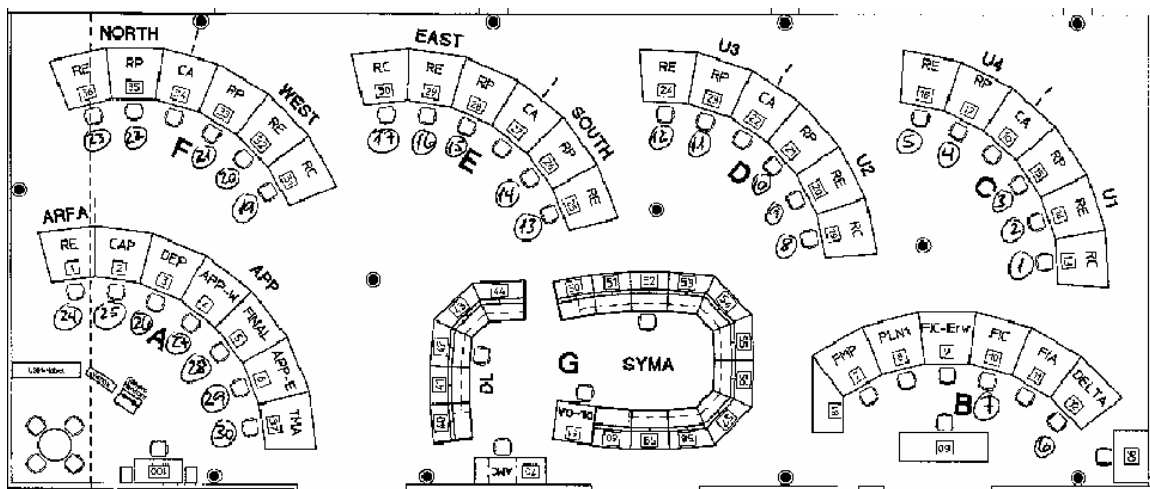
Figure 4: CIR layout (schematic)

In the CIR layout (cf. figures 4 and 5), the numbers of the Xservers which serve the respective radar screen of the ICWS are also entered. Every two Xservers receive the radar data from one Xclient. For every three operative Xclients, one Xclient is ready in standby mode.
