Büro für Flugunfalluntersuchungen BFU
Bureau d'enquête sur les accidents d'aviation BEAA
Ufficio d'inchiesta sugli infortuni aeronautici UIIA
Uffizi d'inquisiziun per accidents d'aviatica UIAA
Aircraft Accident Investigation Bureau AAIB

Summary Report No. 1970

concerning the Marvel Schebler / Precision Airmotive
carburettor respectively float system faults in Switzerland

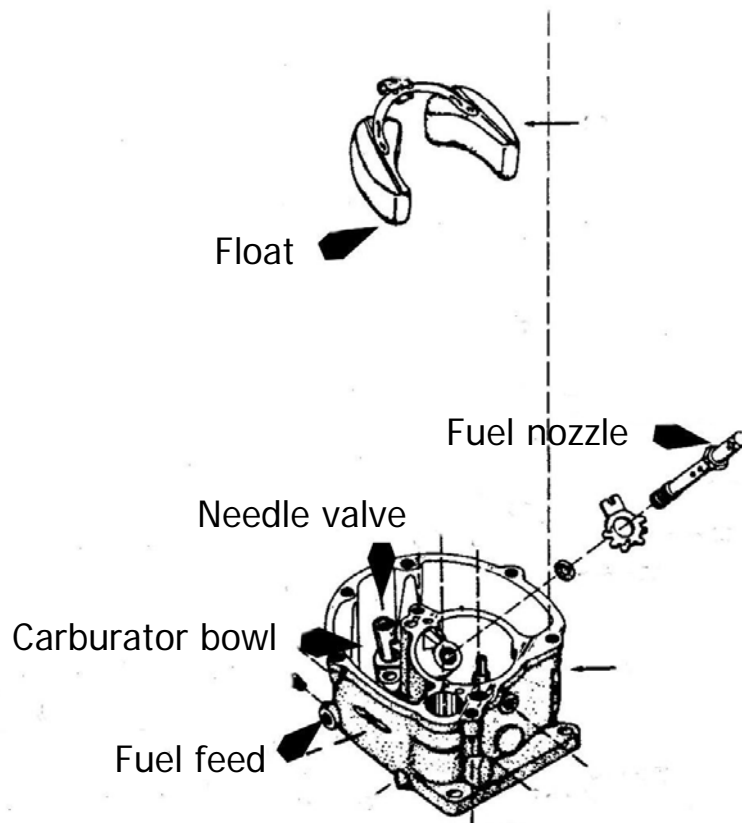
In order to avoid pressure fluctuations which might result in an incorrect mixture generation, the fuel level in the carburettor bowl must be kept as constant as possible. To control the level, a buoyancy device, known as a float, controls a needle valve. When the level in the carburettor bowl drops, the float opens the needle valve and allows the fuel to flow in. When the desired fluid level is reached, the valve seals the fuel feed. The desired fluid level is permanently set by the float and the needle valve. If the needle valve does not close when the fluid level is reached, this causes the carburettor bowl to overflow (see Fig. 1).

Fig. 1: Partial view of the Marvel Schebler/Precision Airmotive carburettor
