Final Report No. 2092

concerning the serious incident (AIRPROX)

involving the Airbus A321 aircraft, registration F-GTAE

and the Airbus A320 aircraft, registration CS-TNG

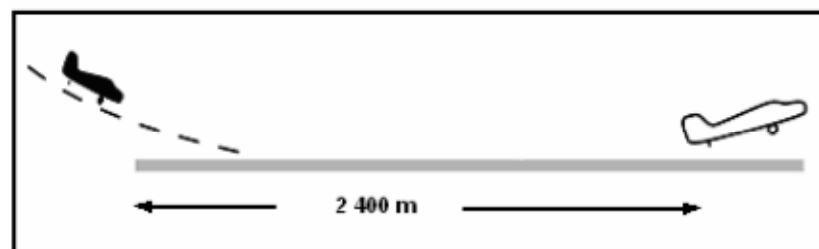
Fig. 9-11

the preceding aircraft is airborne and has passed a point at least 2 400 m from the threshold of the RWY (Figure 9-11).
