Summary Report

Aircraft	Avro 146-RJ100	HB-IYR		
Operator	Swiss Global Air Lines AG, Malzgasse 15, 4052 Basel			
Owner	Swiss International Air Lines Ltd., Malzgasse 15, 4052 Basel			
Pilot	Swiss citizen, born 1982			
Licence	EASA (European Aviation Safety Agency) Airline Transport Pilot Licence Aeroplane (ATPL(A)), issued by the Federal Office of Civil Aviation (FOCA)			
Flying hours	Total	3,419 h	During the last 90 days	91 h
	On the incident type	3,171 h	During the last 90 days	91 h
Co-pilot	German citizen, born 1990			
Licence	EASA Commercial Pilot Licence Aeroplane CPL(A), issued by FOCA			
Flying hours	Total	820 h	During the last 90 days	73 h
	On the incident type	550 h	During the last 90 days	73 h
Location	approx. 8 NM south of runway 28 in Zurich			
Coordinates	---	Altitude	approx. FL 080	
Date and time	24 th October 2016, 19:28 UTC			
Type of operation	Scheduled flight			
Flight rules	Instrument Flight Rules (IFR)

Flight phase	Approach to runway 28 in Zurich			
Type of serious incident	Oil fume smell in the cockpit, use of oxygen masks			
Point of departure	Birmingham airport (EGBB)			
Destination	Zurich Airport (LSZH)			
Injuries to persons	Crew	Passengers	Third parties	
M

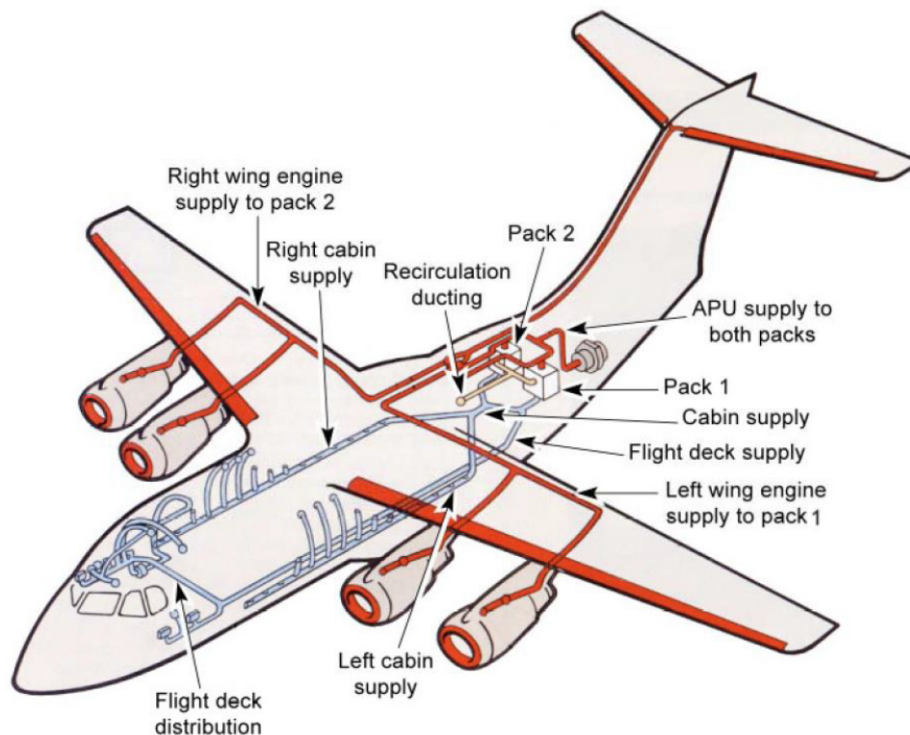
Illustration 1: Bleed air system (source: flight crew operation manual (FCOM) of Swiss)

The pressure ventilation system supplies the cockpit and cabin with conditioned air. This is taken as APU bleed air or as ENG bleed air and is processed by two air conditioning packs (PACKs). The two PACKs are located at the rear of the aircraft (see illustration 1).

PACK 1 is supplied by the APU or the left-hand engines, PACK 2 is supplied by the APU or the right-hand engines. Under normal circumstances, PACK 1 supplies the cabin and cockpit, whilst PACK 2 only supplies the cabin.

The same hot bleed air from the engines (in red on illustration 1) that also feeds the two air conditioning packs can prevent the formation of ice on the leading edges of the wings and of the horizontal stabiliser. The activation or deactivation of the defroster thereby also changes the condition of the bleed air which is supplied to the packs.

After a renewed inspection of the air quality using an aerotracer¹, oil fume particles could be detected in the air as soon as the bleed air from engine 2 was used. It should be noted that the bleed air from engine 2² feeds the left-hand air conditioning pack, which is primarily responsible for the air supply in the cockpit (see illustration 1). As there was also evidence of fume particles after the incident on 1st October 2016 under the same conditions (see previous incidents), the maintenance company decided to change engine 2.
