## Summary Report

| <b>Aircraft</b> | AVRO 146-RJ100 | HB-IYT | | |

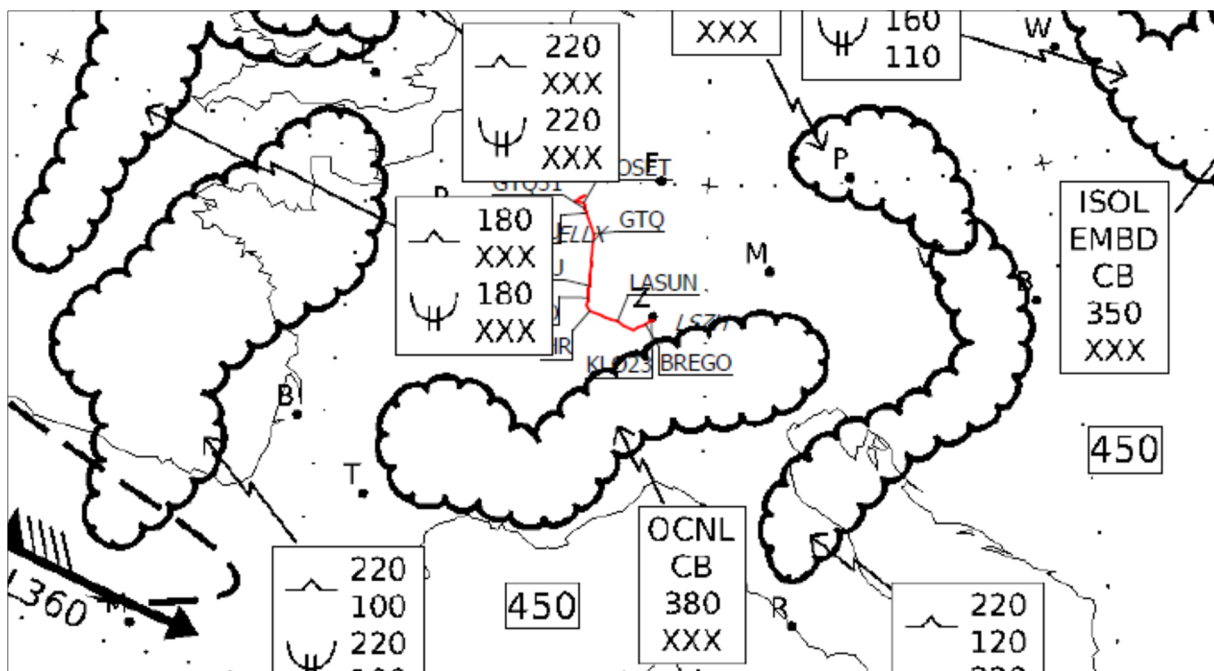
**Illustration:** Extract from the flight weather map used by the flight crew with the forecast for 18:00 UTC. The planned flight path from Zurich to Luxembourg was recorded in red.

The flight weather forecasts on which the flight preparation was based did not present the prospect of any thunderstorm activity for Luxembourg, but rather only light, transient showers. Weather that would allow unproblematic flying was forecast for the alternate airport, Brussels. Against this backdrop, the flight crew's decision to carry extra fuel for 20 further minutes of flight time is understandable, but it meant that there was relatively little time available to assess the situation when weather conditions developed differently than expected.
