Summary Report

Aircraft	AVRO 146-RJ100	HB-IYW	
Operator	Swiss Global Air Lines AG, Malzgasse 15, 4052 Basel (Switzerland)		
Owner	Swiss International Air Lines Ltd., Malzgasse 15, 4052 Basel (Switzerland)		
Pilot	Swiss citizen, born 1974		
Licence	Airline transport pilot licence aeroplane (ATPL(A)) according European Aviation Safety Agency (EASA), issued by the Federal Office of Civil Aviation (FOCA)		
Flying hours	Total 9535 h	During the last 90 days 142 h	
	On the incident type 5888 h	During the last 90 days 142 h	
Copilot	Swiss citizen, born 1969		
Licence	EASA ATPL(A), issued by FOCA		
Flying hours	Total 9423 h	During the last 90 days 127 h	
	On the incident type 9112 h	During the last 90 days 127 h	
Location	2 NM east of runway 10 in Nuremberg		
Coordinates	---	Altitude approx. 2000 ft AGL ¹	
Date and time	15 September 2016, 13:27 UTC		
Type of operation	Scheduled flight		
Flight rules	Instrument flight rules (IFR)

Flight phase	Climb		
Type of serious incident	Smell of oil in the cockpit, use of oxygen masks		
Point of departure	Nuremberg Airport (EDDN)		
Destination	Zurich Airport (LSZH)		
Injuries to persons	Crew	Passengers	Third parties
Minor	0	0	0
None	4	90	-
Damage to a

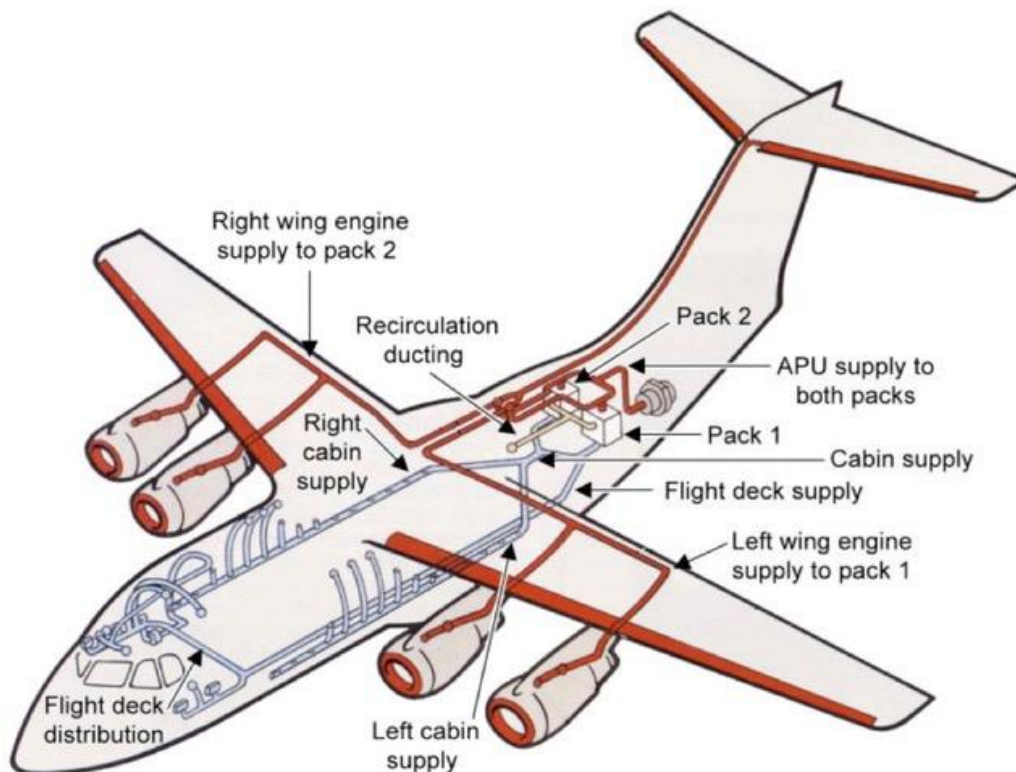
The pressure ventilation system supplies the cockpit and the cabin with conditioned air. This is taken as bleed air from the APU or the engines and processed by two air conditioning packs (PACKs). Both PACKs are located at the rear of the aircraft (see illustration 1).

Illustration 1: Bleed air system (source: flight crew operation manual (FCOM) of Swiss)

PACK 1 is supplied by the APU or the left-hand engines, PACK 2 is supplied by the APU or the right-hand engines. Under normal circumstances, PACK 1 supplies the cabin and the cockpit, and PACK 2 only supplies the cabin. When only one PACK is in operation, it supplies both the cabin and the cockpit.
