Swiss Transportation Safety Investigation Board STSB Annual Report 2018

Swiss Transportation Safety Investigation Board STSB

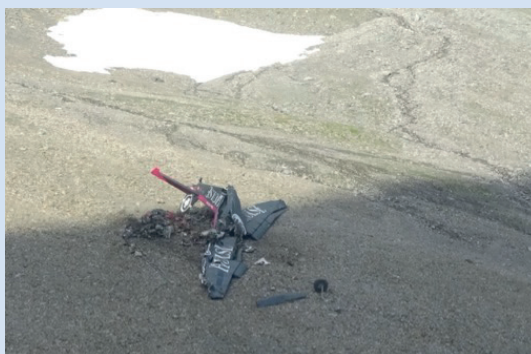
On 4 August 2018 at 16:10, an historic Junkers Ju 52/3m g4e commercial aircraft, registered as HB-HOT and operated by Ju-Air from Locarno airport, took off on a flight to Dübendorf military airfield. The plane collided approximately vertically with the terrain at 16:56 about 1.2 km

Considerable corrosion damage was found on the wreck of the HB-HOT on the spars, hinges and fittings of the wings and in the area of the cabin floor plate. Two of the three engines were equipped with newly manufactured cam disks which had defects.

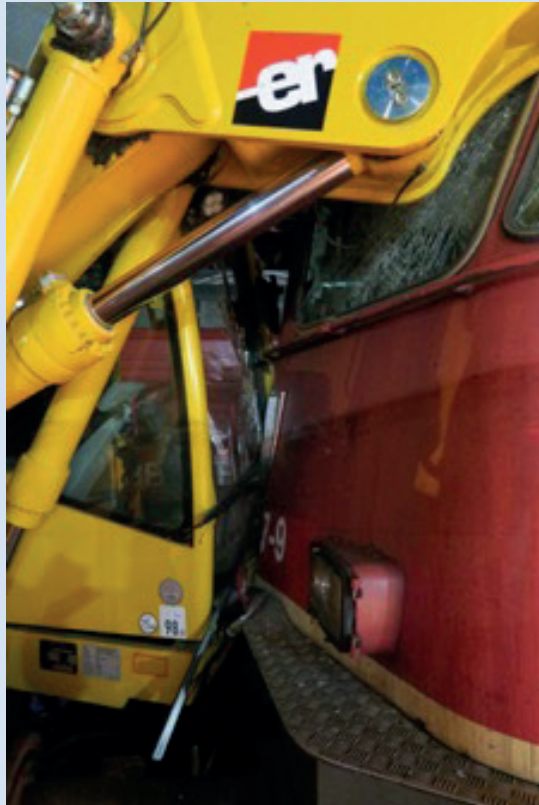
A road-rail vehicle joining, between two axle counting points, a closed track equipped with a clear track detection device in the form of an axle counter system does not automatically generate an occupied signal for the track concerned. The presence of the vehicle is not signalled to the signal box. This means that the track closure can be lifted, even though there is a vehicle on the track.

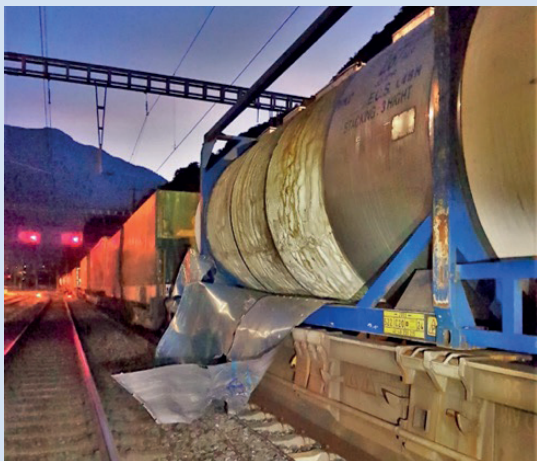
At 04:16 on 19 September 2018, freight train 42017, travelling from Cologne Eifeltor (D) to Busto Arsizio (I), triggered an alarm in the profile and antenna location system after the south portal of the Gotthard Base Tunnel (GBT) in Claro (CH). The train was stopped in accordance with regulations for an inspection at the Bellinzona San Paolo intervention station. During the inspection, the locomotive driver discovered that the metal casing of a tank container loaded on the 16th wagon had come loose and was protruding sideways into the track area. This metal casing protruding beyond the clearance gauge damaged infrastructure elements over several kilometres between Claro and Bellinzona San Paolo.

Violation of the clearance gauge by incorrectly fastened or loose parts of a wagon or its load can lead to hazards that can cause not only material damage but also injuries.
