# Swiss Transportation Safety Investigation Board STSB Annual Report 2019

Swiss Transportation Safety Investigation Board STSB

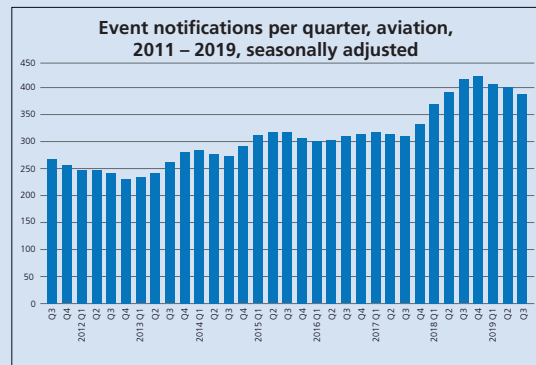
**Diagram 1:** Number of incidents reported per quarter and relevant to the aviation sector between 2011 and 2019. Seasonal effects were adjusted by means of a moving average.

Since 2011, the number of reported incidents has steadily increased, to a provisional maximum of 1566 in 2019 (diagram 1). In contrast to 2018, when the number of investigations opened reached its peak of 119, in 2019 the number of investigations opened, 64, was considerably lower (diagram 2).

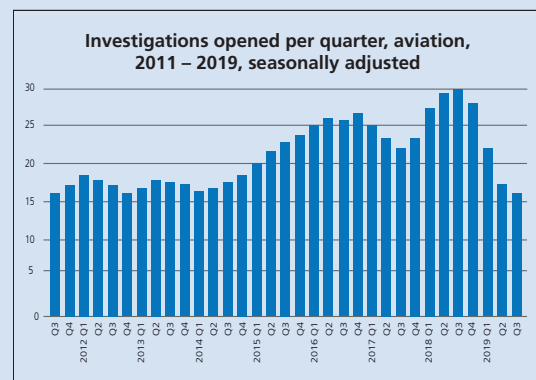
**Diagram 2:** Number of investigations opened per quarter in aviation due to reported incidents. Seasonal effects were adjusted by means of a moving average.

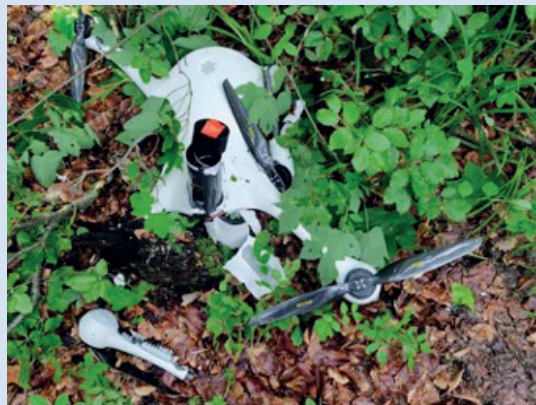
Approximately two minutes after take-off at the University of Zurich, Irchel, the drone flight termination system tripped automatically and initiated an emergency landing.

After deployment of the parachute, the canopy suspension line ruptured and the drone fell unchecked to the ground in the wood and was destroyed.

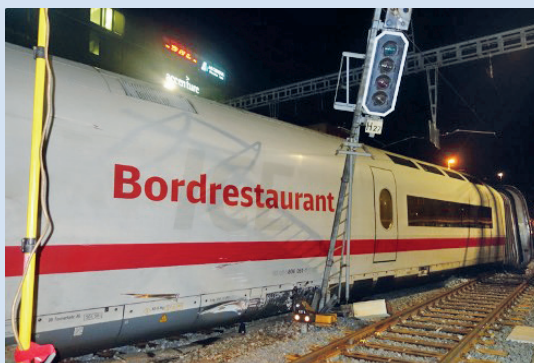
The derailment of the ICE 75 when arriving at Basel SBB station at the curved double-slip points 317 is due to the fact that as a result of the large gap dimension caused by the stock rail tilting away at the switch rail, the first left wheel of carriage 9 ran on to the top edge of the switch rail some 50 cm after its tip, lost its guidance from the rail and derailed after two metres. The investigation showed that the inadequate lubrication of the rail running edges and switch rails can contribute to the risk considerably.

Measurements and various simulations showed that the friction coefficient between the wheel flange face and rail flank can reach values of up to 0.6. This results in significant lifting of the wheel when travelling around a curve, which in turn can – and did – lead to a critical condition for derailment in
