Swiss Transportation Safety Investigation Board STSB Annual Report 2024

Swiss Transportation Safety Investigation Board STSB

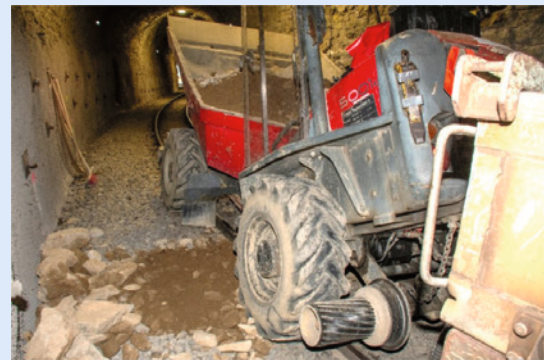
- The machine operator relied on his colleague's information that the rear rail undercarriage had been successfully lowered.
- The dumper truck was not additionally secured to prevent it rolling away unintentionally during on-tracking. There was no specification to this effect in the operating rules.

During on- or off-tracking of road-rail vehicles, one rail axle remains unbraked for a short amount of time, during which the other axle must apply the entire holding force. If this holding force is insufficient, the vehicle will slip or roll away, especially on steep gradients. Little training or consideration is given to protection against this risk.

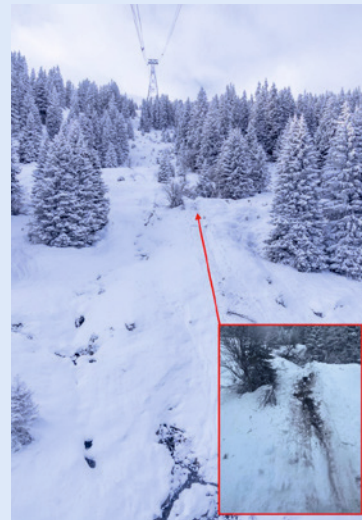
- The load measuring device in cable car cabin No 2 was deactivated.
- The cable car was operated with the load measuring device deactivated and passengers and material were transported at the same time.
- The machine operator incorrectly calculated the weight of the material transported.
- The cabin attendant had limited operating experience.

A load measuring device is a safety device that plays a key role in the safe operation of a cableway system when people and material are transported at the same time. It is only permitted to override this load measuring device in emergency situations, i.e. not permanently. Because it frequently malfunctioned, the load measuring device was regularly deac-
